## FIELD VISIT REPORT

### MURUNGA WEWA TANK REHABILITATION (PHASE II – CSIAP)

**Location:** Murunga Wewa Tank, Wilmannna Cascade, Hambantota District

**Project:** Climate Smart Irrigated Agriculture Project (CSIAP) – Phase II

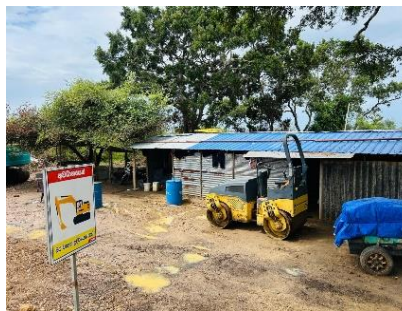
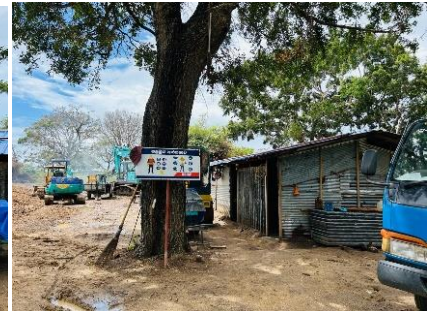
1. Construction and Site Management:  
The contractor has established a site office at the worksite.

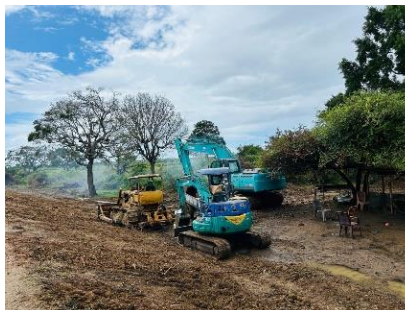
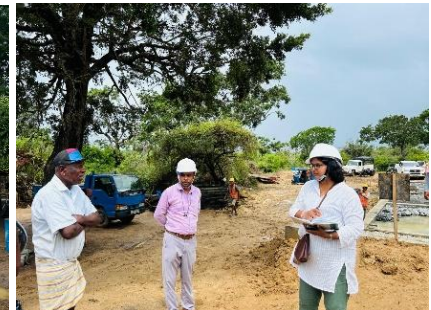
2. Machinery was present, but inactive on the day of the visit due to heavy rainfall earlier.

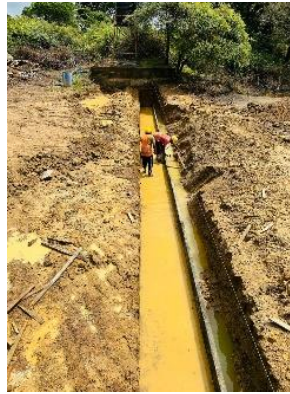
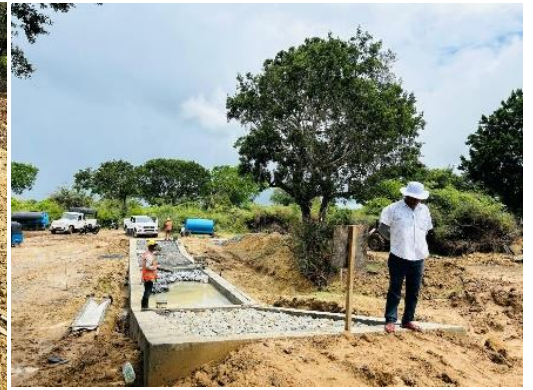
3. About eight laborers were engaged in light duties during the visit.

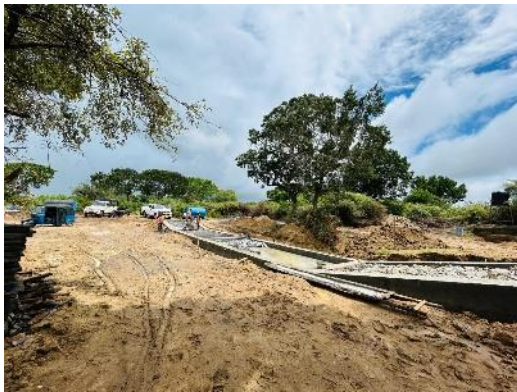
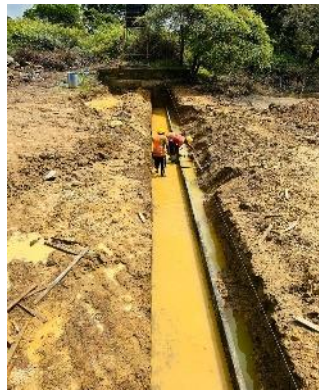
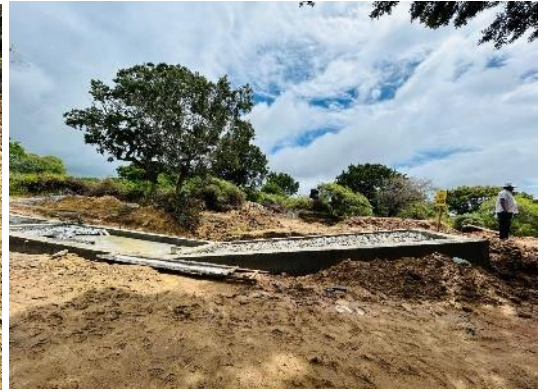
4. Construction Progress & Delay: Farmers reported significant deviations in the weather pattern, with an unusual increase in rainfall during the last months. The contractor originally planned to complete the rehabilitation by August 2025, but due to unusually heavy rains over the past three months, completion is now expected by September 2025.

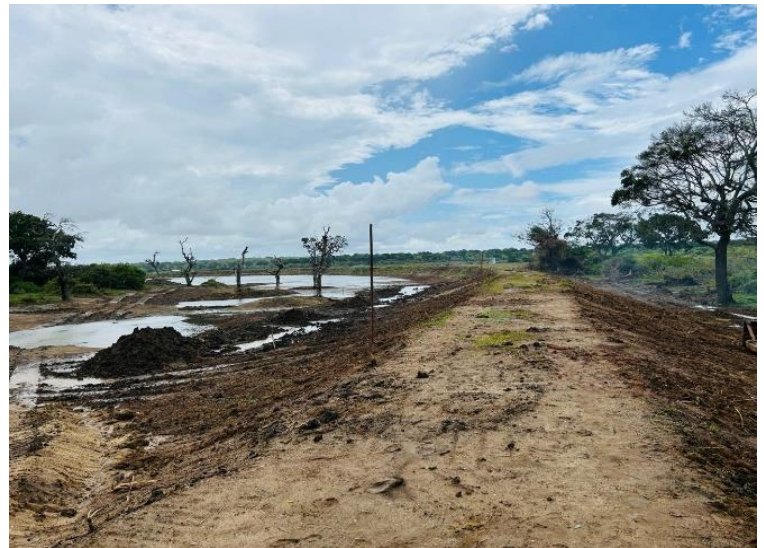
5. Environmental Compliance: The tank is located within a wildlife boundary. Elephant movement and crocodile sightings were noted, especially Elephant movements after 4:30 pm. Contractors are not permitted to work after 6:00 pm. An elephant fence has been temporarily installed to safeguard workers and equipment. It was reported that wildlife officer visits the site regularly during major construction/ rehabilitation activities. All relevant information (vehicle numbers, worker names, IDs) was submitted to DWLC beforehand. Approximately 30% of tank water is retained to support wildlife, in line with DWLC guidance.

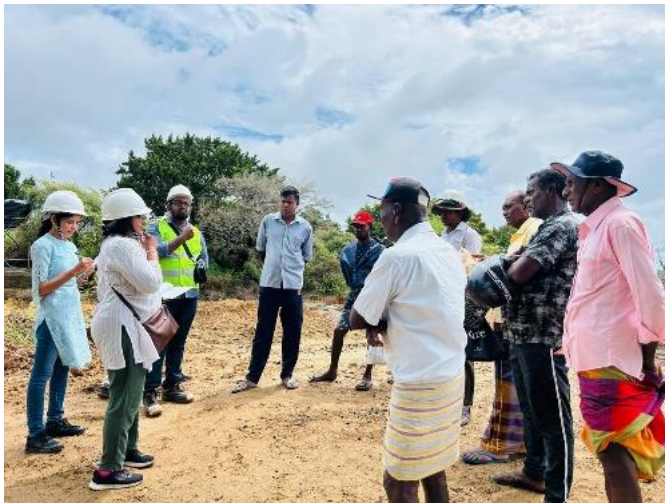
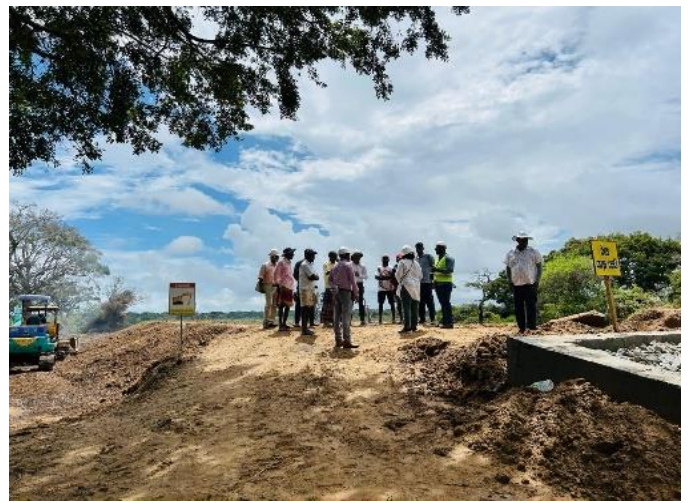
8. Community & SAC Engagement: Farmers and SAC members confirmed they had participated in formation and ratification meetings, and agreed to forego the Yala season. SAC members received training on monitoring material quality, work supervision, and implementing rotational visits to the site. Due to wildlife threats, especially to female SAC members, consistent on-site monitoring by women is challenging.

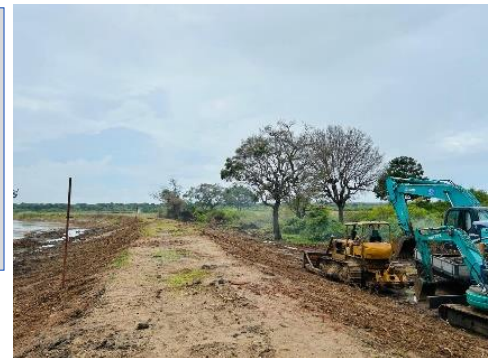
9. Farmer Cooperation & SAC Presence: Farmers agreed to forego Yala paddy cultivation. During the visit, members of the Farmer Organization and the Social Audit Committee (SAC) were present. SAC comprises five members (3 males, 2 females); however, only male members were observed onsite due to safety concerns stemming from wildlife presence.

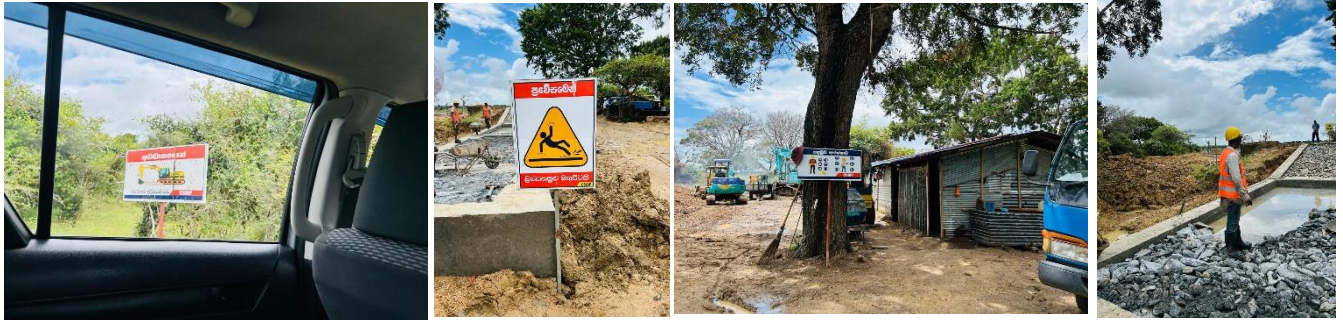
11. Good practices identified include the implementation of Occupational Health and Safety (OHS) measures at the site.

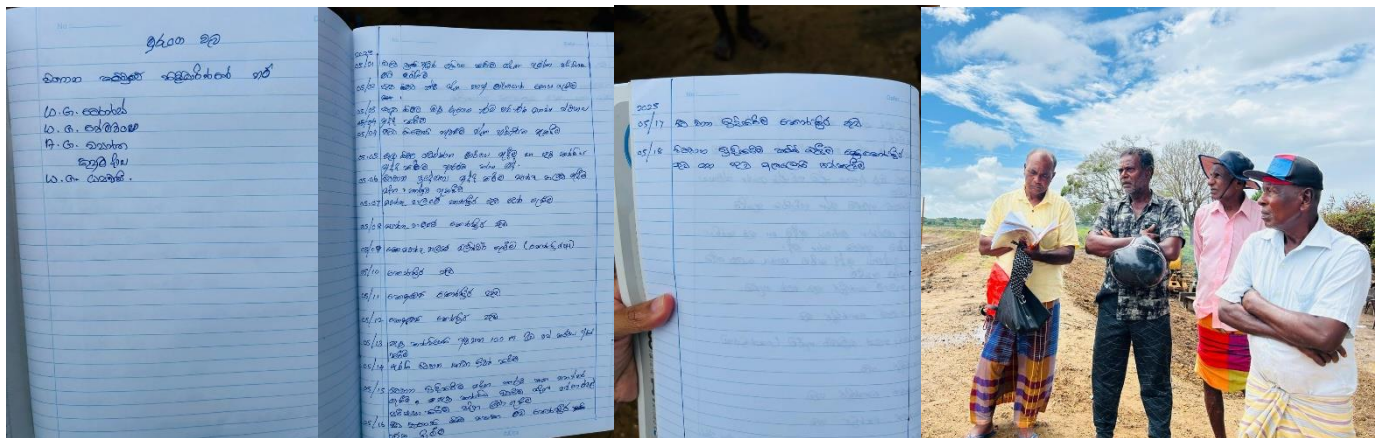
12. The site logbook is being properly maintained. The Site Audit Committee (SAC) is actively involved.
