## Field Visit Report

Wali Ara Downstream Development / Rehabilitation (Phase II – CSIAP)

### Wali Ara Downstream Development / Rehabilitation (Phase II – CSIAP)

- Date of Visit: 20/05/2025
- Location: Wali Ara, Eththiliwewa Cascade
- Project: Climate Smart Irrigated Agriculture Project (CSIAP) – Phase II
- Contractor: CISS Engineering
- Start Date of Work / Contractor Mobilized: 2<sup>nd</sup> week of May, 2025
- Visited by: Dr. Sithara Attapattu (World Bank), Ms. Sharmila Shanmuganathan (PMU), the Safeguard Team, and the Technical Team of the DPDO/SP&UP

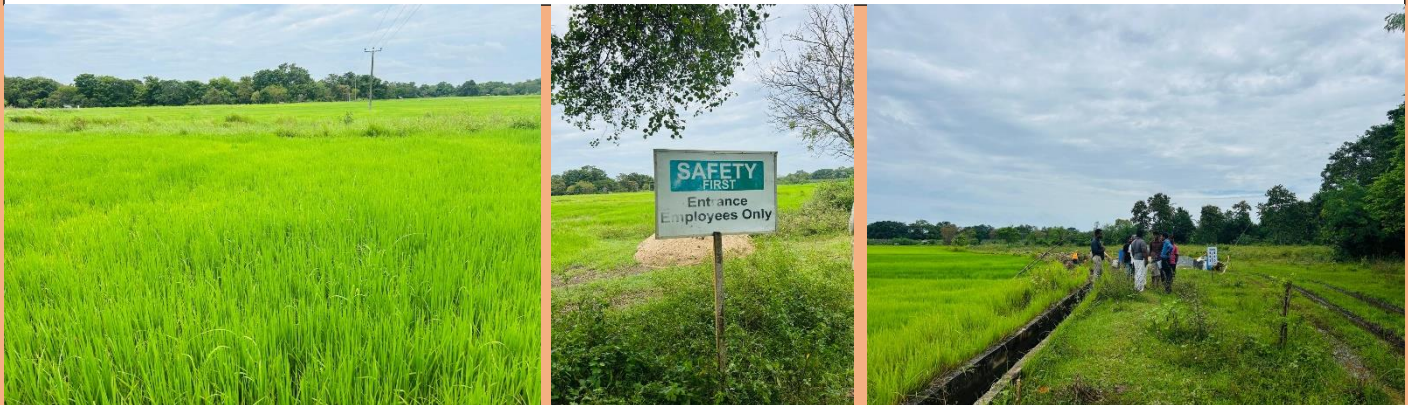
- No tree removal or significant vegetation clearing observed at the site.
- The site is not located within Forest Department (FD) or Department of Wildlife Conservation (DOWLC) boundaries.
- Signboards were present and clearly visible at the site.
- Road access to the site exists; however, due to muddy conditions and slight flooding, vehicular movement is restricted.
- Farmers have cultivated paddy in the surrounding lands, which limits access to some canal sections during the rainy period.
- Contractor reported that transportation of construction materials is currently being done manually due to high water levels and continuous rainfall.
- **The contractor must display the subproject name board at the site to ensure public awareness and accountability of the works.**

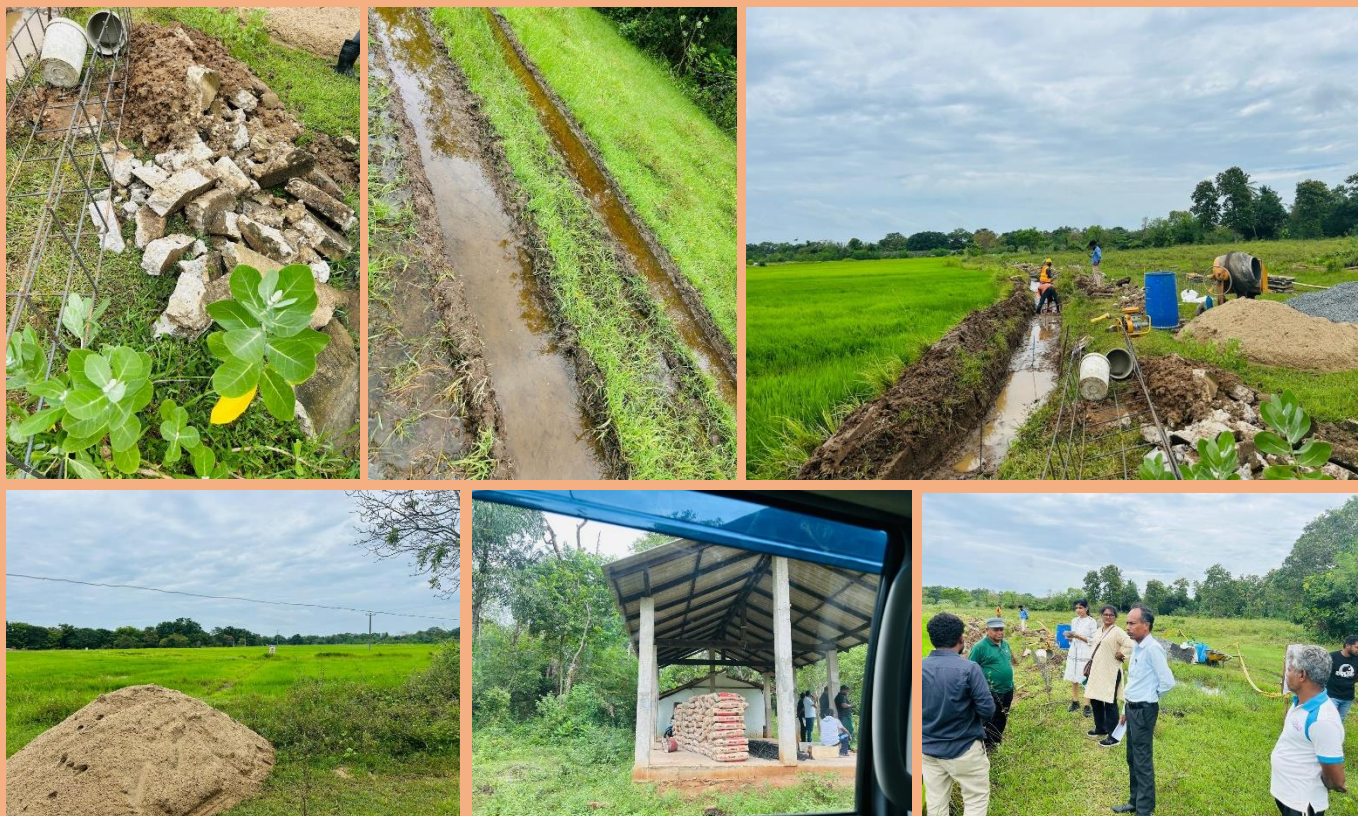
- Canal rehabilitation work had already commenced.
- Work involves concrete lining of canals, which cannot proceed during rainy conditions.
- Contractor reported potential to conduct parallel work on different canals, but access challenges—especially for canals in the middle of paddy fields—delay progress.
- No machinery was observed at the site during the visit.
- Material storage is taking place at a rented house nearby.

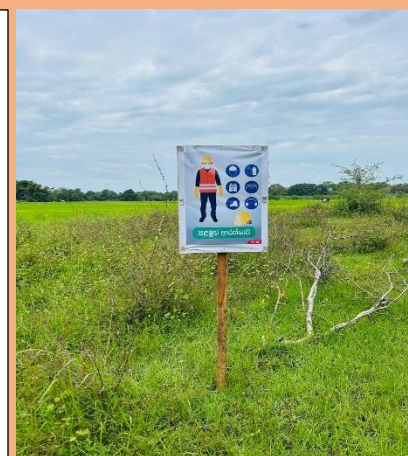
- No tree cutting or clearing of protected vegetation observed.
- No dredging or large-scale excavation taking place at the moment.
- Slight flooding and muddy terrain reported.
- Elephant movement in the area was mentioned by farmers; however, no direct conflict or sighting was recorded during the visit.
- Environmental risk level associated with the site is considered moderate, primarily due to delays from weather conditions and animal movement risks.

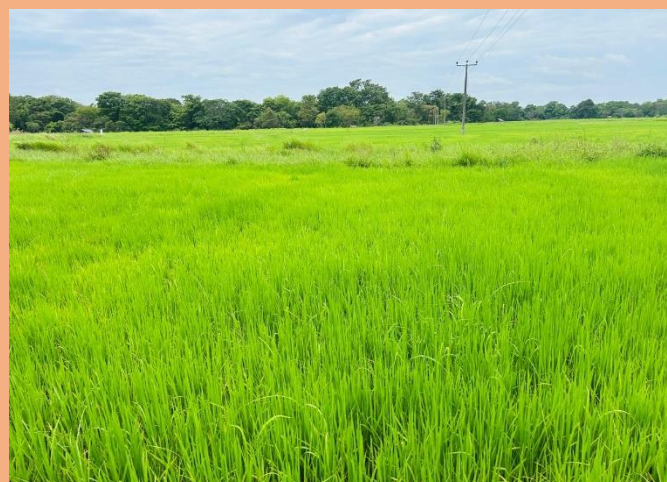
- Farmers have cultivated paddy in the canal vicinity and expect to harvest within 1.5 months.
- Farmers expressed willingness to allow use of their land for vehicle movement post-harvest.
- No land acquisition or removal of assets required at this stage.
- No reported damage or threat to cultural or community properties.

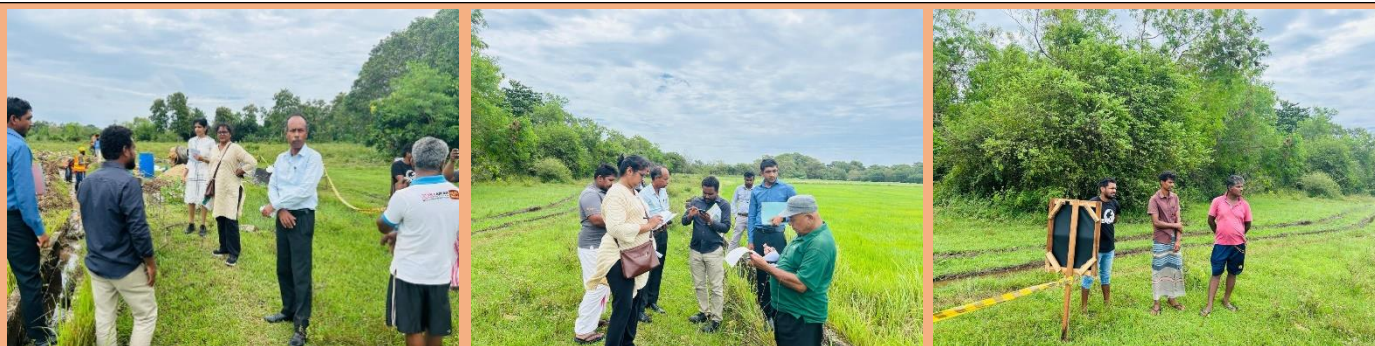
- Farmer Organization (FO) and SAC members were present and engaged during the visit.
- Farmers are aware of the project activities and have shared constraints due to weather.
- No grievances were reported yet. SAC was established as grievance redress mechanism at grassroot level, community presence and feedback were active.

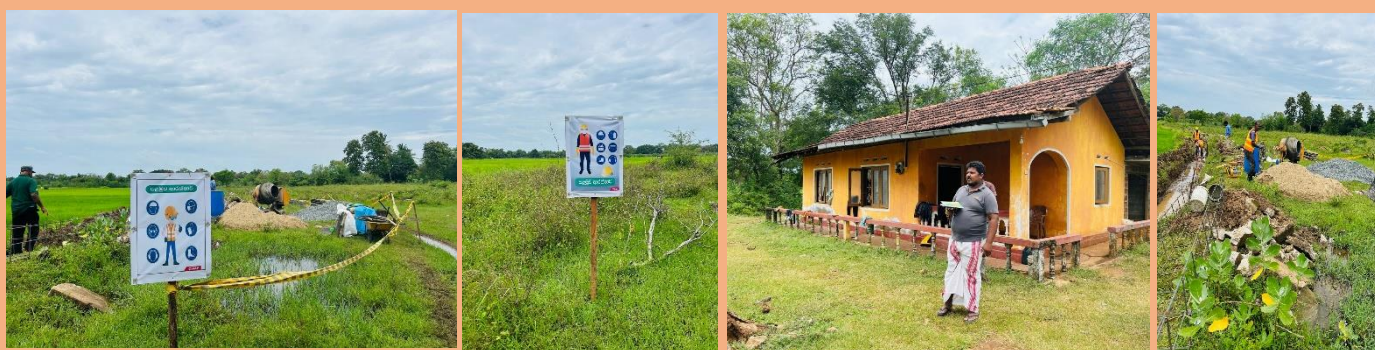
- Contractor has rented a house to accommodate laborers.
- On the day of the visit, 3 workers and the contractor were present.
- No campsite-related waste or occupational hazards were observed.
- Material storage is being managed in the rented accommodation.
- No machinery operation or active hazardous work was observed during the visit.
- Safety sign boards were properly placed at the worksite.
