Field Visit Report
Wilmanna Tank Rehabilitation (Phase II – CSIAP)
Southern Province

FIELD VISIT REPORT

Wilmanna Tank Rehabilitation Site- SP

Date of Visit: 19/05/2025

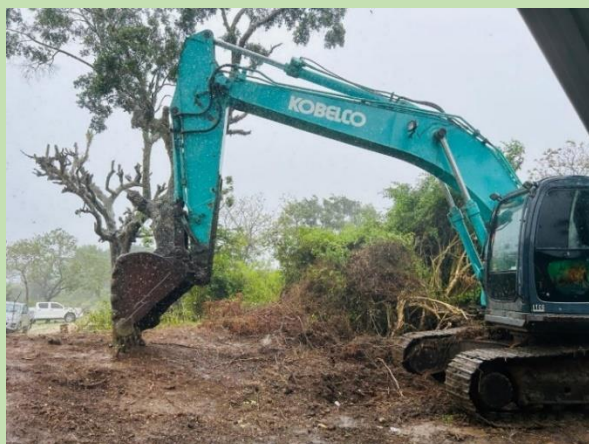
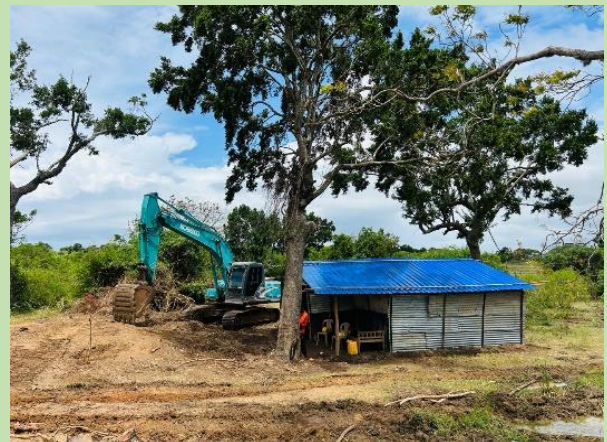
1. The **contractor** has established a **site office** at the **worksite**. A temporary rest camp has been set up at the worksite; however, workers do not stay there overnight. Instead, accommodation has been arranged for laborers 1 km away from the tank site in a rented house.

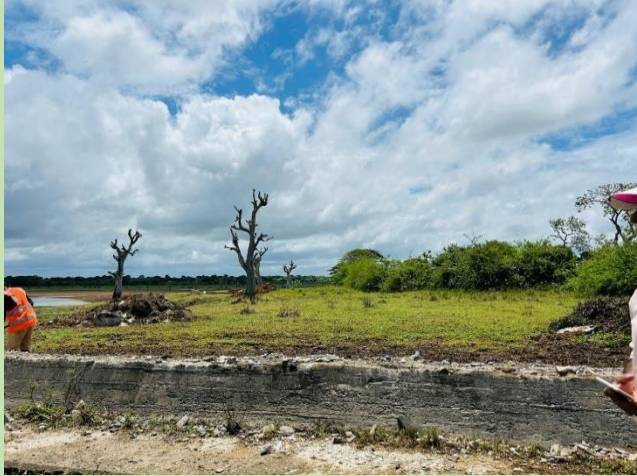
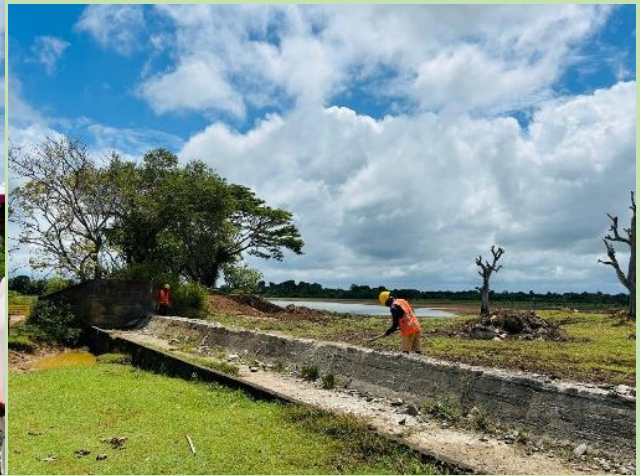
3. Laborers were working at the site where there was dust pollution and were not wearing face masks for protection. They were instructed to wear masks during work involving dust pollution.

- Ensure that **all workers are provided with PPE**, especially dust masks during activities like stone breaking. **Provide raincoats** or protective clothing for workers during rainy periods.

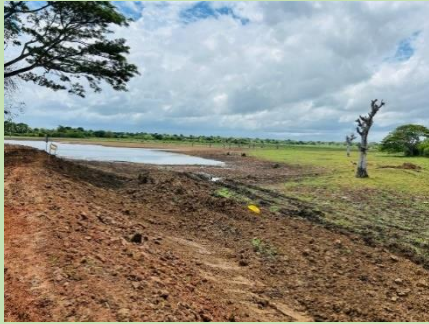
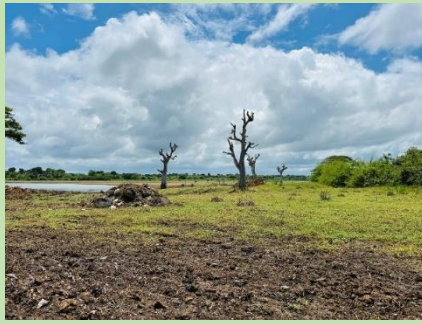
5. *Spill rehabilitation* is in progress. During *stone breaking* work on the spill, workers were observed **not wearing dust masks**. They were immediately instructed to wear proper PPE (Personal Protective Equipment).

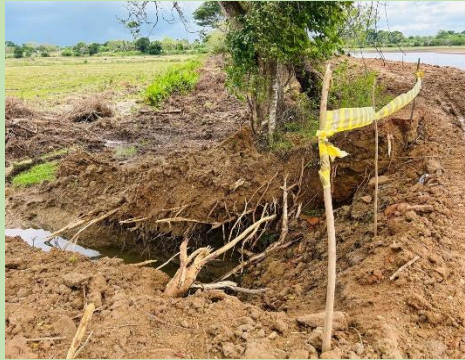
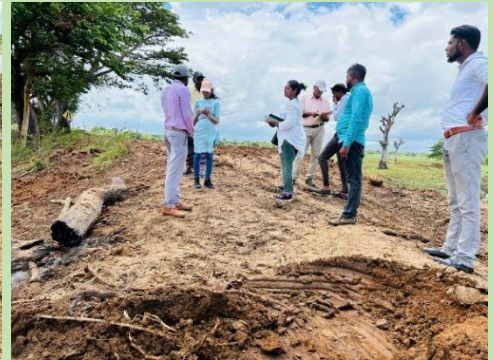
6. *Desilting* is ongoing, and the *dredged material* is **not** being removed from the site as farmers have requested it for filling low-lying paddy lands.

7. An *artificial water drawdown* was implemented by *cutting the tank bund* to facilitate **dry working conditions**.

- Continue involving the **SAC and FO** in monitoring the use of dredged material and ensure transparent sharing of project timelines and decisions.
- Ensure **daily logs are maintained** on work progress, safety incidents, and environmental observations. Encourage SAC members to document concerns and share updates with project officials for prompt action.

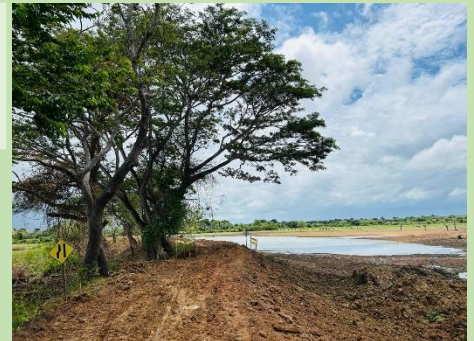
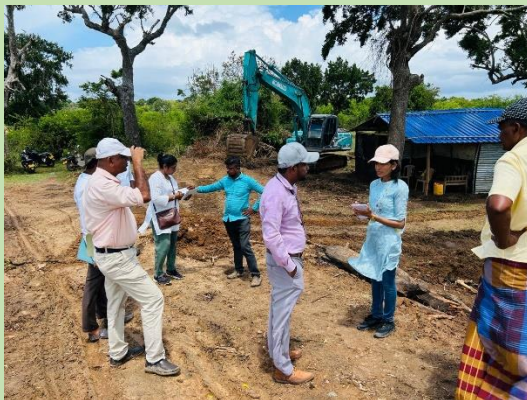
8. The *tank bund* is not used for *transport*; it functions solely as a *reservoir*. Therefore, no *road access blockages* were observed.

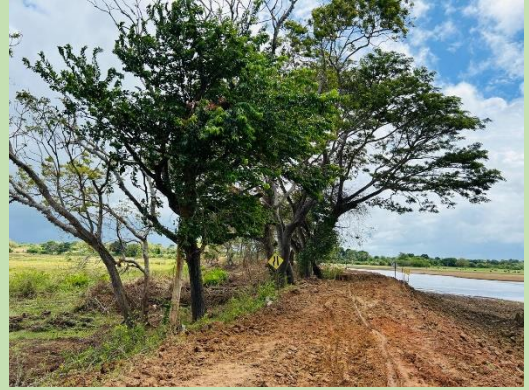
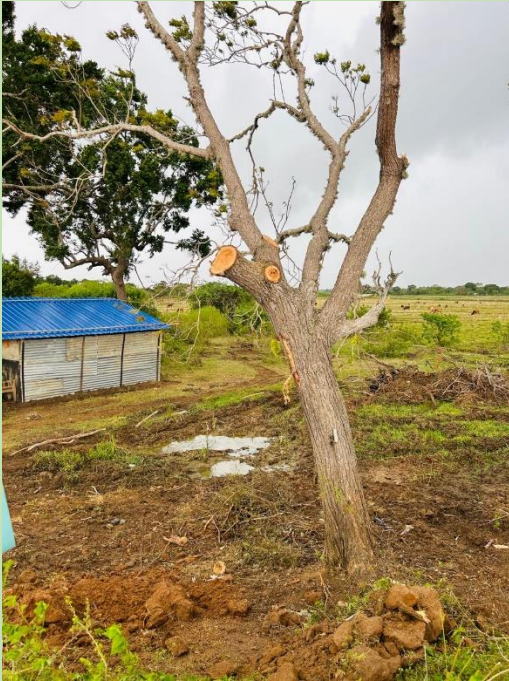
9. The *temporary shelter* at the worksite is located *under trees*, posing **safety risks** during *heavy rain*, *lightning*, or *falling branches*.

10. Within a *1-hour period*, *high temperature* was followed by *heavy rainfall* at the worksite. During the *field visit*, *workers* were observed without *raincoats* or *protective clothing* despite the rain.

11. The contractor has requested permission to install an elephant fence around the site because the tank is located near elephant corridors, where Human-Elephant Conflict (HEC) is a significant concern.

12. The **upstream area** of the tank falls within the **Lunugamvehera Forest Reserve**, while the **downstream area** is managed by the **Department of Wildlife Conservation (DWLC)**.

- Expedite the **approval and installation of an elephant fence** to safeguard workers and assets. Keep workers informed about **safe timings** and **protocols in case of elephant sightings**.

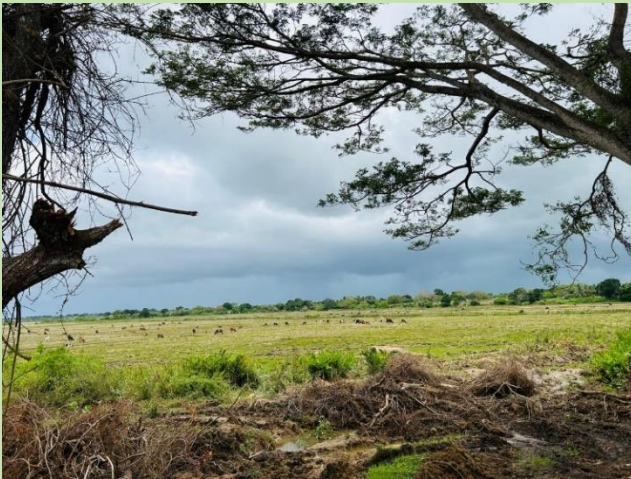
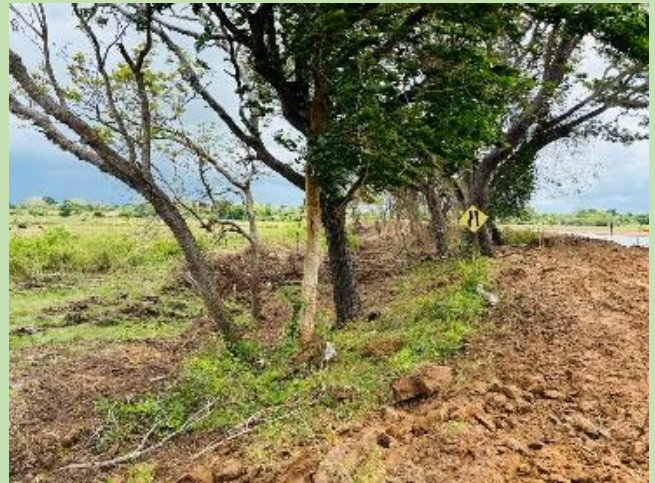
13. **Vegetation clearance** and **cutting of tree branches** were observed on-site. Seven **Kohomba trees** were proposed for removal — only those **upstream** will be removed, while trees in the **downstream** area will remain.

- Ensure tree removal (7 Kohomba trees) follows proper **approval and documentation** protocols. Avoid unnecessary vegetation clearance unless approved under environmental guidelines.
