Field Visit Report
Yoda Maha Wewa Rehabilitation (Phase II – CSIAP)
Southern Province

FIELD VISIT REPORT

YODAMAHA WEWA TANK REHABILITATION (PHASE II – CSIAP)

Date of Visit: 19/05/2025

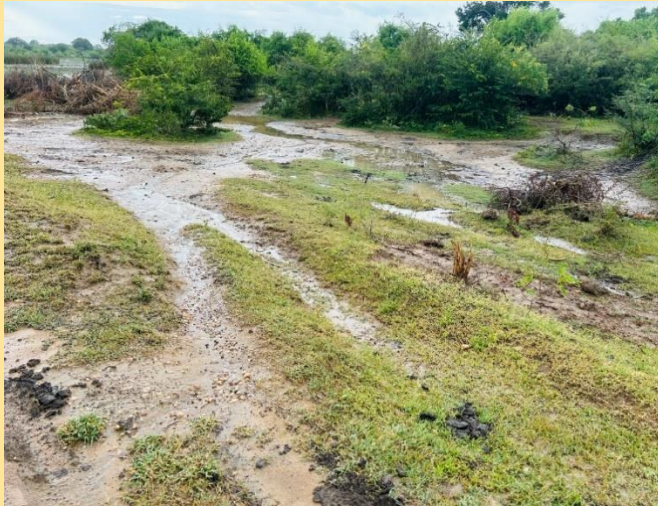
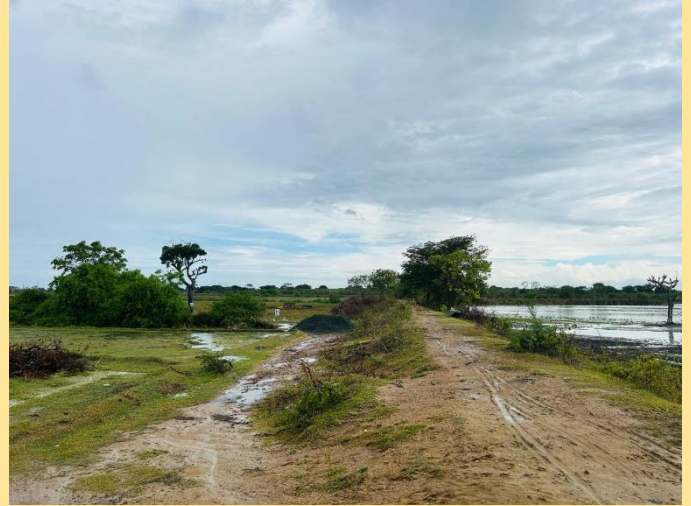
1. The **contractor** was in the process of **setting up a temporary hut** at the **work site** during our visit. Approximately **two laborers** were engaged in the **construction of the shelter**.
2. A **site rest house** is being set up; however, **work has temporarily stopped** due to **heavy rainfall**. During the **site visit**, **contractor representatives**, **Social Audit Committee (SAC)** members, and **Farmer Organization (FO)** members were **present and engaged in discussions**. The **contractor** has **rented a house** located **3 km away** from the **tank site** to **accommodate workers**.
3. Due to the risk of **wild animal encounters**, especially elephants, a request has been made by the contractor to install an **elephant fence** to secure the working area.

- **Tree removal** should follow **guidelines** from the **Forest Department**.
- Finalize and implement a **comprehensive replanting plan** with **specific locations** and **native species**, ensuring **survival monitoring** post-planting.
- Expedite the **approval** and **installation** of an **elephant fence** to **safeguard workers and machinery**.
- Ensure all **workers** receive a **safety briefing** and follow **protocols** in case of **elephant sightings**.
- Keep the **Farmer Organization (FO)** and **Social Audit Committee (SAC)** updated regularly about the **project timeline**, **desilting procedures**, and **environmental commitments**.
- The contractor must display the **subproject name board** at the site to ensure public awareness and accountability of the works.

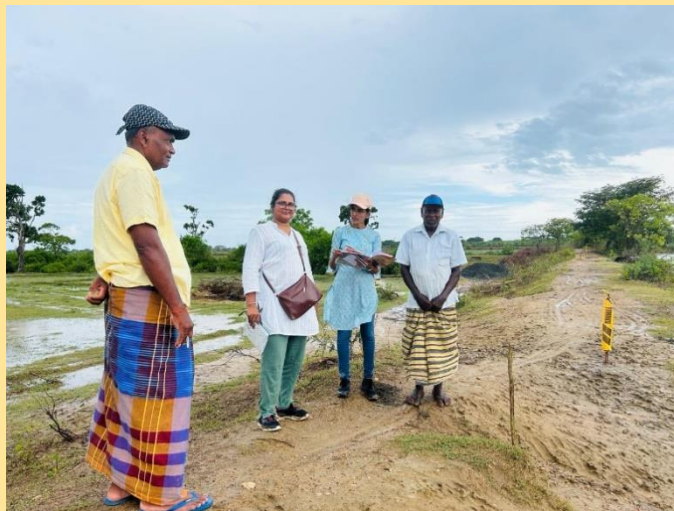
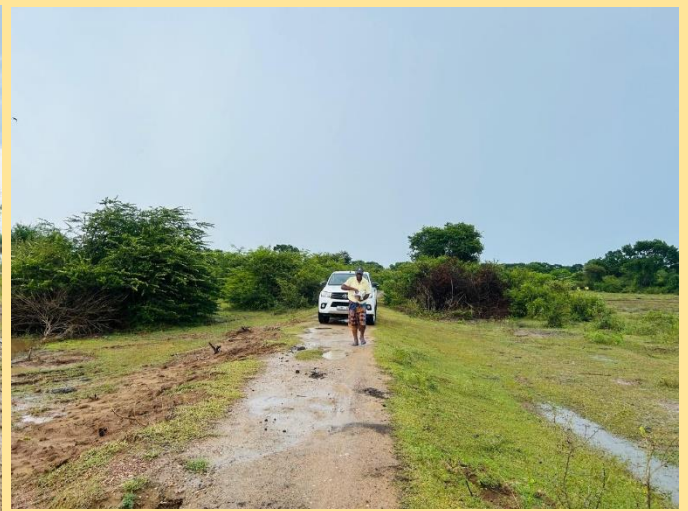
4. The **tank** is located within a **sensitive boundary**. **Elephant movement** and **crocodile sightings** were noted, particularly **elephant activity after 4:30 PM**. As a safety measure, **contractors are not permitted to work after 6:00 PM**.

5. **Farmers** and **Social Audit Committee (SAC) members** were present at the site during the visit. Due to **wildlife threats**, especially to **female SAC members**, **consistent on-site monitoring by women** remains **challenging**.

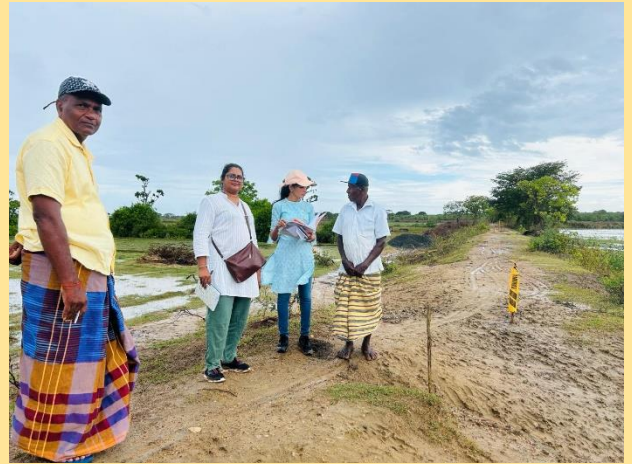
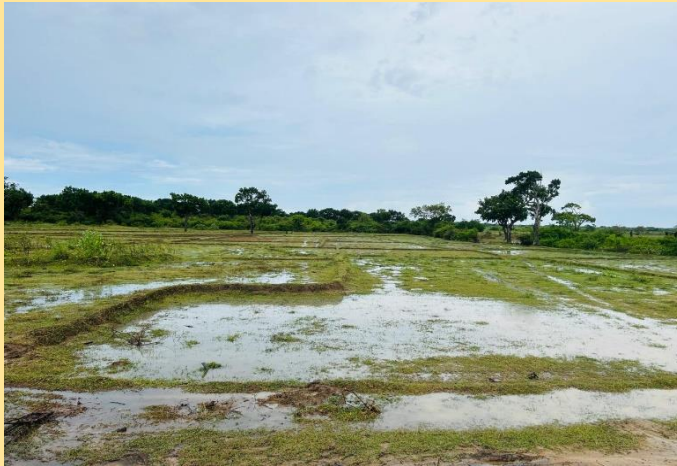
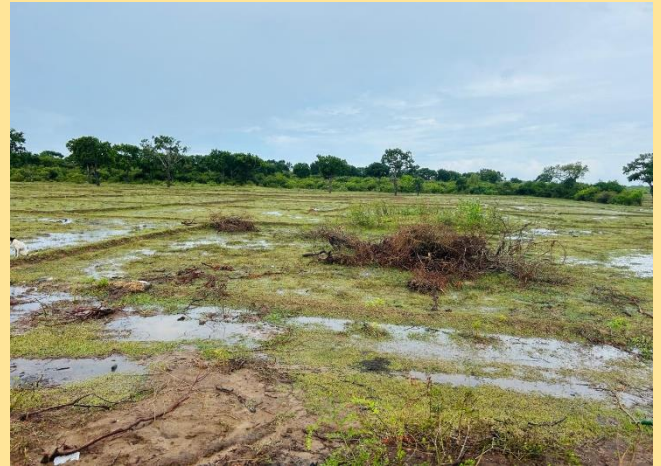
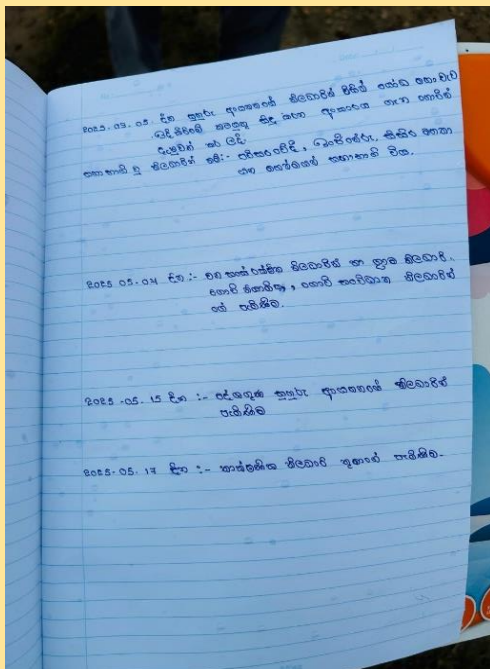
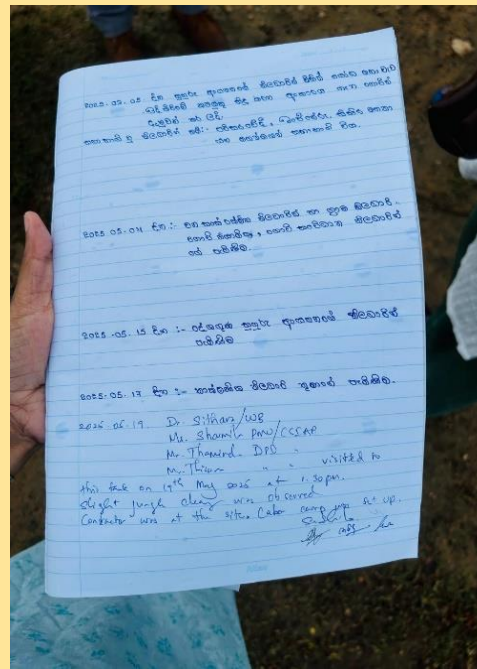
6. It was informed that **no rip-rap structure** or **spill raise** is planned for this tank. It was observed that **one common spill** exists for both **Yodamaha Wewa** and **Murunga Wewa**. **Desilting activities** are planned and will be conducted in a way that respects **ecological balance**. **Dredged material** will be provided to the **Farmer Organization (FO)** upon submission of a **request letter**. It was advised that **dredging** should only be carried out at the **current water level** to avoid negative impacts on **biodiversity** and **ecosystem health**.

7. Farmers agreed to forego Yala paddy cultivation to give priority to tank rehabilitation. As a result, a livelihood loss during the Yala season was observed. An agreement had already been reached with the farmers to forego Yala cultivation. Farmers have requested green gram seed compensation under the Livelihood Support Assistance (LSA) program. As of the visit date, no compensation had been provided. Farmers have requested compensation by June.

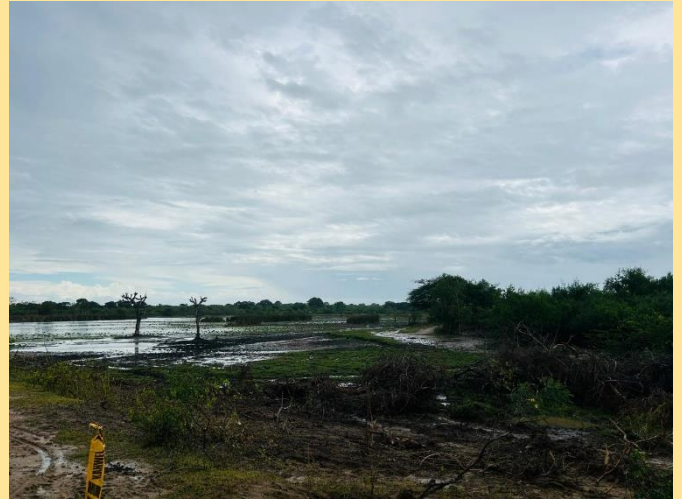
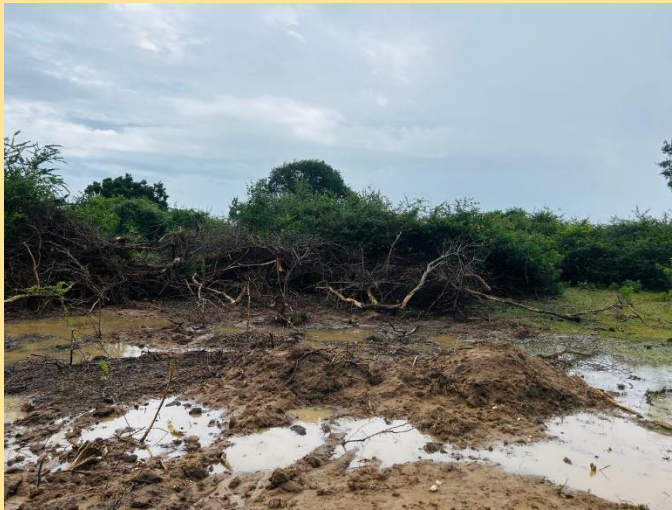
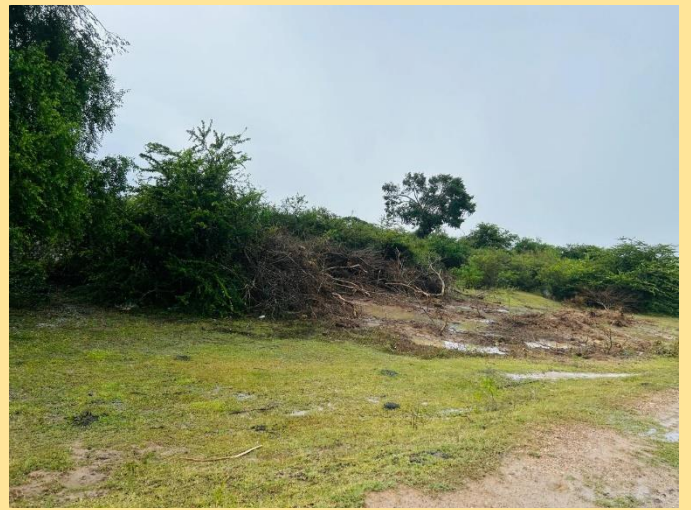
8. The site logbook is being properly maintained, and the Site Audit Committee (SAC) is actively involved in monitoring activities.

9. **Vegetation clearance** was observed **on-site**. A total of **28 trees** have been **identified for removal**, mainly located along the **middle of the tank bund**. **Tree removal** will be **aligned with conditions** set by the **FD and DWLC**. **Forest Departments** have agreed to provide **3-foot tree saplings** for **replanting** as part of the **restoration plan**.
