Field Visit Report
Mattigaththawa Wewa Rehabilitation (Phase II – CSIAP)
Southern Province

FIELD VISIT REPORT

MATTIGATHTHAWEWA REHABILITATION (PHASE II – CSIAP)

Date of Visit: 19/05/2025

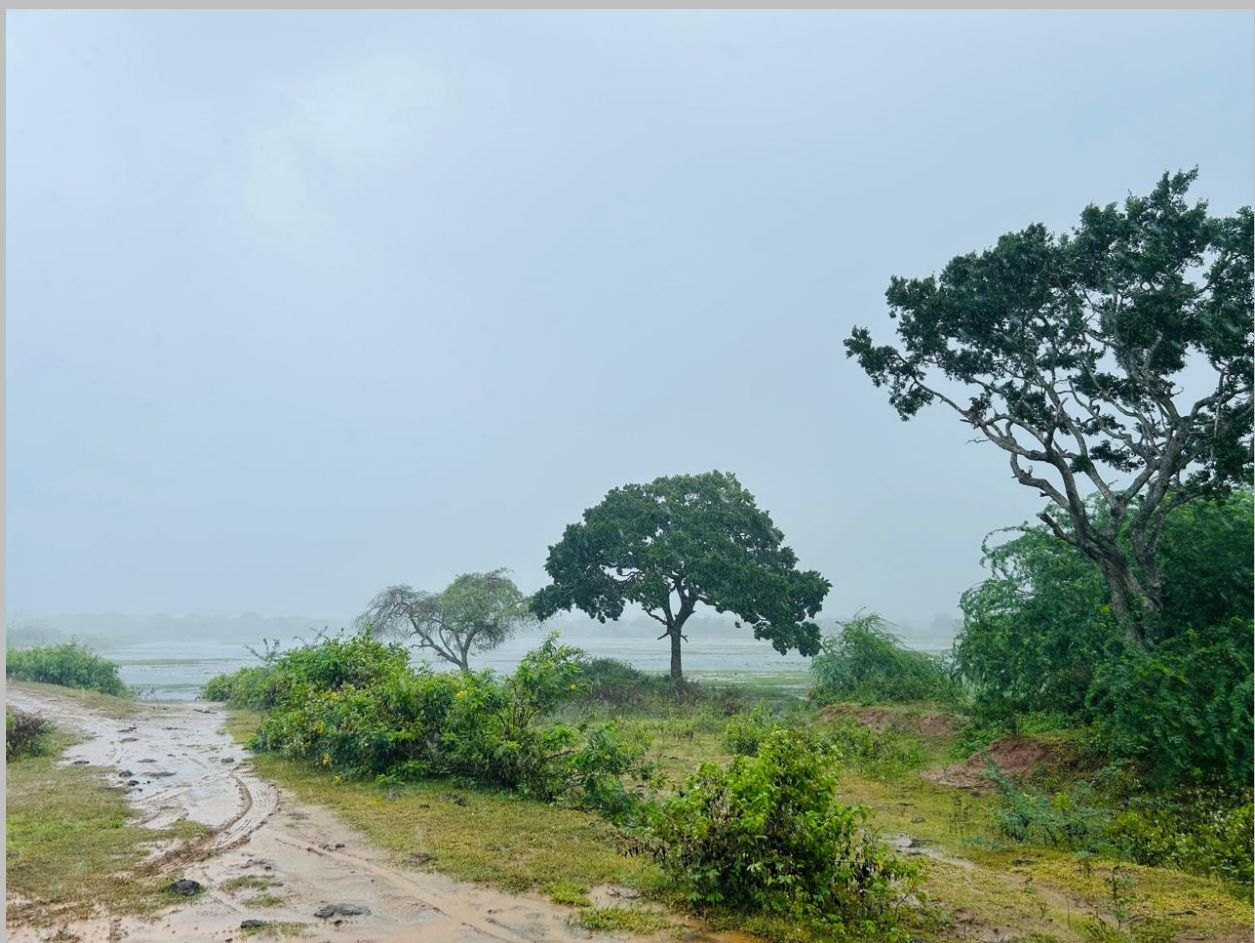
Mattigaththawa Tank is located within the **Badagiriya Forest** and falls under the **jurisdiction** of the **Forest Department**. It is a **protected area**, and only **downstream rehabilitation works** are proposed under the current **project scope**. The tank is identified as a **Human-Elephant Conflict (HEC)** site and has experienced **frequent rainfall** in recent months.
