Field Visit Report

Walas Wewa Tank Rehabilitation (Phase II – CSIAP)

Trincomalee, Eastern Province

The World Bank financed Climate Smart Irrigated Agriculture Project (CSIAP)

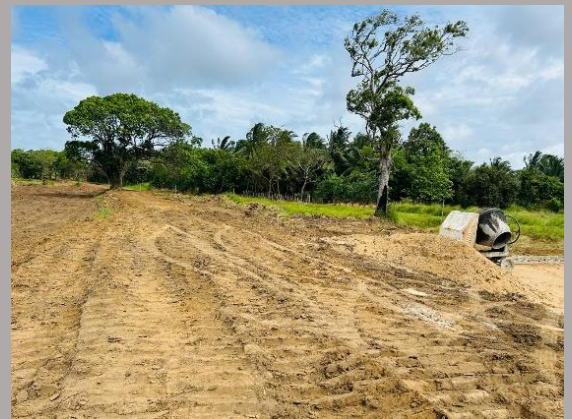
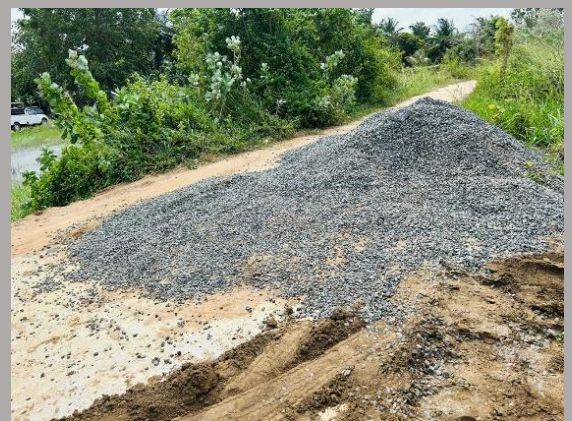
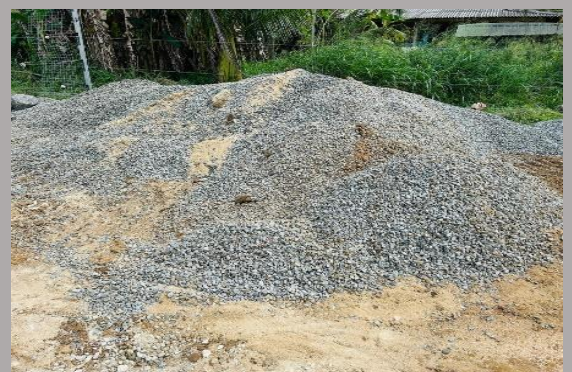
- No name board was displayed at the site.
- The contractor must display the subproject name board to ensure public awareness and accountability.
- A permanent elephant fence was observed around the tank, which is stopped during working hours. Work stopped at 6:30 PM due to HEC (Human-Elephant Conflict) issues. The operation of the elephant fence has been informed to the Civil Security Department.

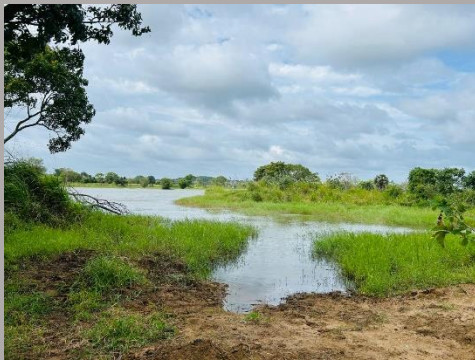
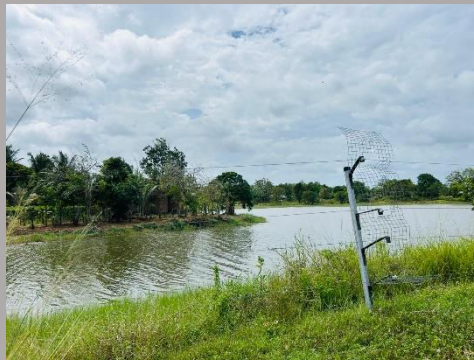
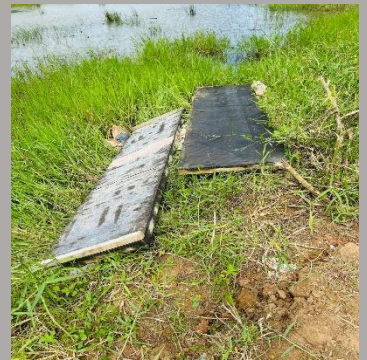
- The site is **outside** any socially and environmentally sensitive area. No impact on **protected species** or **habitats** was reported.
- No **tree removal** or **vegetation clearance** was noted.
- **Minor flooding** was observed in **downstream canal earthworks**.
- **Elephant presence** was reported occasionally; an **elephant fence** has been **permanently established**.
- **Environmental risk** is considered **low**. However, **garbage and materials** were not properly placed—the site must be **cleaned**, and **waste disposal areas** organized.
- The **site office** should be **properly set up** to withstand rain and wind.

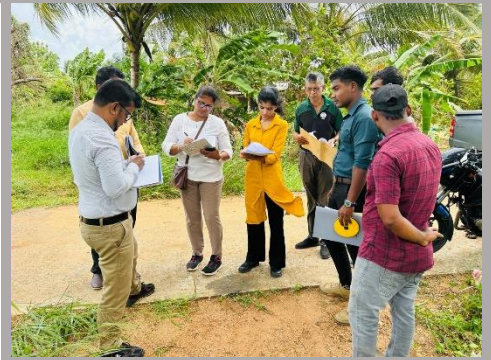
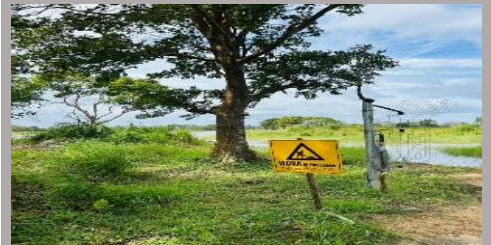
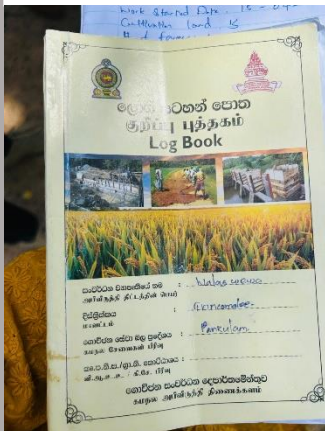
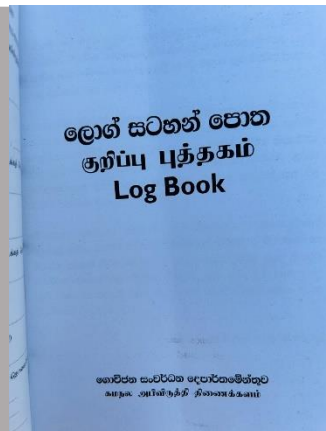
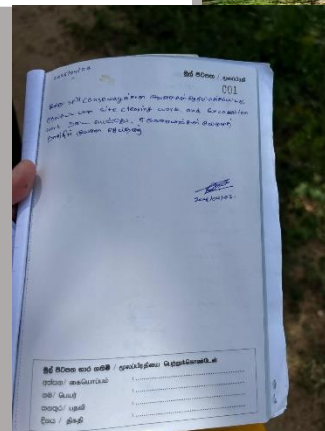
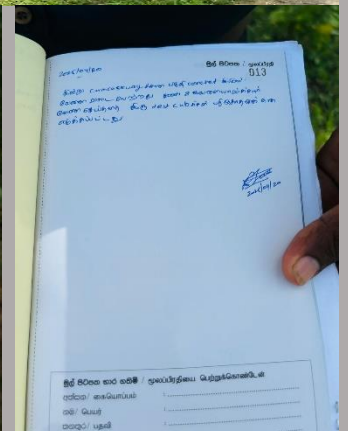
- A temporary shed had collapsed and needs to be re-erected.
- No workers were present during the visit. The contractor mentioned that 6–7 laborers are usually employed.
- The first aid box and grievance box were missing or not placed. Only one safety signboard was displayed, which was not sufficient for the site.
- Material storage was disorganized. The site should be maintained in a clean manner.
- OHS measures require improvement.
- A log book was maintained by the DAD supervisor.
