Field Visit Report
Siyambalagas Wewa Rehabilitation (Phase II – CSIAP)
Southern Province

FIELD VISIT REPORT

SIYAMBALAGAS WEWA REHABILITATION (PHASE II – CSIAP)

Date of Visit: 20/05/2025

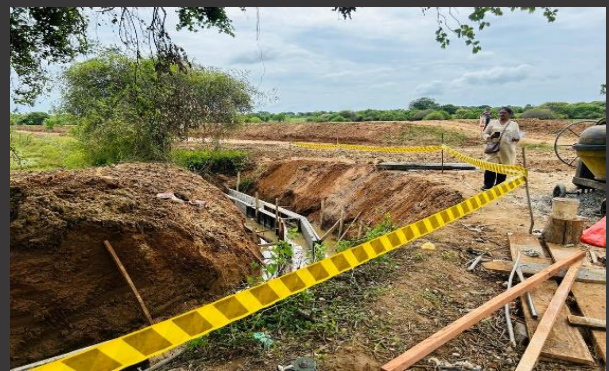
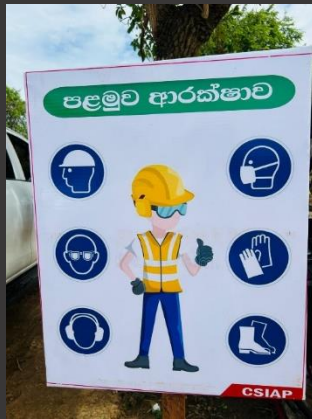
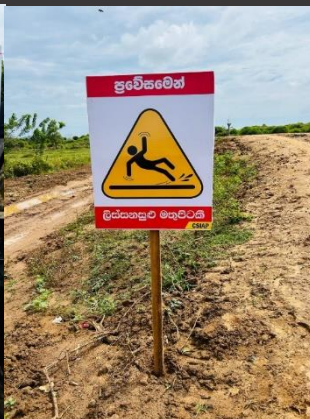
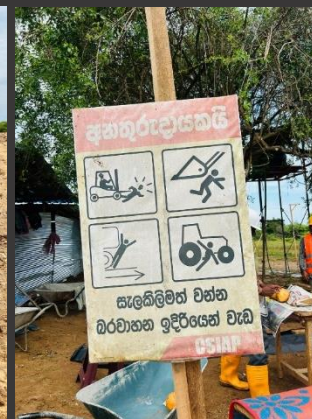
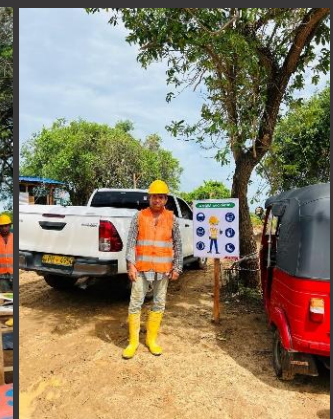
- **Safety signboards** have been properly displayed at necessary locations to ensure compliance with Occupational Health and Safety (OHS) guidelines.

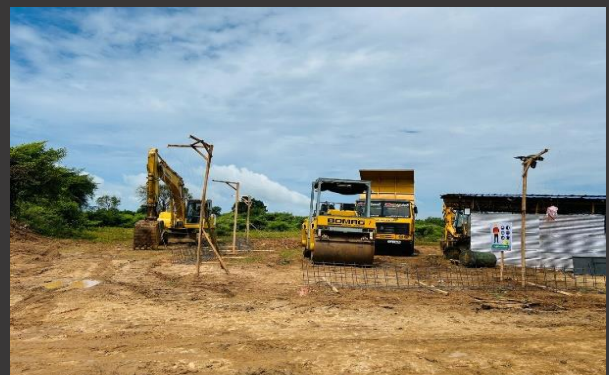
- A **labor camp** has been established and is equipped with **CCTV camera surveillance** for monitoring.
- Some laborers reside **overnight at the camp**, while additional accommodation has been arranged through a **rented house**.

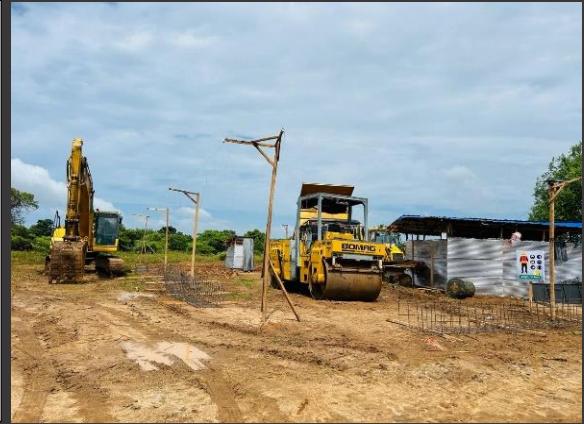
- **Vegetation clearing** has commenced; minimal clearing was observed at the site.
- Due to proximity to the **forest area**, the **contractor has requested the installation of an elephant fence** to ensure the safety of workers and the site.

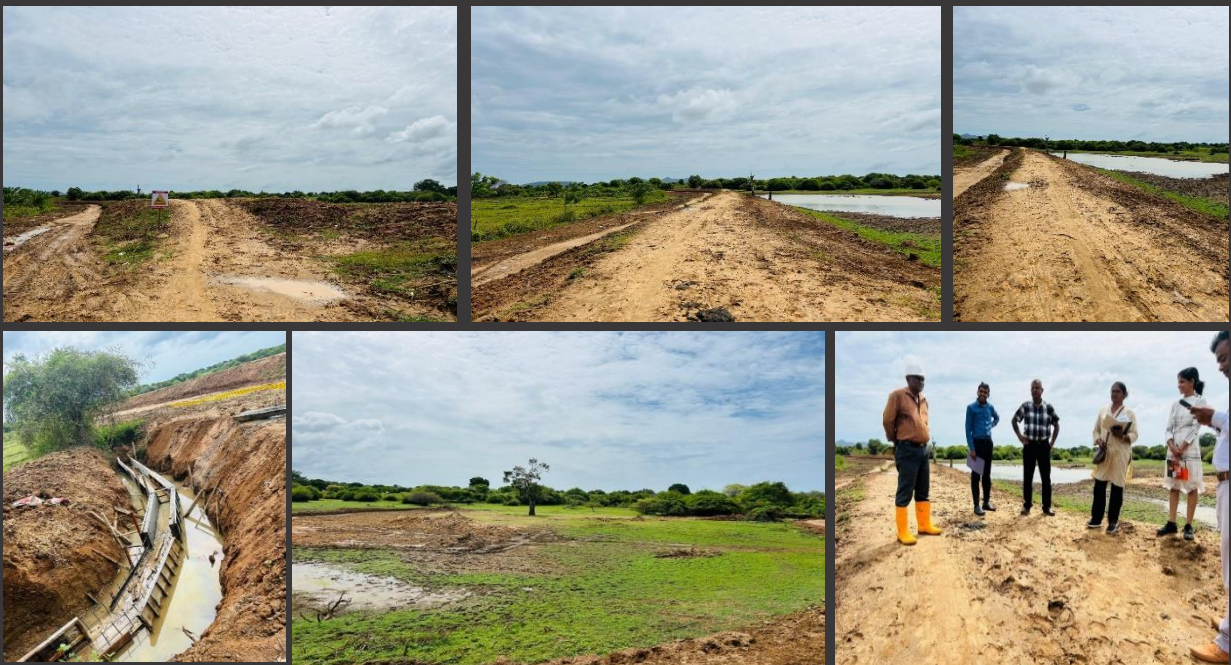
- The following construction activities were observed:
 - Desilting
 - Spill rehabilitation
 - Canal lining
 - Bund improvement
- On the day of the visit, no machinery was operational due to **heavy rainfall**.
- **Desilting work** had already commenced prior to the visit.
- **No tree removals** were noted during the site inspection.
- Initial **water drawdown was not carried out**, but a **partial drawdown occurred after the bund breach**.
- The **bund was observed to be leaking and breached**, and **compensation** is expected to be provided to affected farmers.

- **Repair and strengthening of the bund** should be prioritized to prevent further breaches.
- **Labor shortages** may impact progress; engaging with local CBOs/FOs for labor support or alternate solutions is advised.
- Ensure that **canal leveling and use of burrow soil** is supervised to avoid long-term water flow or irrigation issues.
- **Ongoing coordination** with farmers and SAC is essential for transparency and participatory monitoring.
- The contractor must display the **subproject name board** at the site to ensure public awareness and accountability of the works.

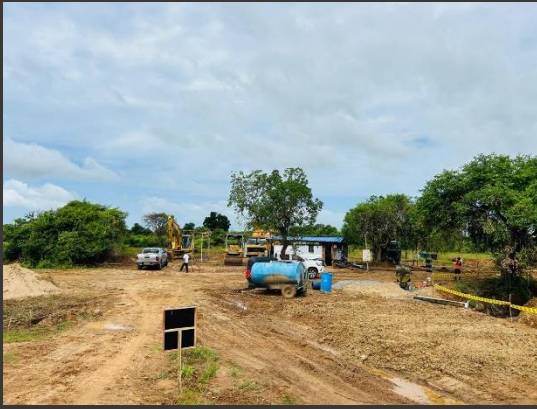
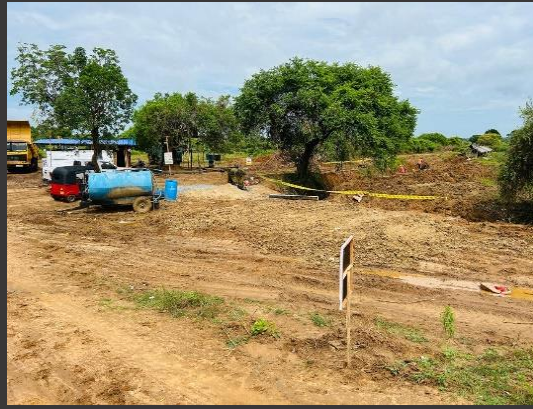
2. Machinery was present, but inactive on the day of the visit due to heavy rainfall earlier.

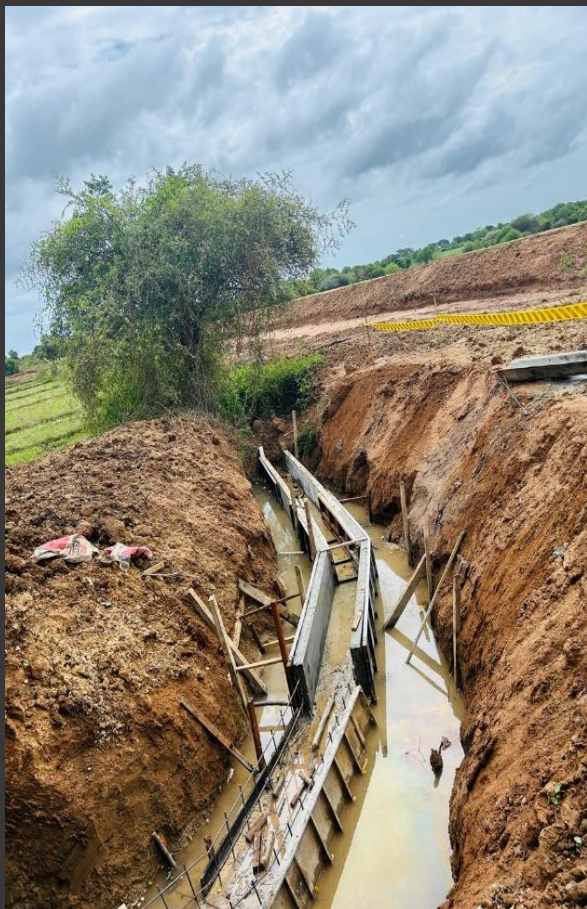
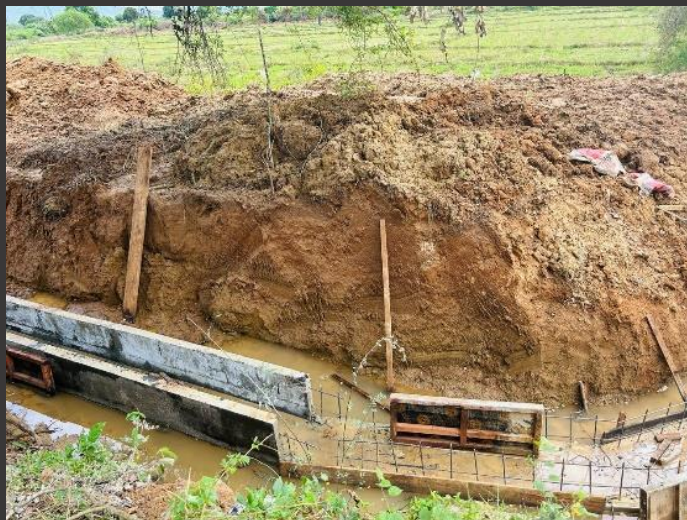
During the visit, **canal construction** was ongoing but temporarily stopped due to rain. It was observed that the **canal level is currently lower than the paddy field level**. The contractor plans to use **burrow soil to raise the level** to match the surrounding fields. The **Farmers' Organization (FO)** has **requested burrow soil** for leveling their paddy fields.
