Field Visit Report

Duppaththage Wewa Downstream Development / Rehabilitation (Phase II – CSIAP)

The World Bank financed Climate Smart Irrigated Agriculture Project (CSIAP)

21/05/2025

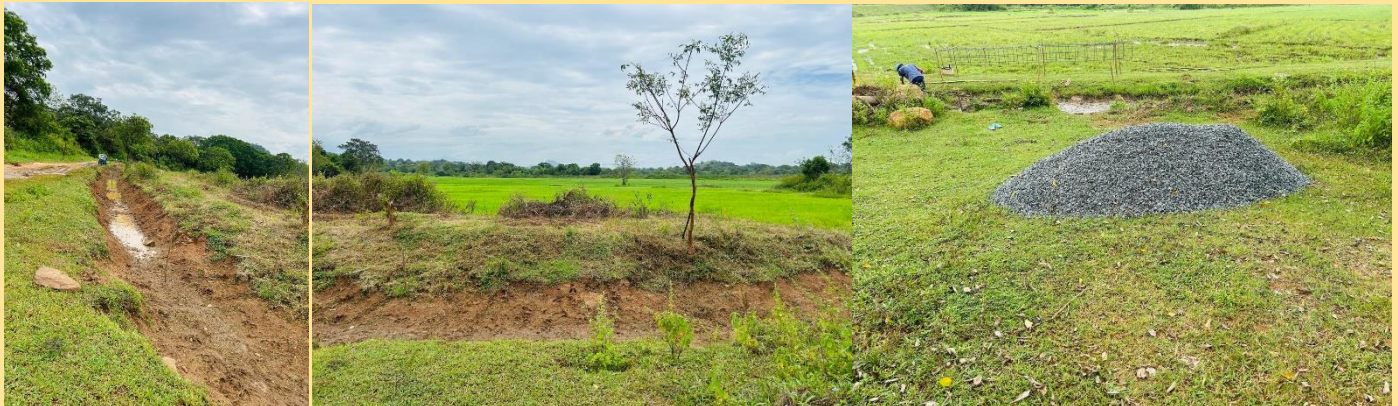
- Only downstream canal works are proposed under this phase.
- Site clearing has been completed.
- Construction materials have been stored at the site.
- Access roads are available; however, due to recent rainfall, the roads are muddy and partially flooded, which restricts the movement of vehicles.
- Farmers indicated this is not typically a rainy period in their area, but weather conditions have temporarily affected transportation.
- **The contractor must display the subproject name board at the site to ensure public awareness and accountability of the works.**

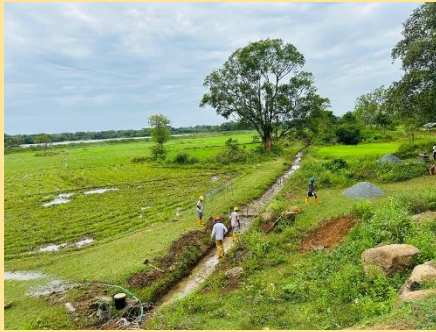
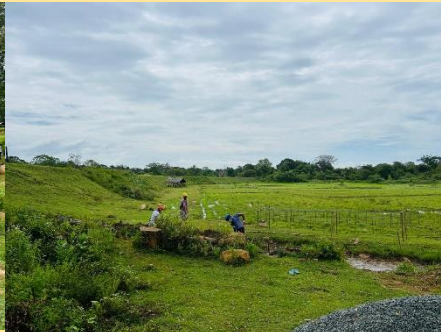
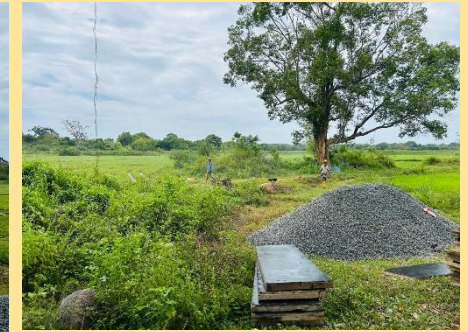
- Canal rehabilitation work (concrete works) has commenced.
- Due to current rainy conditions, further construction activities are temporarily halted and will resume once the site becomes dry.
- Contractor plans to complete the canal works within **three months**.
- Water is being released for cultivation **two days per week for 8 hours**, allowing canal work to proceed on the remaining five days.
- No heavy machinery was observed at the site during the visit.

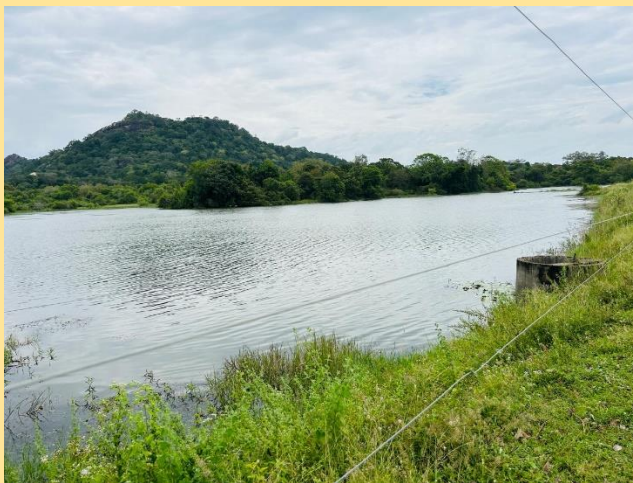
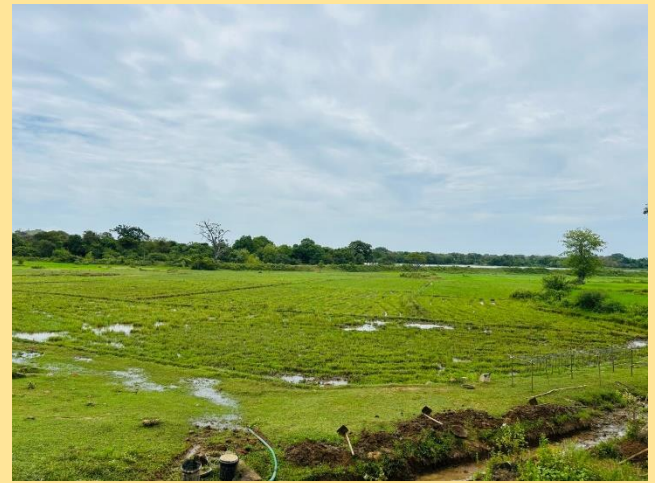
- The site is not within the Forest Department (FD) or Department of Wildlife Conservation (DOWLC) boundary, but the tank is approximately **300 meters** from the forest boundary.
- No tree removal or vegetation clearance was observed.
- Slight flooding and muddy conditions were noted.
- Occasional elephant presence was reported in the area.
- No impact on protected or sensitive species or habitats was reported.
- The environmental risk level is considered **low**.

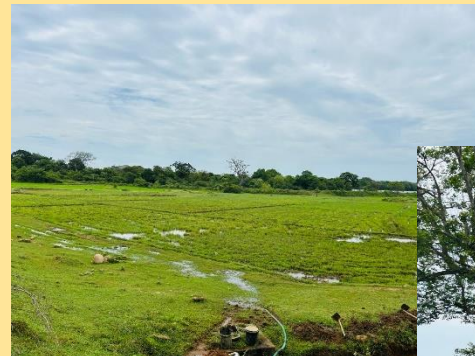
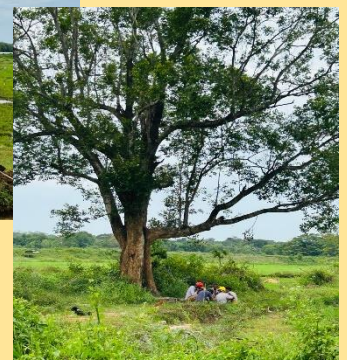
- Farmers have cultivated paddy in the downstream area and expect to harvest in **1.5 months**.
- There is **no observed livelihood loss** due to the project activities.
- Therefore, **Livelihood Support Assistance (LSA)** is not required.
- No compensation is applicable at this site.

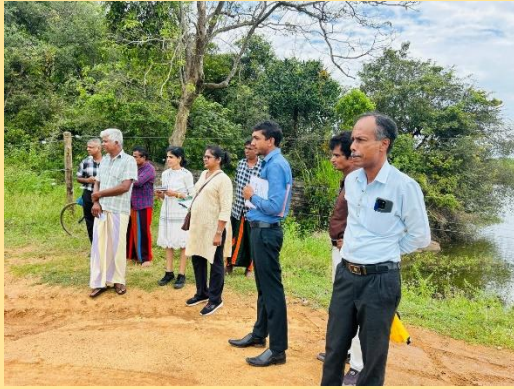
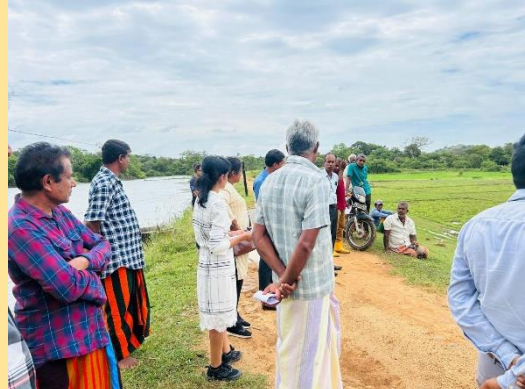
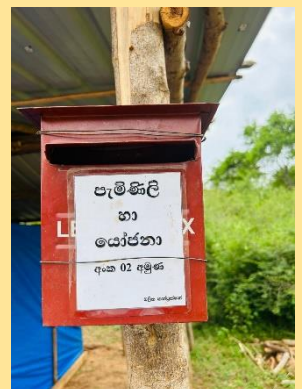
- Farmer Organization (FO) and Social Audit Committee (SAC) members were present and engaged during the visit.
- Contractor and farmers are coordinating well regarding water release schedules and construction timelines.
- No significant grievances were reported by the community.
