Field Visit Report
Weheragala Anicut canal – Kokara Canal Development/ Rehabilitation (Phase II – CSIAP)
Southern Province

The World Bank financed Climate Smart Irrigated Agriculture Project (CSIAP)
Ministry of Agriculture, Livestock, Land and Irrigation (MOALLI)

FIELD VISIT REPORT

KOKKARA CANAL (DOWNSTREAM WORKS) REHABILITATION (PHASE II – CSIAP)

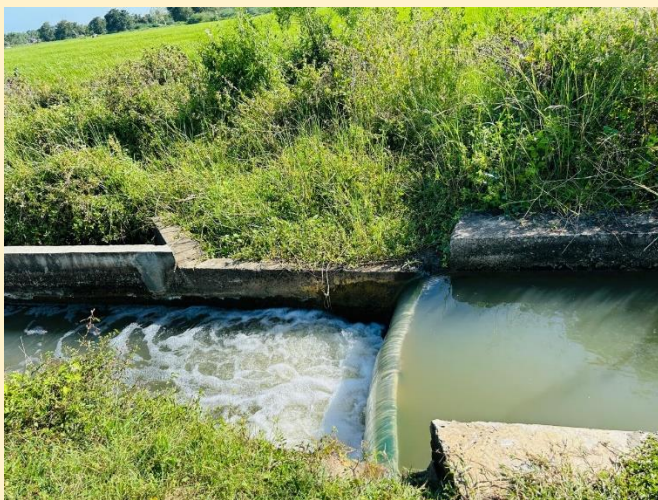
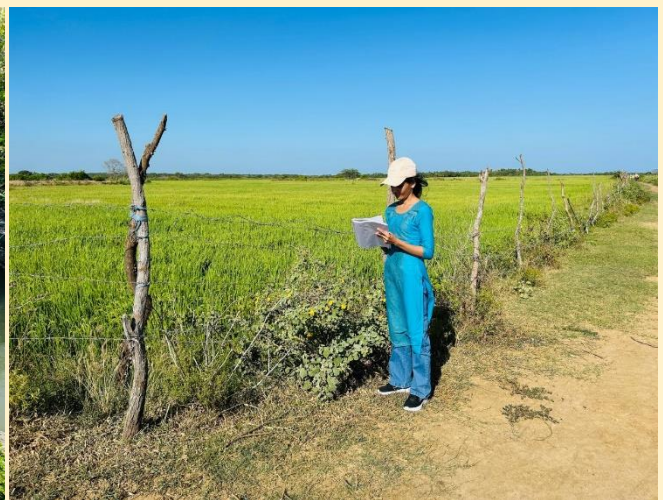
It was observed that the works had only just begun, and no scope-based activities were observed at the site during the field visit.

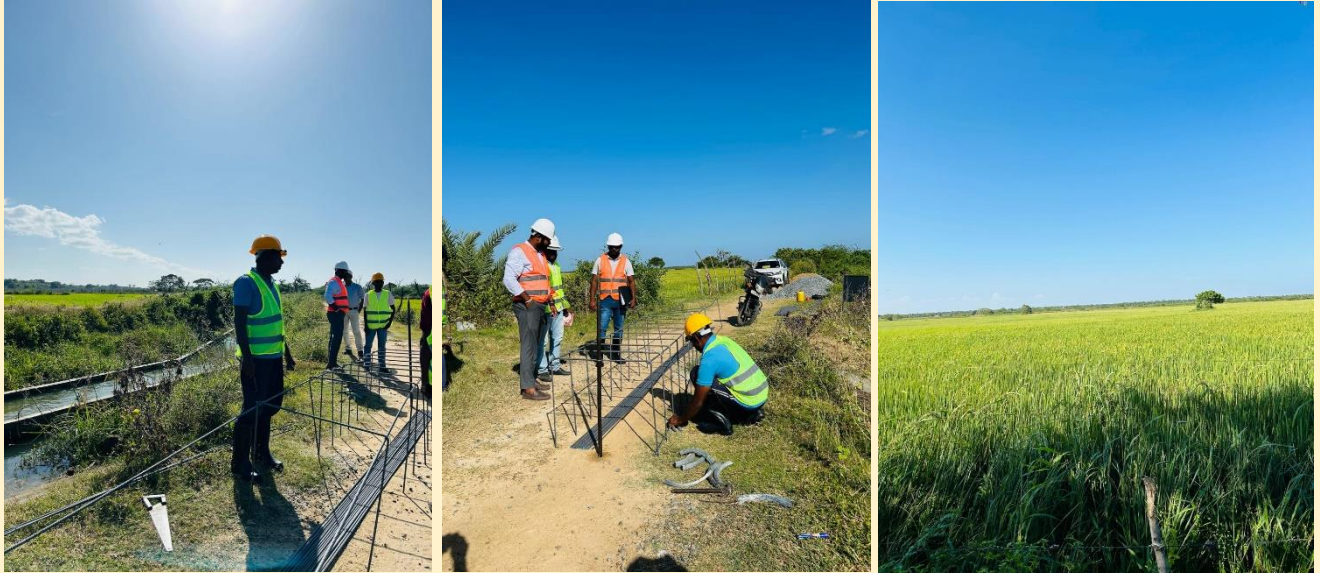
Officers from the implementing agency, along with workers, the contractor's site supervisors, the DPDO technical team, and the safeguard team, were present at the site. It was also observed that workers were wearing personal protective equipment (PPE) while carrying out their tasks.

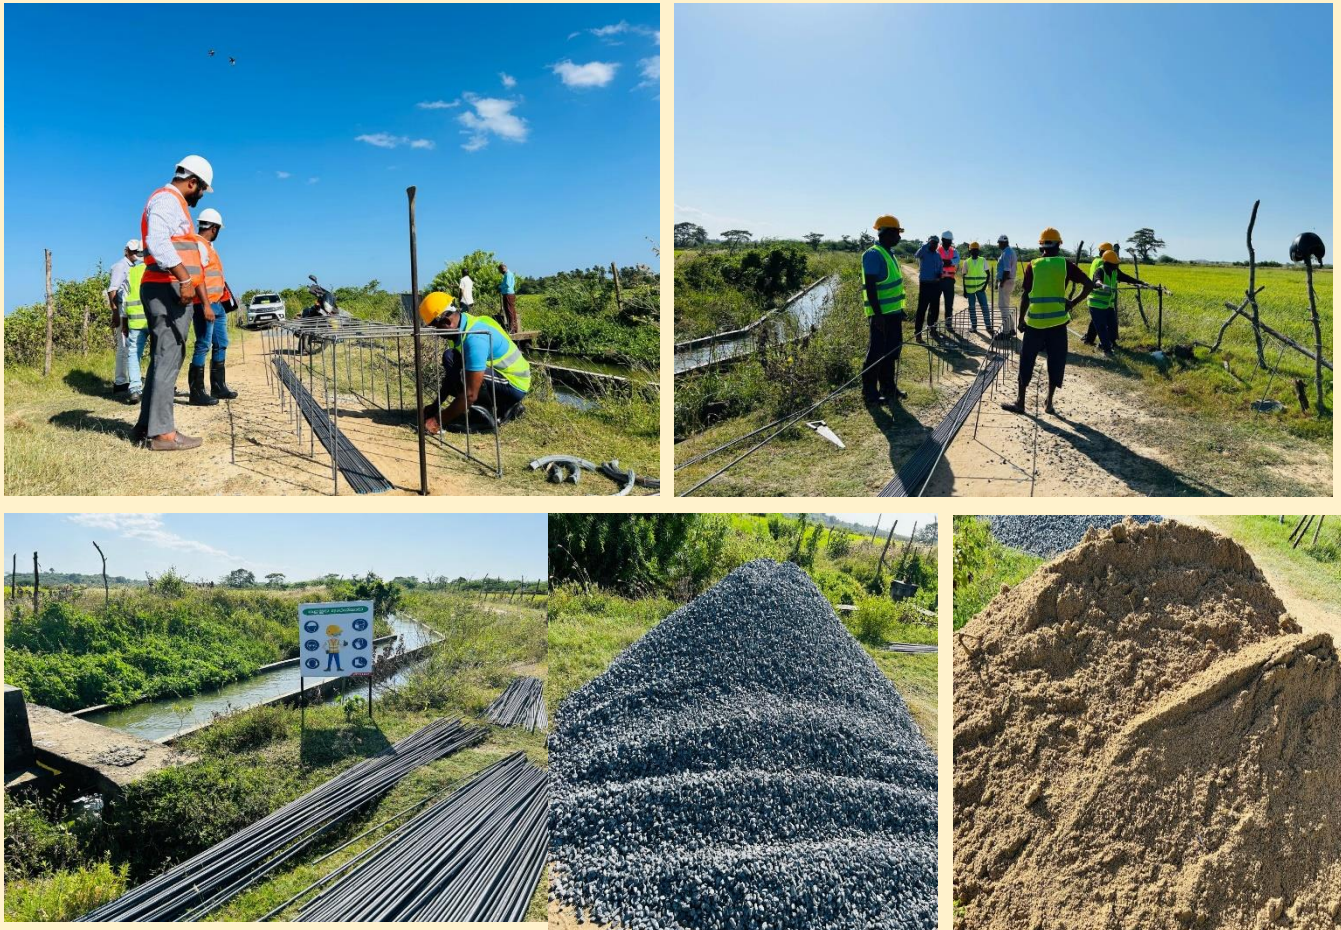
- Farmers have cultivated their paddy fields during the Yala season of 2025, and the harvest is expected within 3–4 weeks from the date of the field visit. Over 192 farmers are cultivating approximately 300 acres of paddy land, jointly across the Arabedda and Kokkara canals, during both the Yala and Maha seasons.
- No tree removal was observed at the worksite. Furthermore, safety signboards were displayed, and workers were observed wearing personal protective equipment (PPE) while performing their tasks.

1. It is recommended that the contractor mobilize at least four (04) separate teams to carry out canal lining and road rehabilitation simultaneously during non-rainy periods. This will help expedite progress, minimize delays due to adverse weather, and ensure the timely completion of works before the onset of the rainy season.
2. Continue to ensure that no tree removal or other environmentally sensitive activities take place within or near the rehabilitation area.
3. The contractor must display the subproject name board prominently at the site to promote public awareness and ensure transparency and accountability.
4. Close coordination and regular monitoring should be maintained during the rehabilitation works to avoid further delays at the site.
