Field Visit Report
Bakmeegama Wewa Tank Rehabilitation (Phase II – CSIAP)
Trincomalee, Eastern Province

The World Bank financed Climate Smart Irrigated Agriculture Project (CSIAP)
Ministry of Agriculture, Livestock, Land and Irrigation

FIELD VISIT REPORT

- **Date of Visit:** 26/05/2025
- **Location:** Bakmeegama Wewa, Bakmeegama Cascade
- **Project:** Climate Smart Irrigated Agriculture Project (CSiAP) – Phase II
- **Contractor:** S.M.S. Enterprises
- **Start Date of Work / Contractor Mobilized:** 16/04/2025
- **Visited by:** Mr. G. Jayantha, and Dr. Sithara Attapattu (World Bank), Ms. Sharmila Shanmuganathan (PMU), Mr. T.Sekaran (SSO/DPDO/EP), and the Technical Team of the DPDO/EP

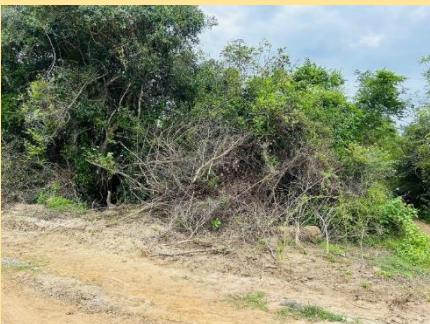
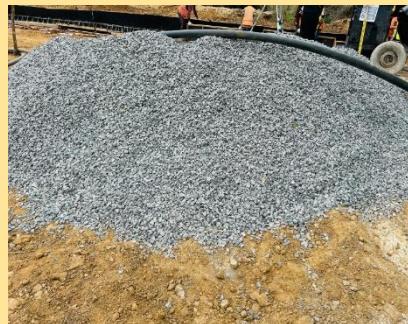
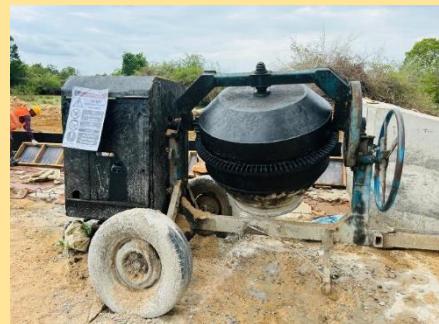
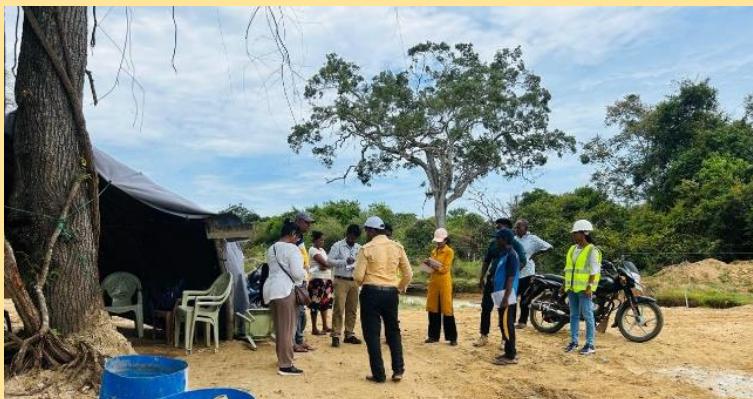
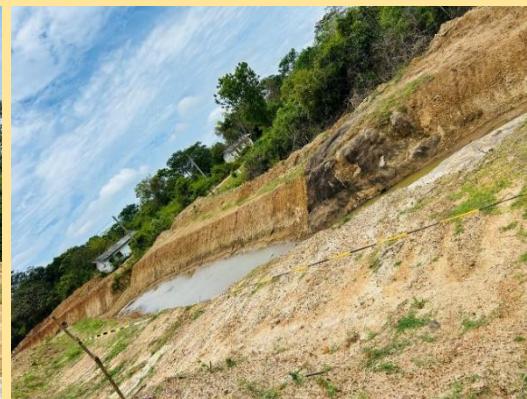
1. Site Preparation and Access

- Work commenced on 16/04/2025.
- Site clearing and material storage were observed.
- No rainfall was recorded during the visit.
- On-site, SAC members, FO members, machinery, four laborers, and one supervisor were present.
- Active community involvement at this site is assessed as moderate.
- The name board was not displayed.
- The contractor must install the name board to ensure public awareness and accountability.
- Construction work had already started.

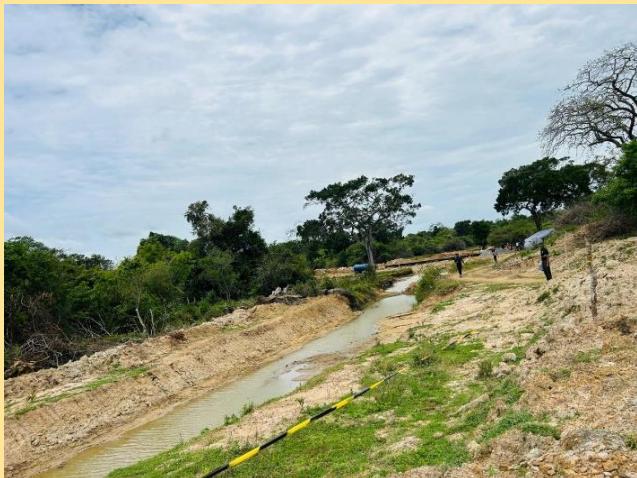
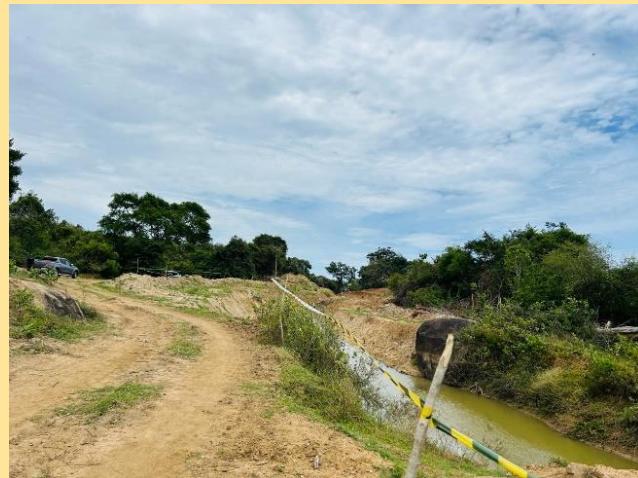
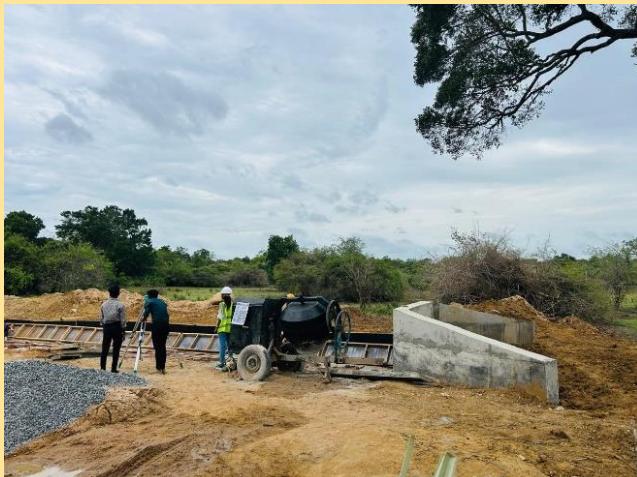
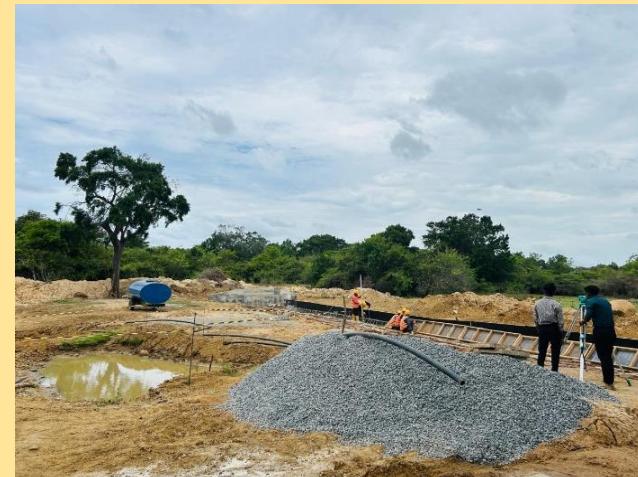
2. Construction Activities and Infrastructure Improvements

- A Technical Officer from the Department of Agrarian Development (DAD) was present at the site.
- Scope-based construction work has commenced, and concrete work is currently in progress.

- Artificial water drawdown was not carried out, as farmers did not agree to forego Yala 2025 cultivation.
- Only one machinery unit was observed on-site.

- Community involvement is assessed as moderate.
- Close monitoring by the DPDO and the Implementing Agency is essential.
- Heavy soil erosion was observed at the earth canal works, as earthwork was carried out without proper turfing.

- The community mentioned that it may take approximately 1½ months to complete paddy harvesting.
- Both the community and the contractor indicated that artificial water drawdown cannot be done all at once, as it could adversely affect nearby households.

- Furthermore, it may take an additional two months to complete the artificial water drawdown and for the land to dry adequately before construction activities can commence at the site.

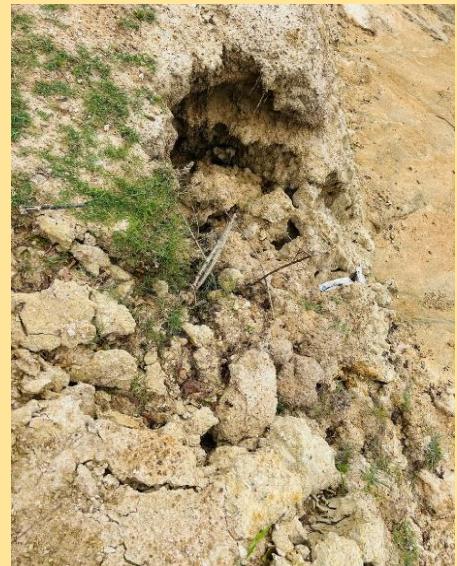
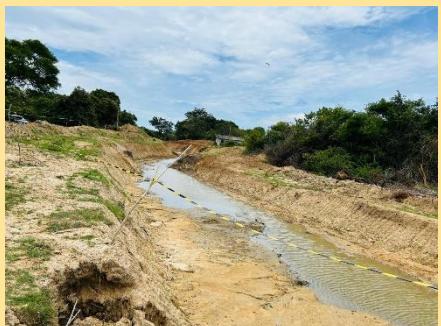
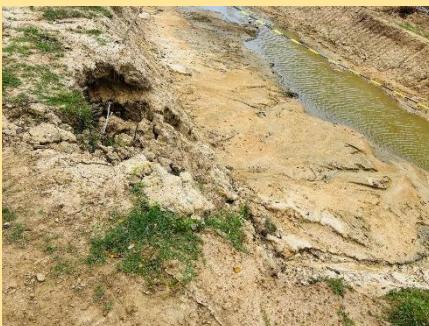
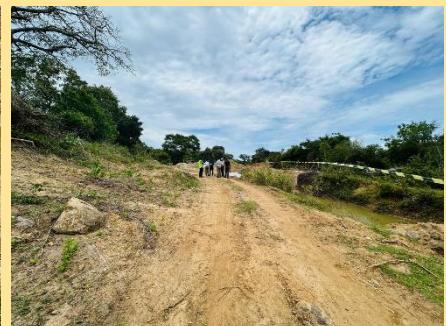
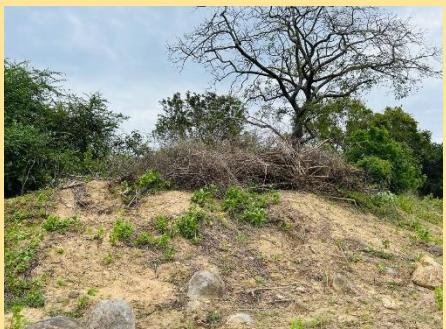
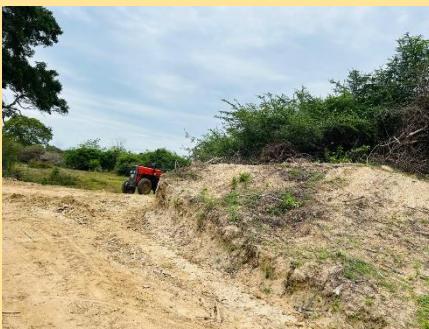
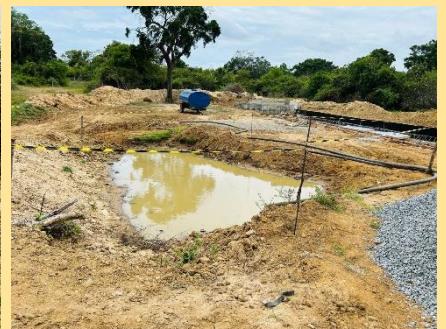
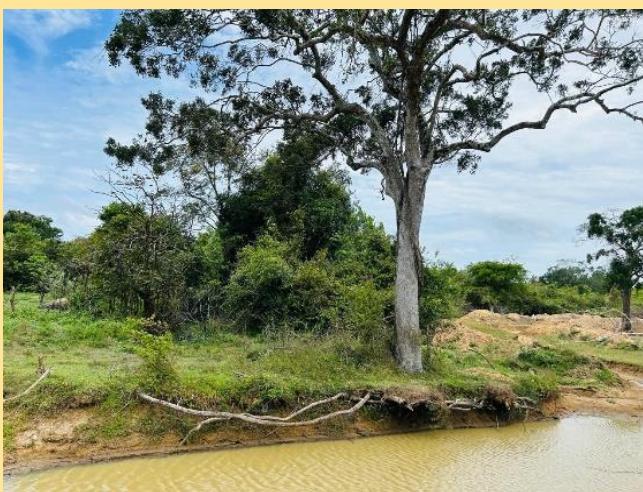
3. Environmental and Ecological Impacts

- The site is located outside any environmentally sensitive area.
- No tree removal was noted; however, slight vegetation clearance was observed.
- Flooding had occurred previously at the site, and soil erosion was identified as a major issue.
- Occasional elephant presence was reported.
- The environmental risk is assessed as moderate, primarily due to soil erosion.
- A site office was set up, but workers do not stay on-site.

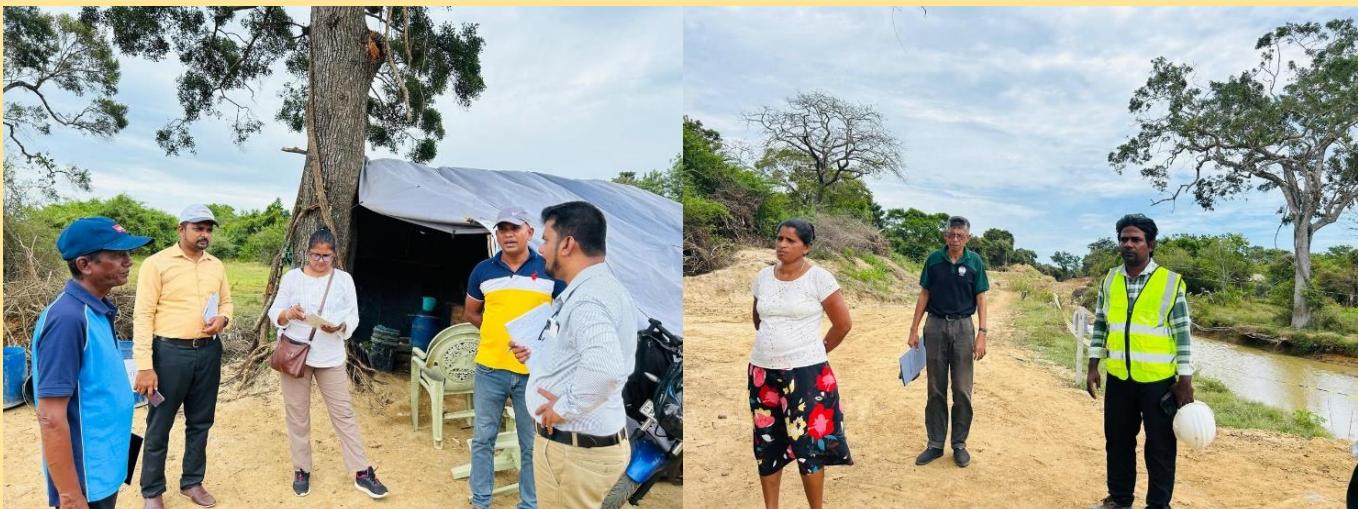
5. Stakeholder Engagement and Community Participation

- FO and SAC members were present and moderately engaged during the visit.
- Weak coordination was noted between the contractor and farmers. The quality of work is questionable, as major soil erosion was observed.
- SAC logbooks were not available at the site.
- No grievances were reported, possibly due to limited community participation.
- An ESMP awareness program had been conducted for the contractor.

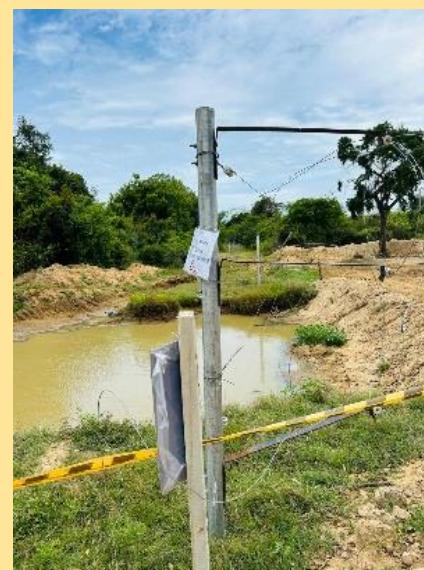
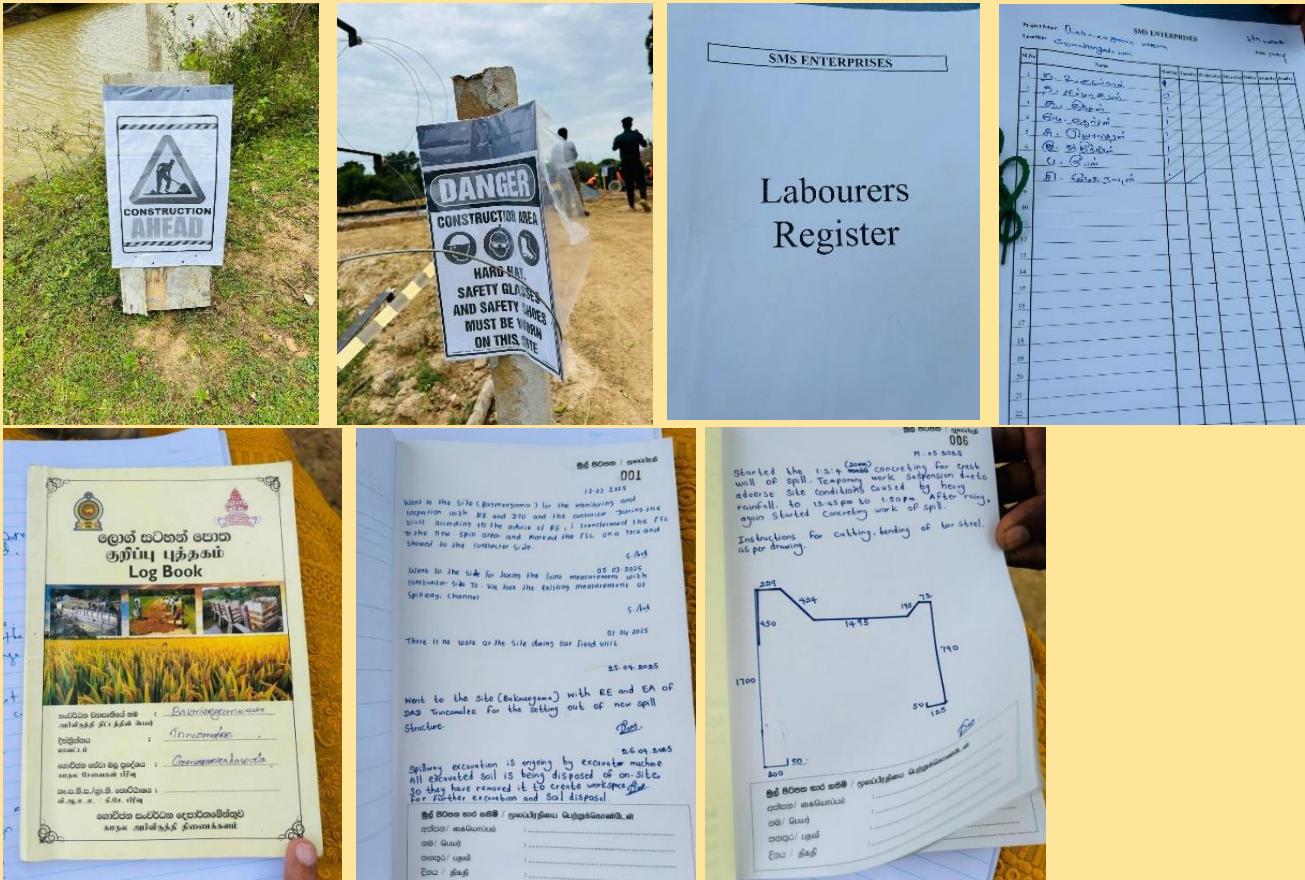
6. Occupational Health and Safety (OHS) and Camp Management

- A temporary shed was established at the site.
- A permanent elephant fence was also installed.
- No machinery was functioning on the day of the field visit.
- Workers engaged in site activities were wearing PPE, and a labor registry was available at the site.
- A first aid box and grievance box were placed at the campsite.
- Safety signboards were inadequate; they should be displayed in color for better visibility.
- Material storage was properly arranged.
- OHS measures require significant improvement.
- ESMP, COC-GBV, GRM, and awareness materials were available at the site.
