Field Visit Report
Annuakkan Wewa Downstream Development/ Rehabilitation (Phase II – CSIAP)
Southern Province

FIELD VISIT REPORT

ANNUKKAN WEWA (DOWNSTREAM WORKS) REHABILITATION (PHASE II – CSIAP)

Date of Visit: 02/07/2025

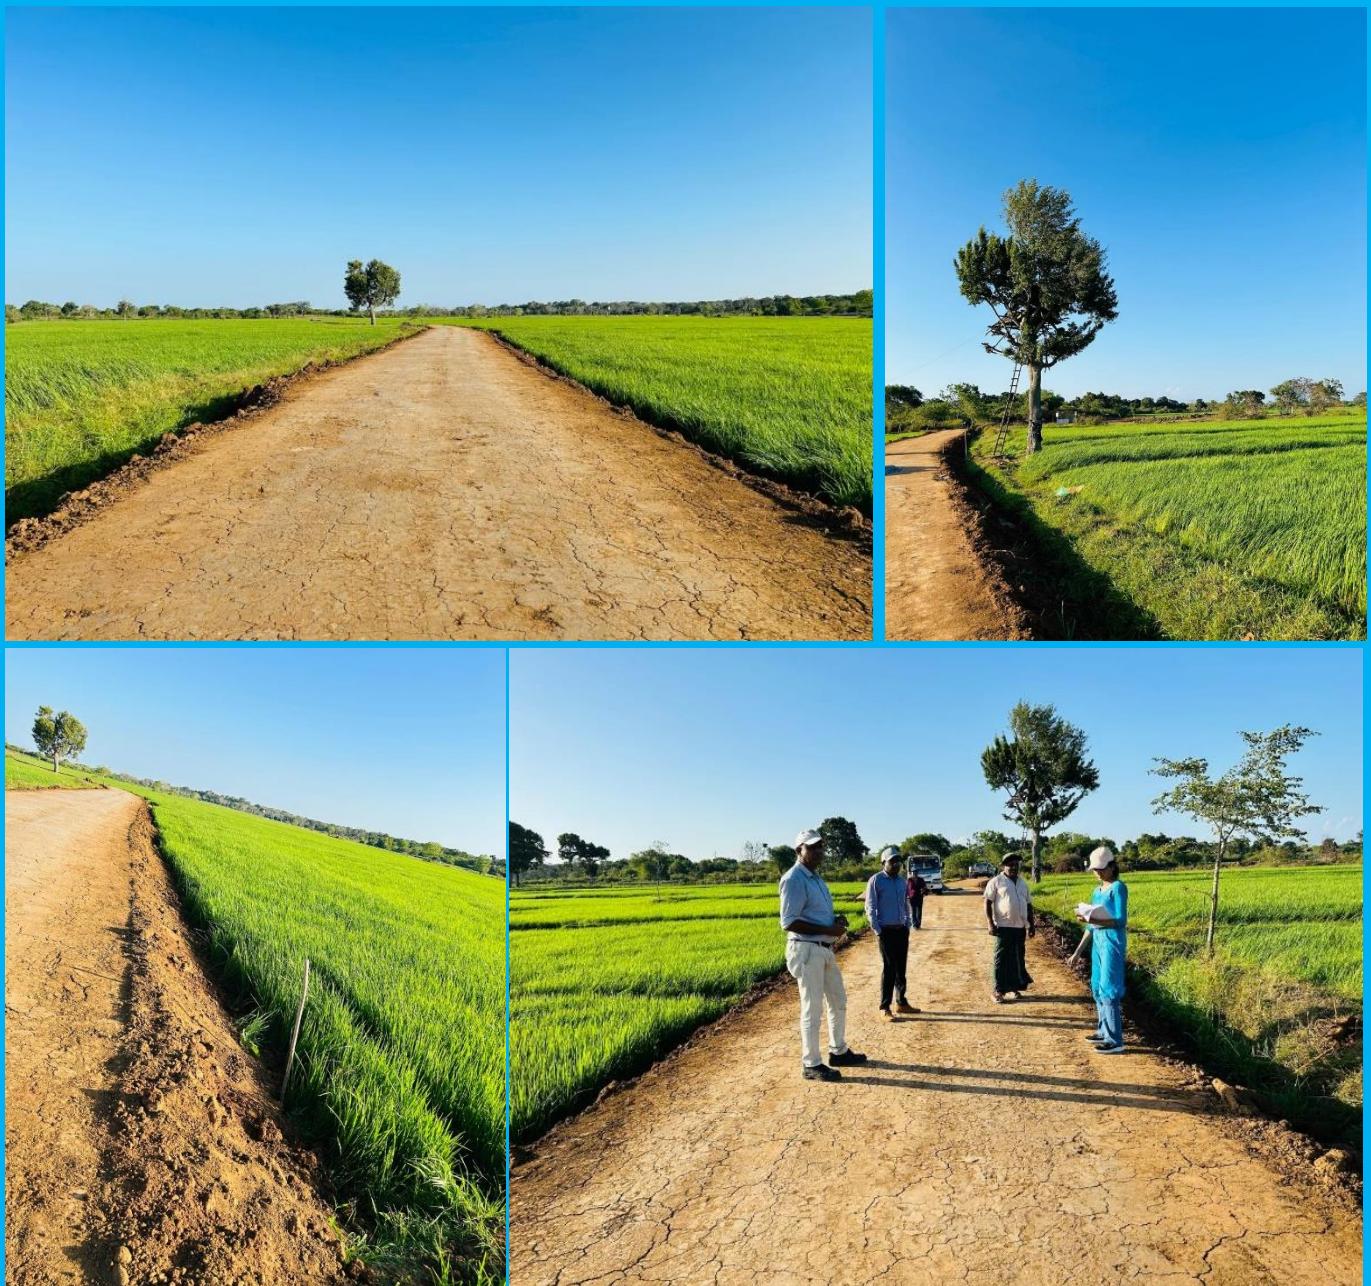
It was observed that agri road rehabilitation is going on.

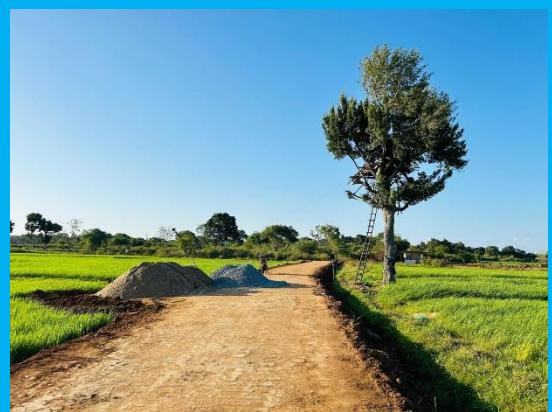
Construction materials were also present at the site.
