Field Visit Report

Kuda Thimbiri Wewa Tank Rehabilitation (Phase II – CSIAP)

The World Bank financed Climate Smart Irrigated Agriculture Project (CSIAP)

30/05/2025

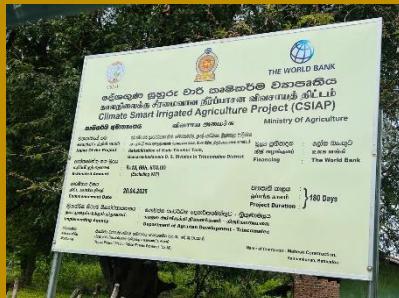
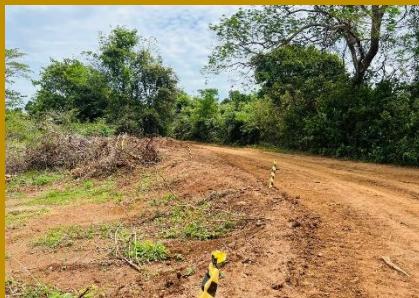
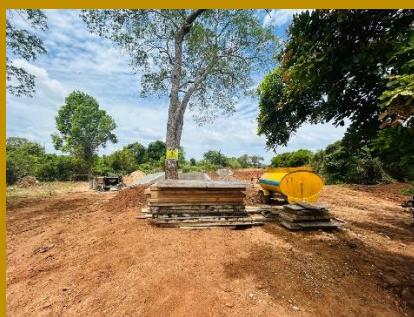
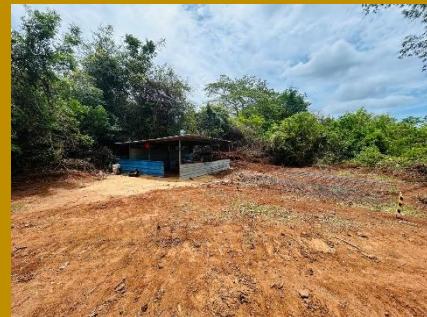
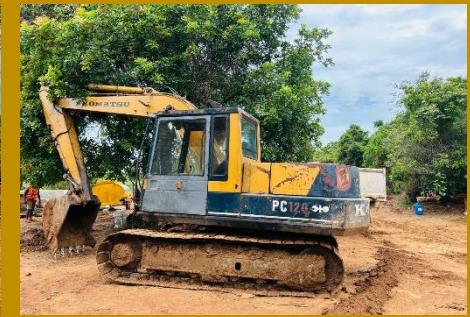
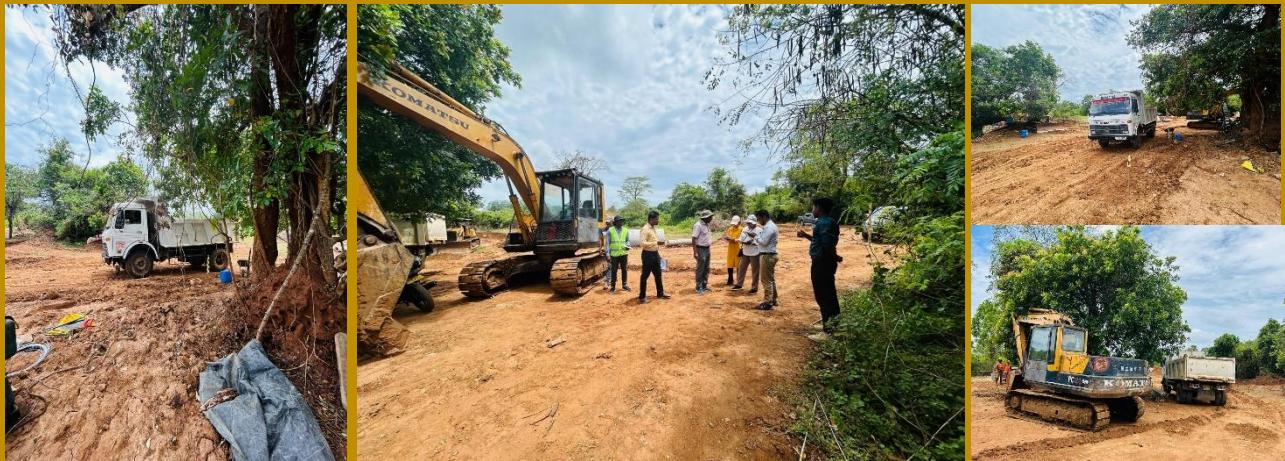
1. Site Preparation and Access

- Work commenced on 02/05/2025.
- The scope of work includes: tank bund improvement, repair of the spill, reconstruction of the sluice, construction of access steps, and improvement of the main channel with one-side agricultural road.
- Site clearing and material storage were completed.
- Access roads were available, and no rainfall was recorded during the visit.
- At the site: farmers, SAC, FO members, heavy machinery, sufficient laborers, contractor-side supervisor, as well as implementing agency-side supervisors were present.
- Name board was displayed.
- Construction work has already commenced.

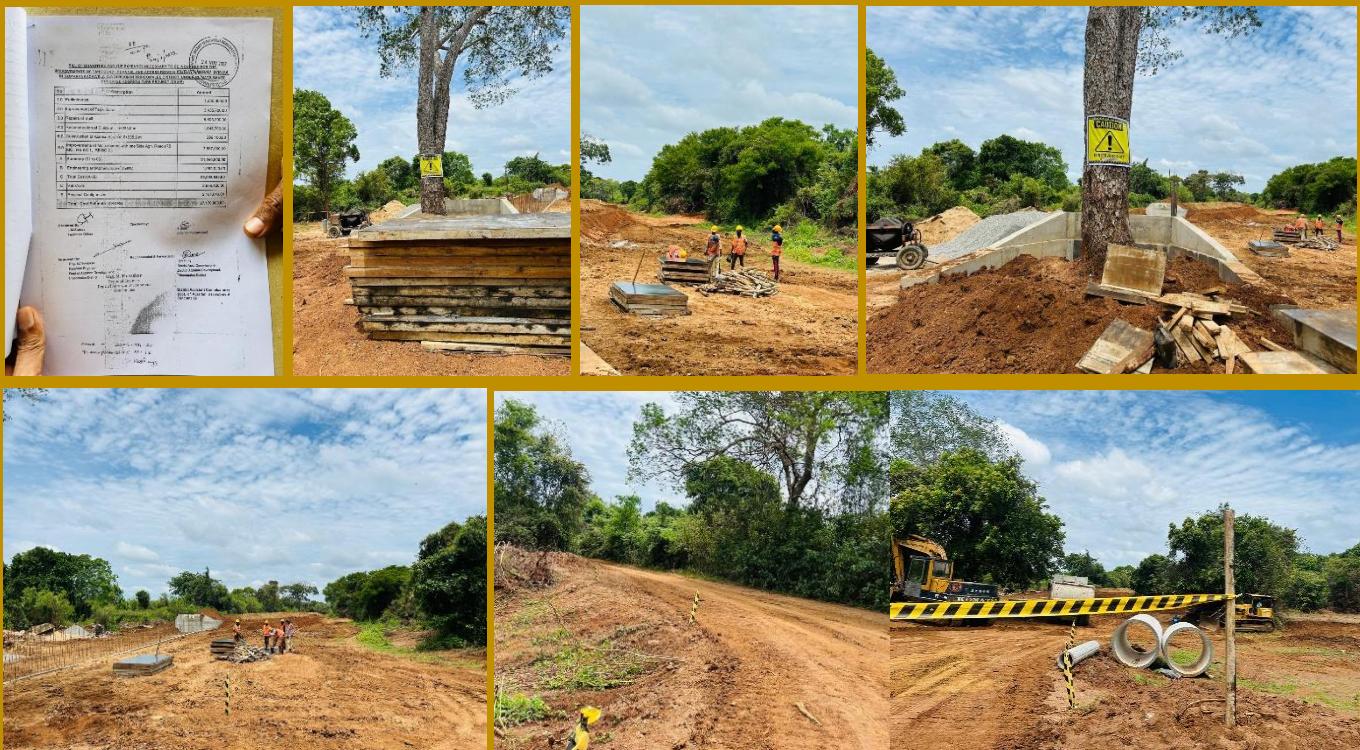
2. Construction Activities and Infrastructure Improvements

- Scope-based construction work had commenced, including sluice removal, concreting work started, and tank bund compaction initiated.
- Artificial water drawdown was not carried out, and farmers have already cultivated Yala paddy 2025.
- Heavy machinery was observed at the site.
- It was noted that the SAC and community members were actively involved.
- No delays were observed on the contractor's side; active SAC involvement and community participation were evident.
- Farmers stated that it would take approximately 1½ months to complete the paddy cultivation, after which water can be released. In the meantime, other construction works can proceed.

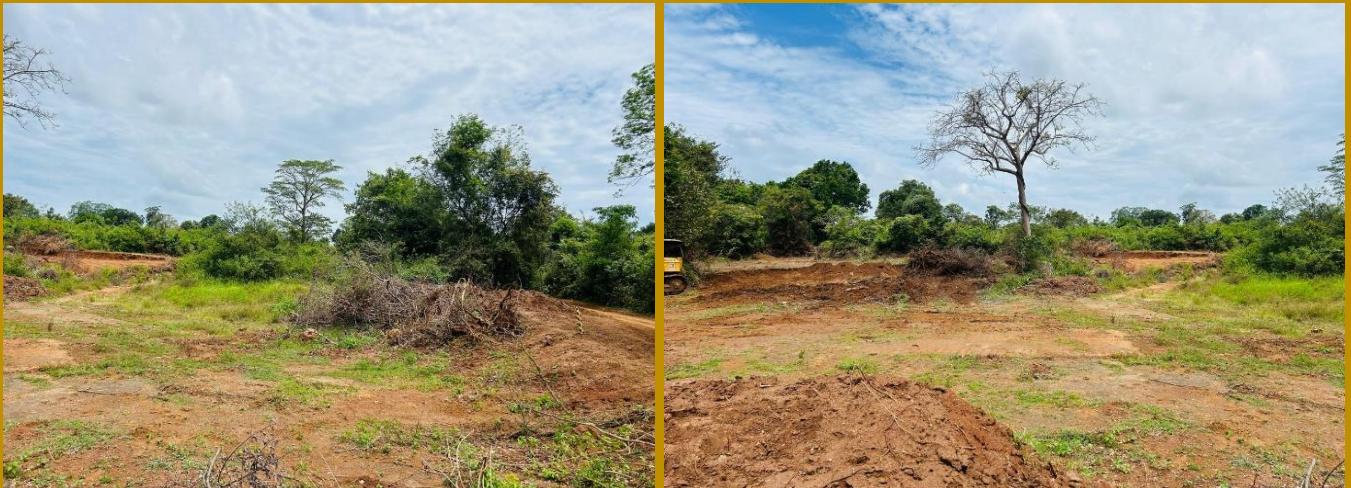
3. Environmental and Ecological Impacts

- The site is located near the Forest Department boundary.
- No tree removal was observed; however, minor vegetation clearing was noted.
- No flooding was reported at the site.
- Occasional elephant presence has been reported in the area.
- The site office was properly set up.

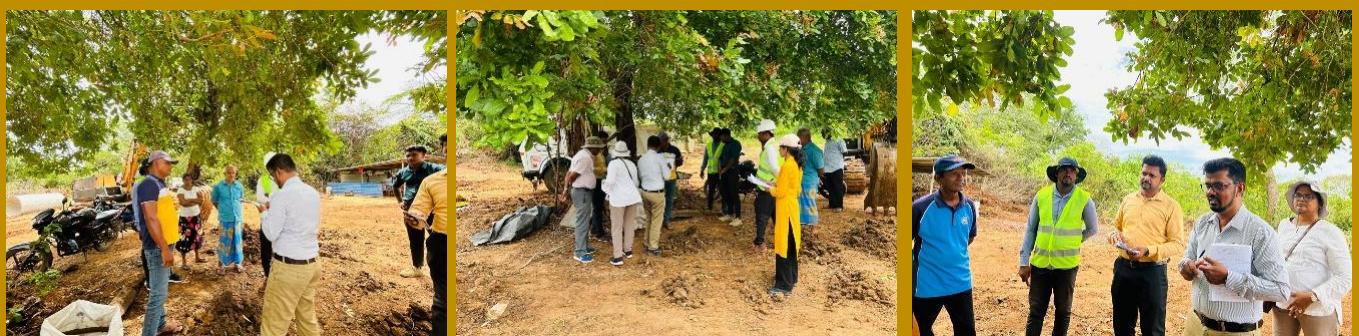
4. Social and Livelihood Impacts

- Farmers did not agree to forego Yala 2025 cultivation for the rehabilitation; therefore, the tank rehabilitation may be delayed by approximately 1½ months.
- No one lost their livelihood due to the tank rehabilitation.
- A rented house was arranged to accommodate the laborers.
- Four local community members were hired for unskilled work.

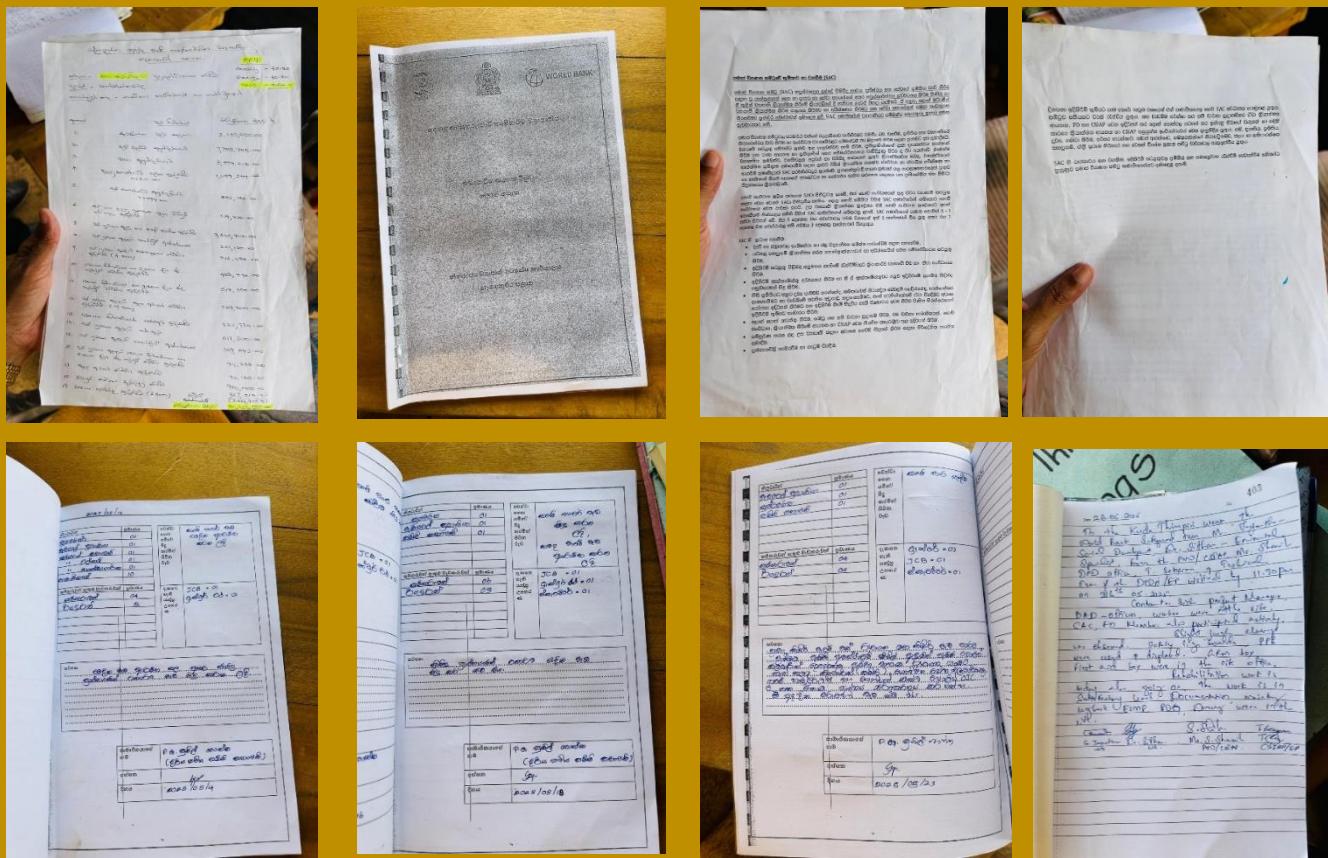
5. Stakeholder Engagement and Community Participation

- FO and SAC members were present and actively engaged during the visit.
- Good coordination was observed between the contractor and farmers, as construction work had already started.
- The SAC is maintaining logbooks, which are available at the site.

- An ESMP awareness program was conducted for the contractor and SAC members.
- SAC members reported that technical officers go off duty by 4:00 p.m. However, when concreting work extends beyond 4:00 p.m., a technical officer should remain on site, as SAC is not responsible for the duties of the technical officer.

- Therefore, the SAC requested that the technical officer stay until the concreting work is completed.
- The SAC also requested the DPDO to provide transport facilities for the technical officer, since this is a high Human-Elephant Conflict (HEC) area.

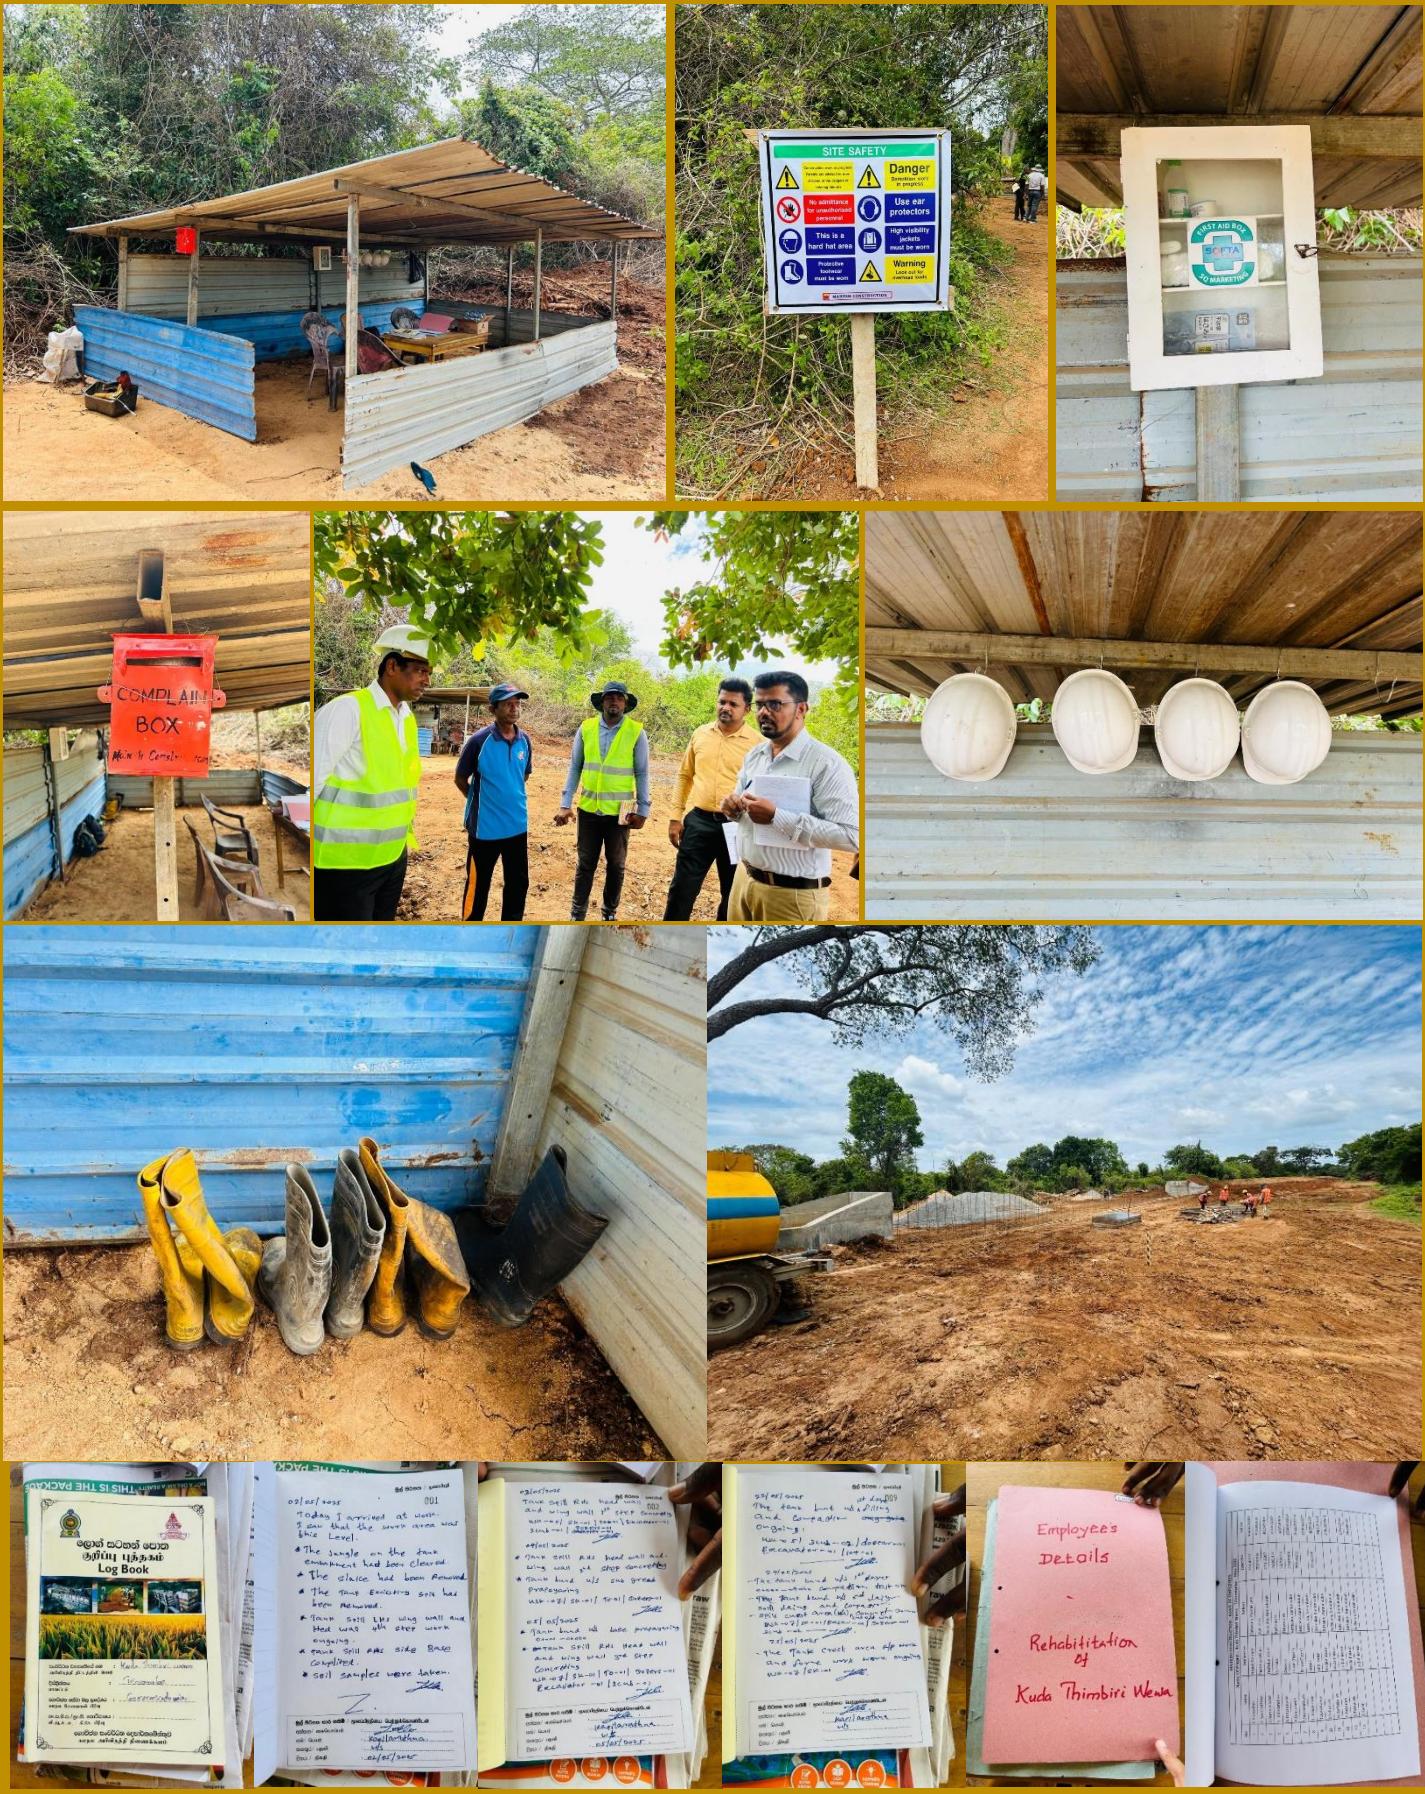
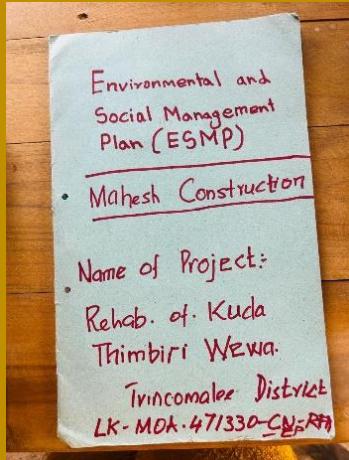
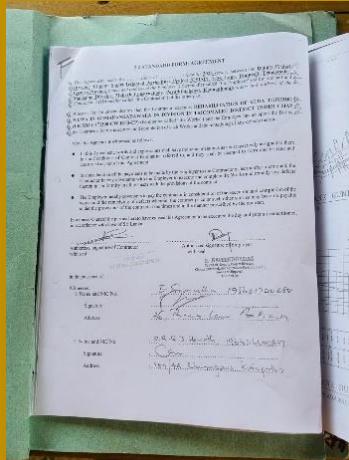
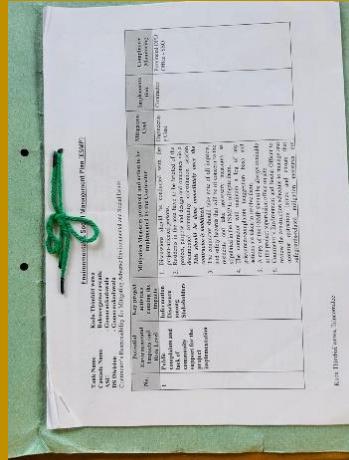
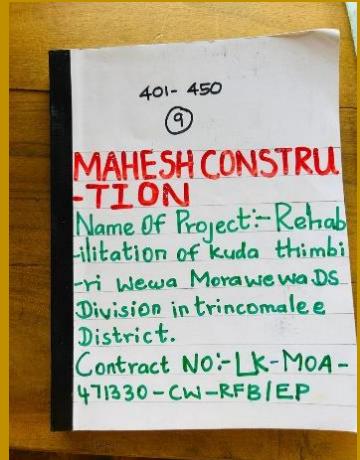
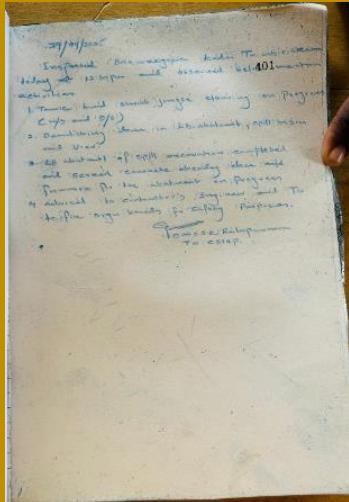
6. Occupational Health and Safety (OHS) and Camp Management

- A temporary shed was established at the site; workers are not stay at night at the worksite.
- A first aid box and grievance box were available at the site. Safety signboards were properly displayed. Material storage was observed and organized.
- OHS measures were clearly displayed, and PPE was used by the workers.
- ESMP, COC-GBV, GRM, and other awareness materials were available at the site.
