Field Visit Report  
Kumbuk Wewa Tank Rehabilitation (Phase II – CSIAP)  
Trincomalee, Eastern Province

## FIELD VISIT REPORT

### Kumbuk Wewa Tank Rehabilitation (Phase II – CSIAP)

- **Date of Visit:** 26/05/2025
- **Location:** Kumbuk Wewa, Kadawaththa Cascade
- **Project:** Climate Smart Irrigated Agriculture Project (CSIAP) – Phase II
- **Contractor:** Rasika Construction
- **Start Date of Work / Contractor Mobilized:**
- **Visited by:** Mr. G. Jayantha, and Dr. Sithara Attapattu (World Bank), Ms. Sharmila Shanmuganathan (PMU), Mr. T.Sekaran (SSO/DPDO/EP), and the Technical Team of the DPDO/EP

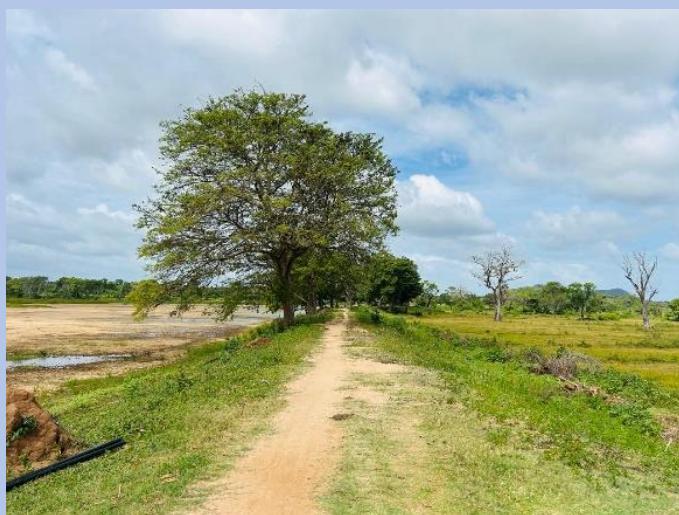
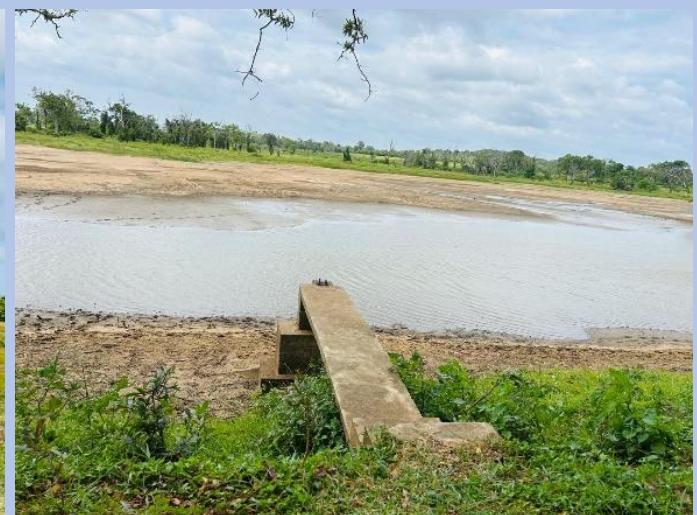
- Work commenced on 15/04/2025.
- The scope of work includes: tank bund improvement, spill and tower sluice repair, head wall-type sluice construction, bathing and access steps construction, improvement of LB and RB main channels, access road improvement, and upstream and downstream canal works.
- Site clearing was observed, but material storage had not yet been initiated.
- Access roads were available, and no rainfall was recorded during the visit.
- At the site, farmers, SAC, FO members, one machinery, one laborer, one supervisor, and the contractor were present.
- Name board was not displayed.
- The contractor must install the name board to ensure public awareness and accountability.
- No construction work had started except for artificial water drawdown.

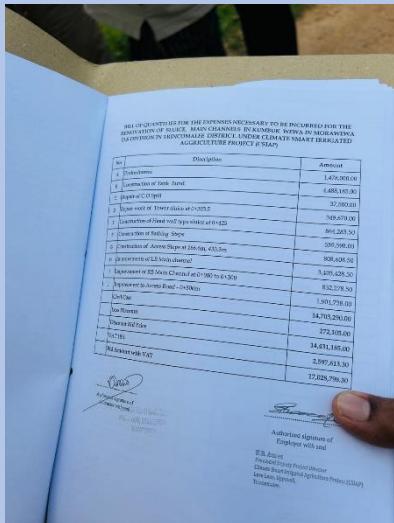
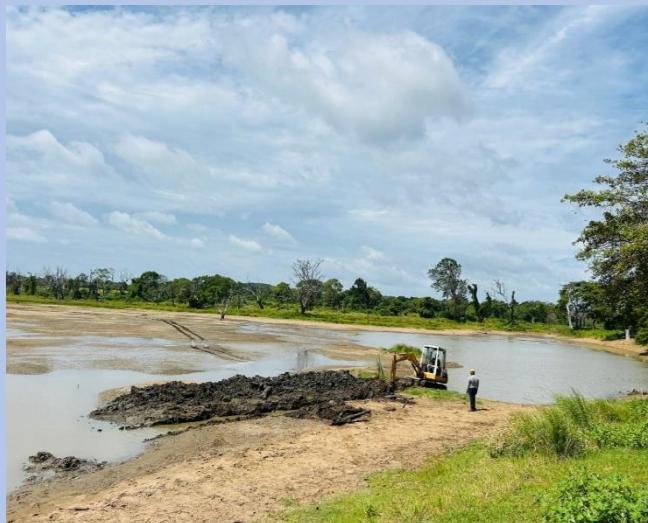
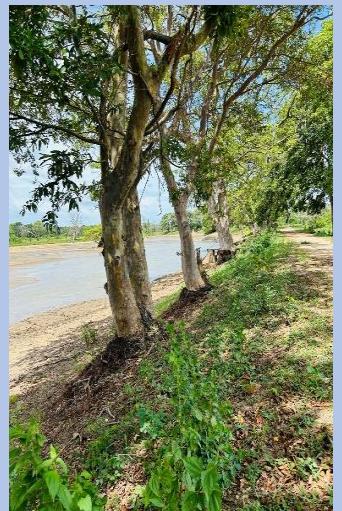
- A technical officer from DAD was present at the site.
- None of the scope-based construction work had commenced.
- Artificial water drawdown was done, and farmers agreed to forego Yala 2025 cultivation.
- Only one machinery was observed.
- Community disappointment was noted due to **delays**, despite their agreement to suspend cultivation.
- Immediate commencement of construction and close monitoring from DPDO and **implementing agency** is essential.

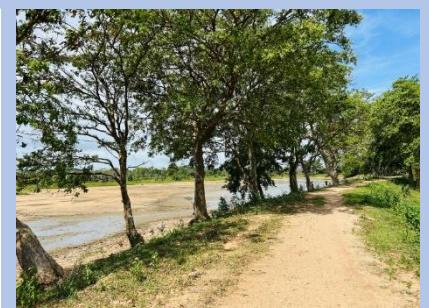
- Site is **outside** any environmentally sensitive area.
- No tree removal or vegetation clearance observed. **No impact on protected species or habitats.** Environmental risk: **Low**.
- No flooding at the site.
- Occasional elephant presence reported.

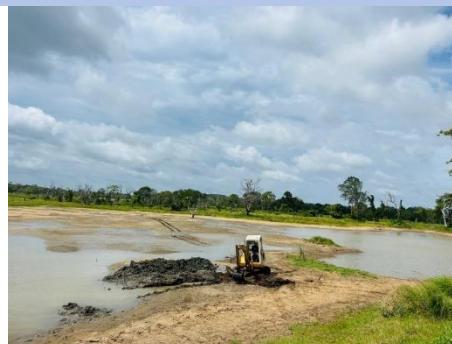
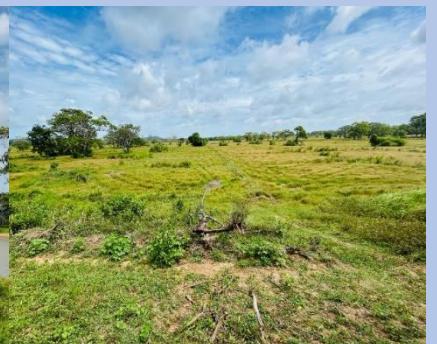
- Farmers agreed to forego Yala 2025 cultivation for rehabilitation.
- Typically, **15 farmers** cultivate **15 acres**, which was **not done** this season.
- Compensation planned: **150 kg** of green gram per farmer.

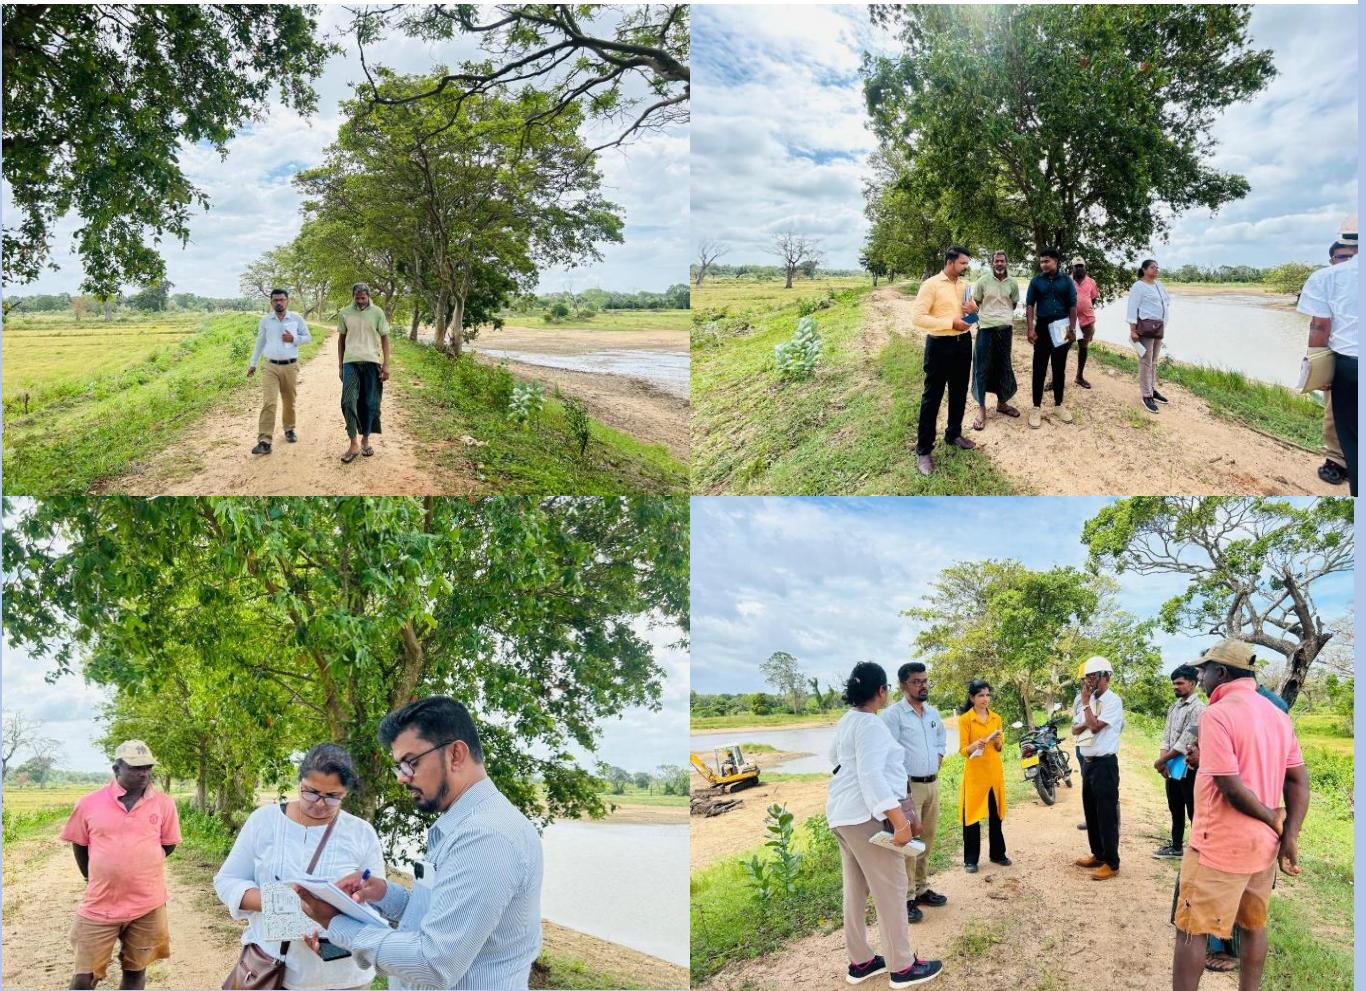
- FO and SAC members were present and engaged during the visit.
- Weak coordination noted between contractor and farmers, as work had not started.
- No SAC logbooks available at the site.
- No grievances reported, possibly due to limited participation.
- ESMP awareness program had been conducted for the contractor by the safeguard officer.

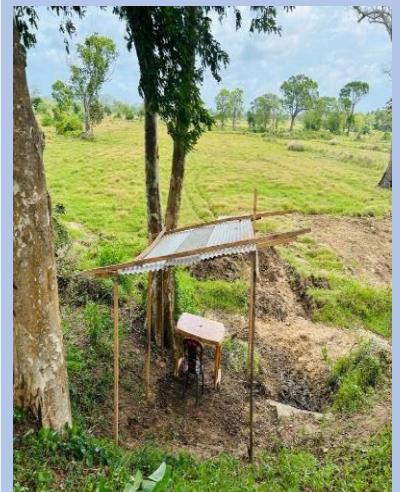
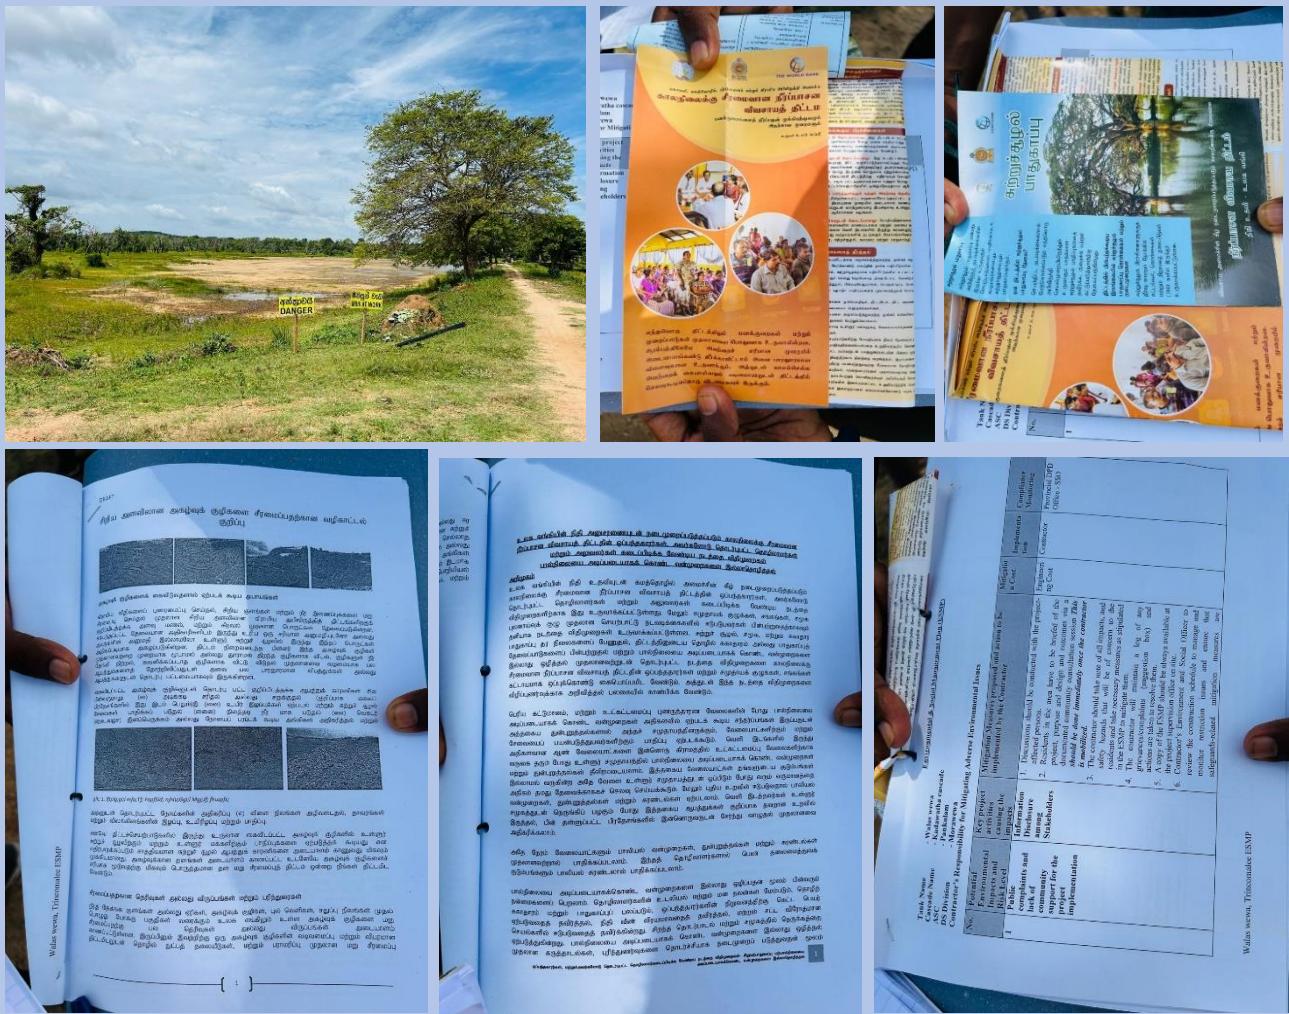
- The site office should be properly set up to withstand rain and wind.
- Material storage was not observed.
- Only one machinery operator was present.
- First aid box and grievance box were not available at the site.
- Safety signboards were inadequate.
- OHS (Occupational Health and Safety) measures require significant improvement.
- As a result of the ESMP awareness programme conducted by the safeguard officer, ESMP, COC-GBV, GRM, and awareness materials were available at the site.
