Field Visit Report
Thuwaran Kulam Tank Rehabilitation (Phase II – CSIAP)
Trincomalee, Eastern Province

30/05/2025

FIELD VISIT REPORT

Thuwaran Kulam Tank Rehabilitation (Phase II – CSIAP)

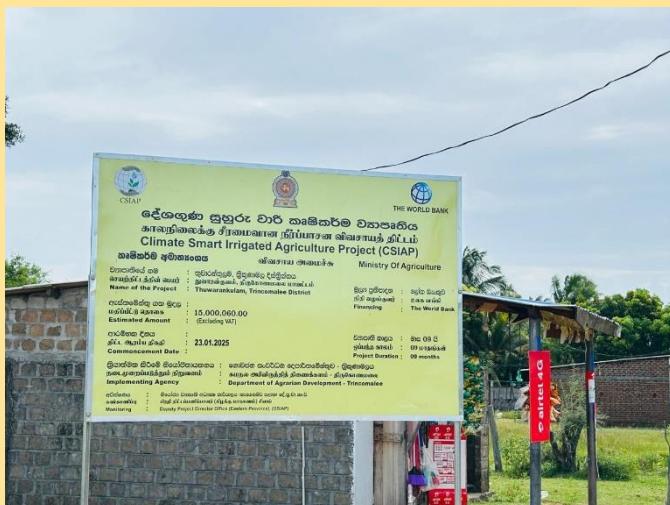
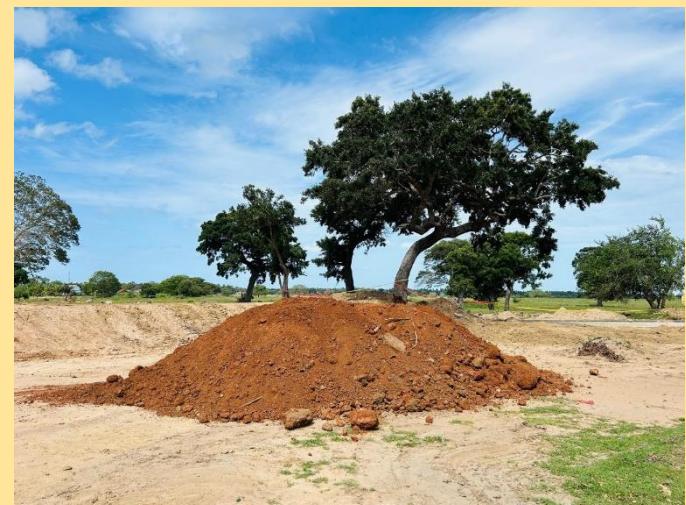
- Work commenced in the 1st week of April, 2025.
- The scope of work includes: **Tank bund improvement, Renovation of LB & RB Sluice, Improvements of LB main channel, Construction of C.O Spill, Improvements of LB-D channel I & II, and Improvements to Farm Road.**
- Site clearing and material storage were noted.
- Access road for this tank is available, and **no rainfall** was recorded during the visit.
- At the site: **Farmers, SAC, FO members, machineries, and the contractor** were present.
- **Name board was displayed.**
- Construction work had already started.

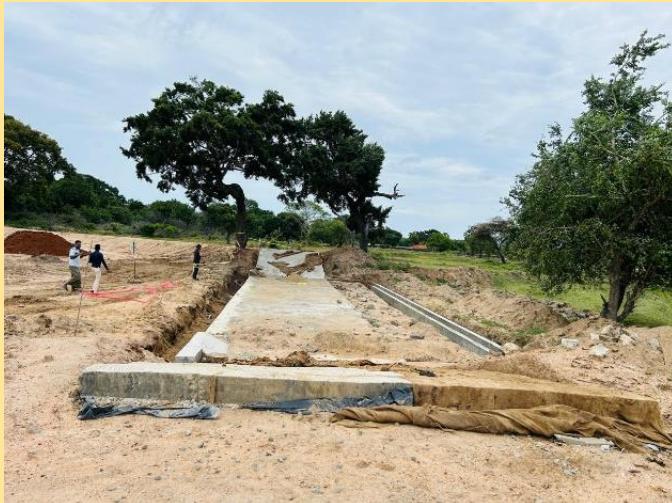
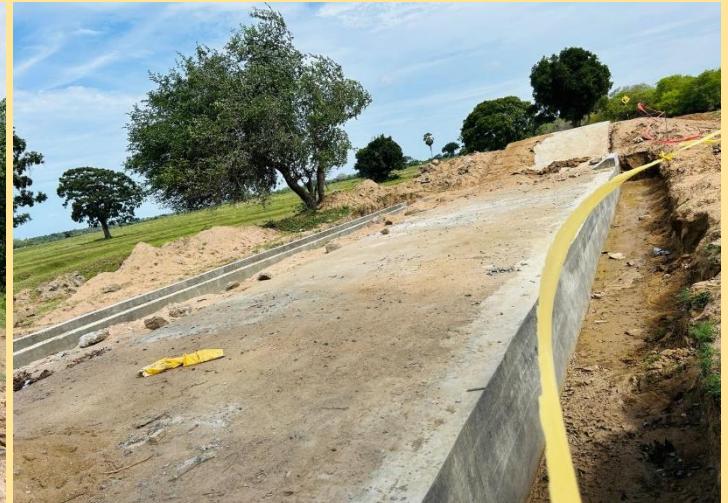
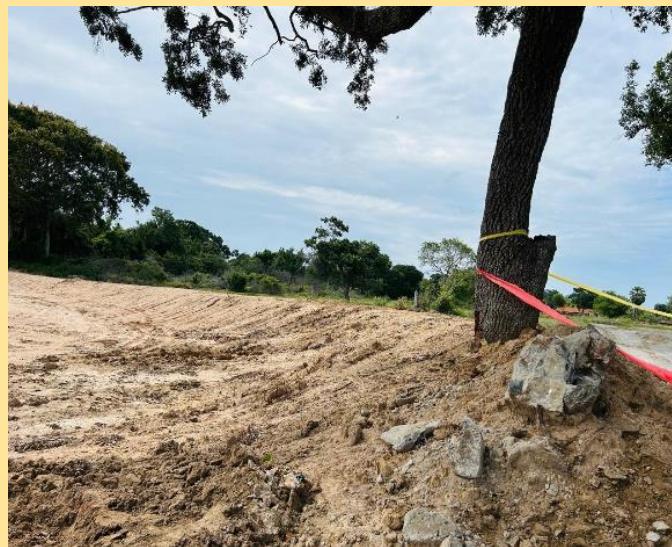
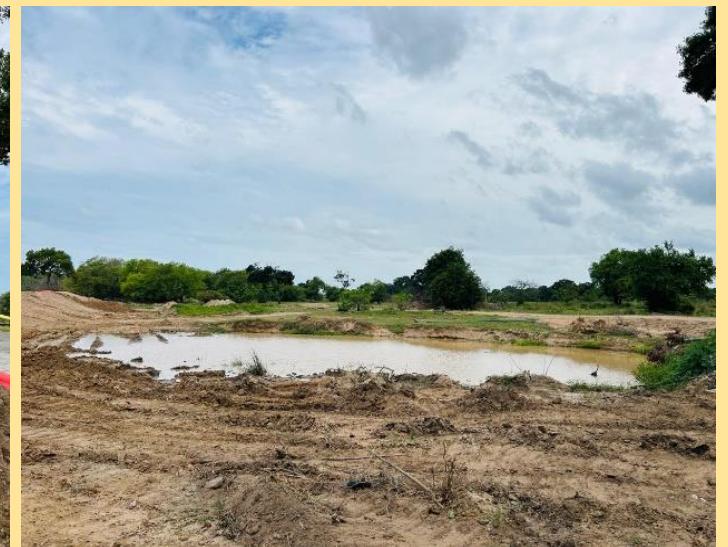
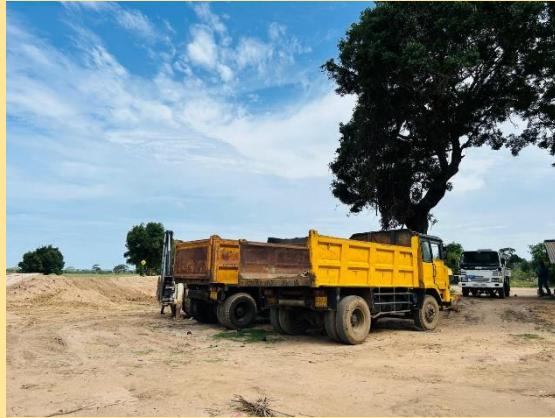
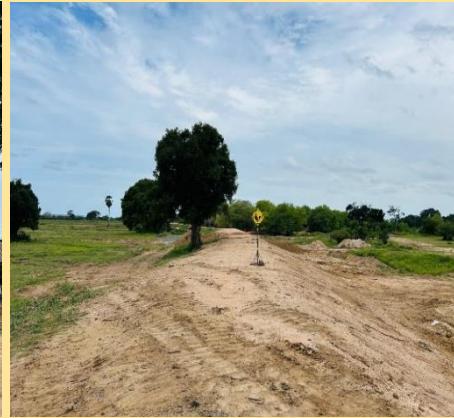
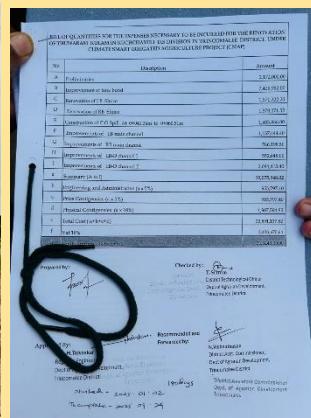
- A technical officer from DAD was present at the site.
- Scope-based construction work had commenced.
- The community repeatedly requested the spill raise, as it was not included in the project scope.
- Continued construction work and close monitoring by the DPDO and the implementing agency are essential.
- Since concreting work has been partially completed, if the contractor expedites the remaining work, the site can be completed before the rainy season.

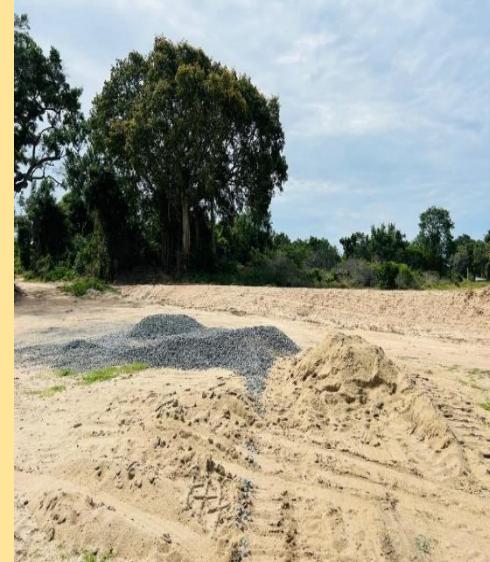
- The site is located 300m from the **forest boundary**. It was **not recommended to raise the spill level**.
- **No tree removal or vegetation clearance** was observed.
- **No flooding** was observed at the site.
- Occasional elephant presence was reported.
- No impact on **protected species or habitats** unless the spill level is raised.
- **Environmental risk: Low**.
- A **burrow pit** was observed; it should be **filled** when the contractor hands over the site.

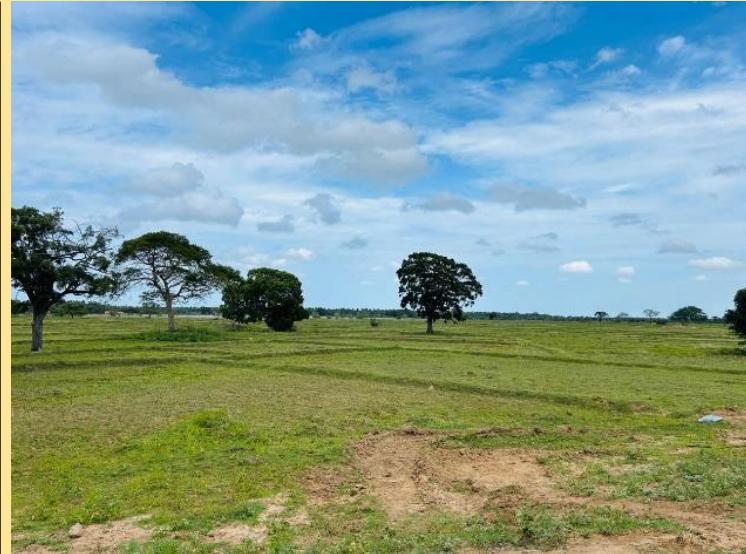
- None of the farmers lost their **livelihood** due to the **tank rehabilitation**.
- Usually, farmers do not cultivate **Yala paddy** due to **water scarcity** in the **tank**.

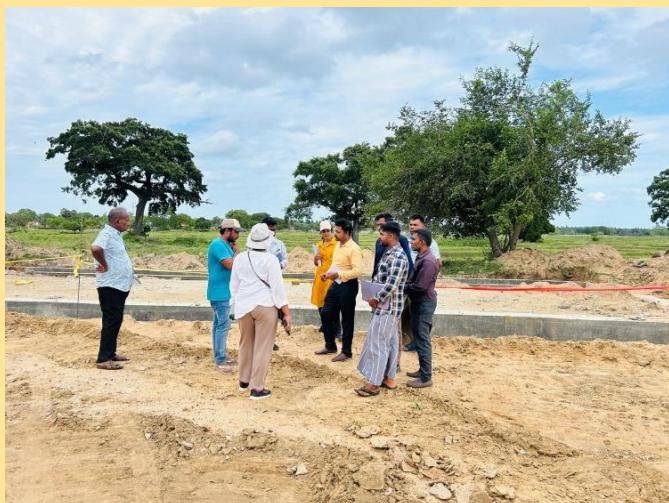
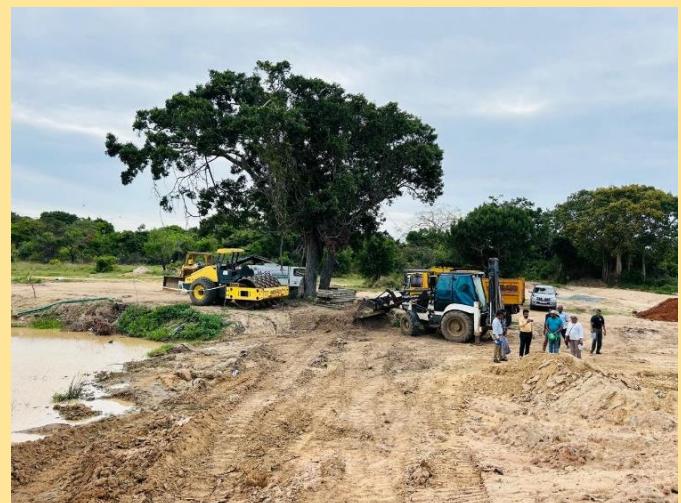
- FO and SAC members were present and engaged during the visit. They were **very active**. The active participation of the SAC was one of the reasons for the **speedy progress** of the tank work at this site.
- Strong coordination was noted between the **contractor and farmers**.
- Properly maintained **SAC logbooks** were available at the site.
- An **ESMP awareness program** had been conducted for the **contractor**.
- A grievance was reported requesting to **raise the spill level**. Farmers were informed that if the **Forest Department agrees** to the **spill raising** and provides **written approval**, it will be considered.
- Farmers requested an **agri road** of approximately 750m in distance.

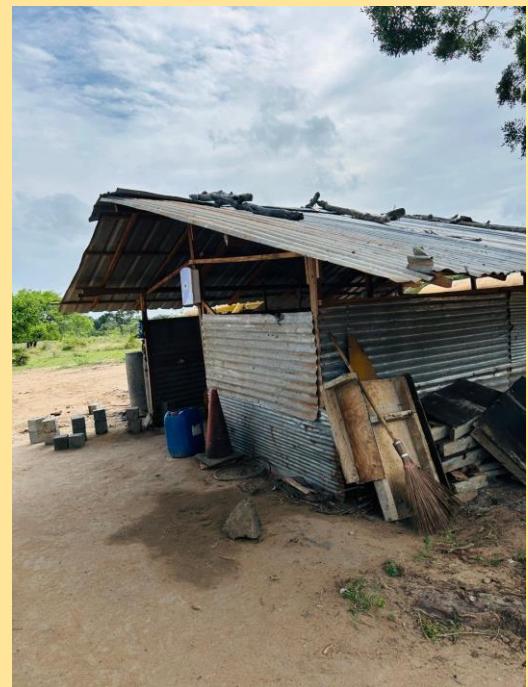
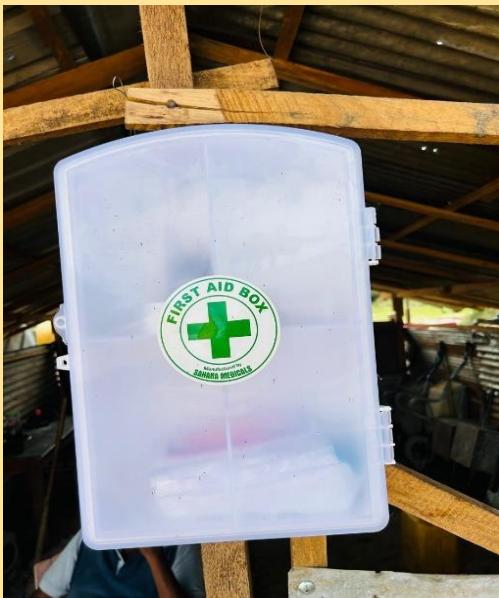
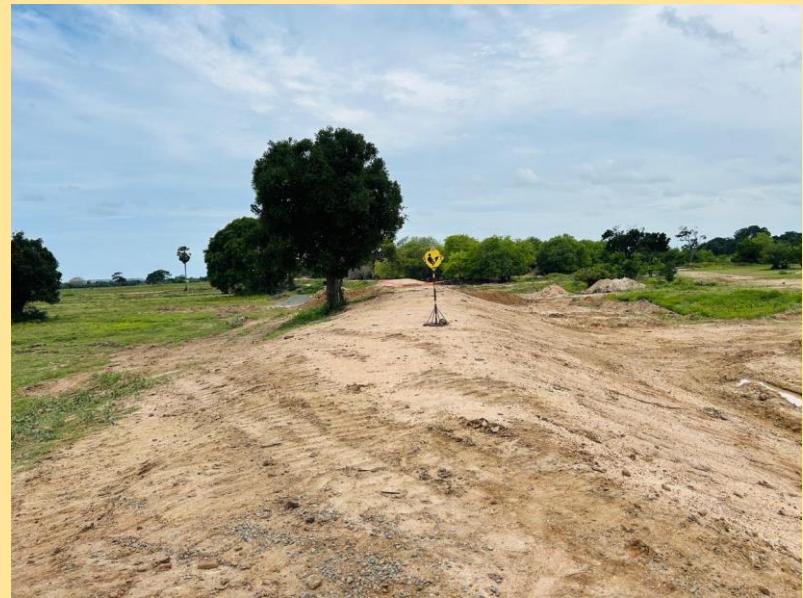
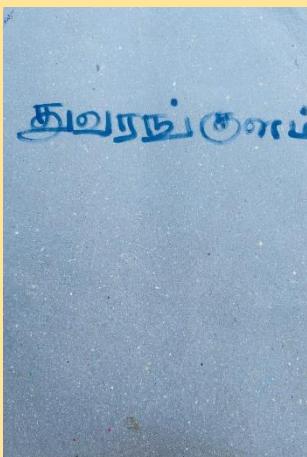
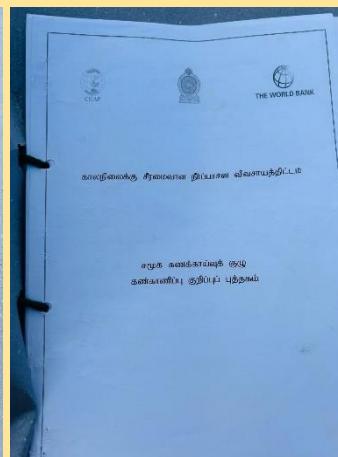
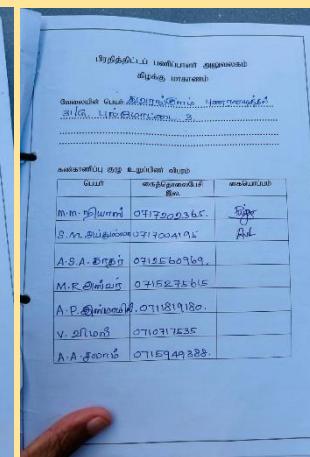
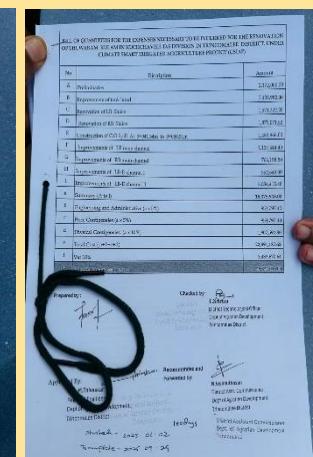
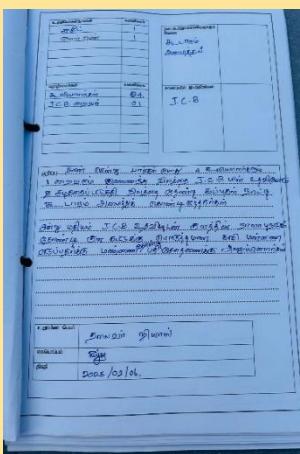
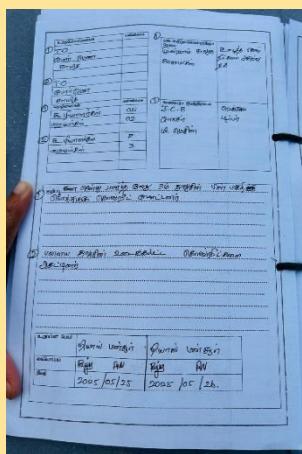
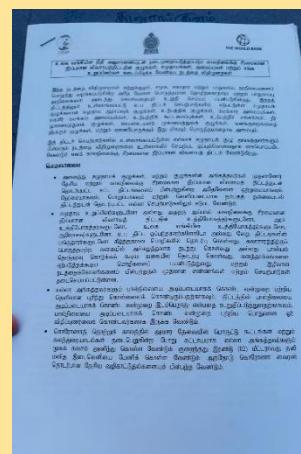
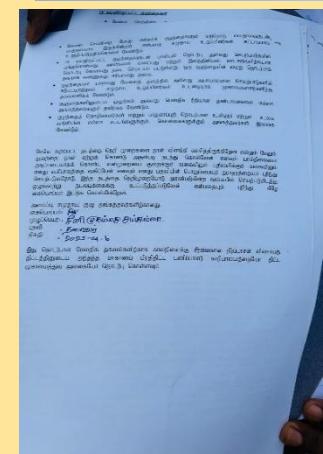
- A **temporary shed** was set up at the site.
- Workers do not stay at the site.
- **No work** was in progress on the day of the **field visit**.
- A couple of **machines** were observed at the site.
- A **first aid box** was placed at the site.
- **Safety signboards** were **inadequate**.
- **Material storage** was observed.
- **OHS measures** require **significant improvement**.
- **ESMP, COC-GBV, GRM, and awareness materials** were available at the site.
