Field Visit Report  
Thammannawa Wewa Downstream Development/ Rehabilitation (Phase II – CSIAP)  
Southern Province

The World Bank financed Climate Smart Irrigated Agriculture Project (CSIAP)  
Ministry of Agriculture, Livestock, Land and Irrigation (MOALLI)

## FIELD VISIT REPORT

### THAMMANNAWA WEWA (DOWNSTREAM WORKS) REHABILITATION (PHASE II – CSIAP)

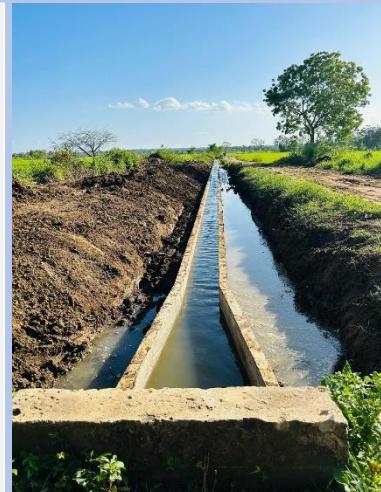
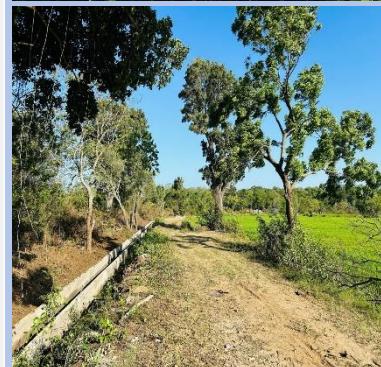
It was observed that 640 meters of concrete canal lining had already been completed, and backfilling was in progress.

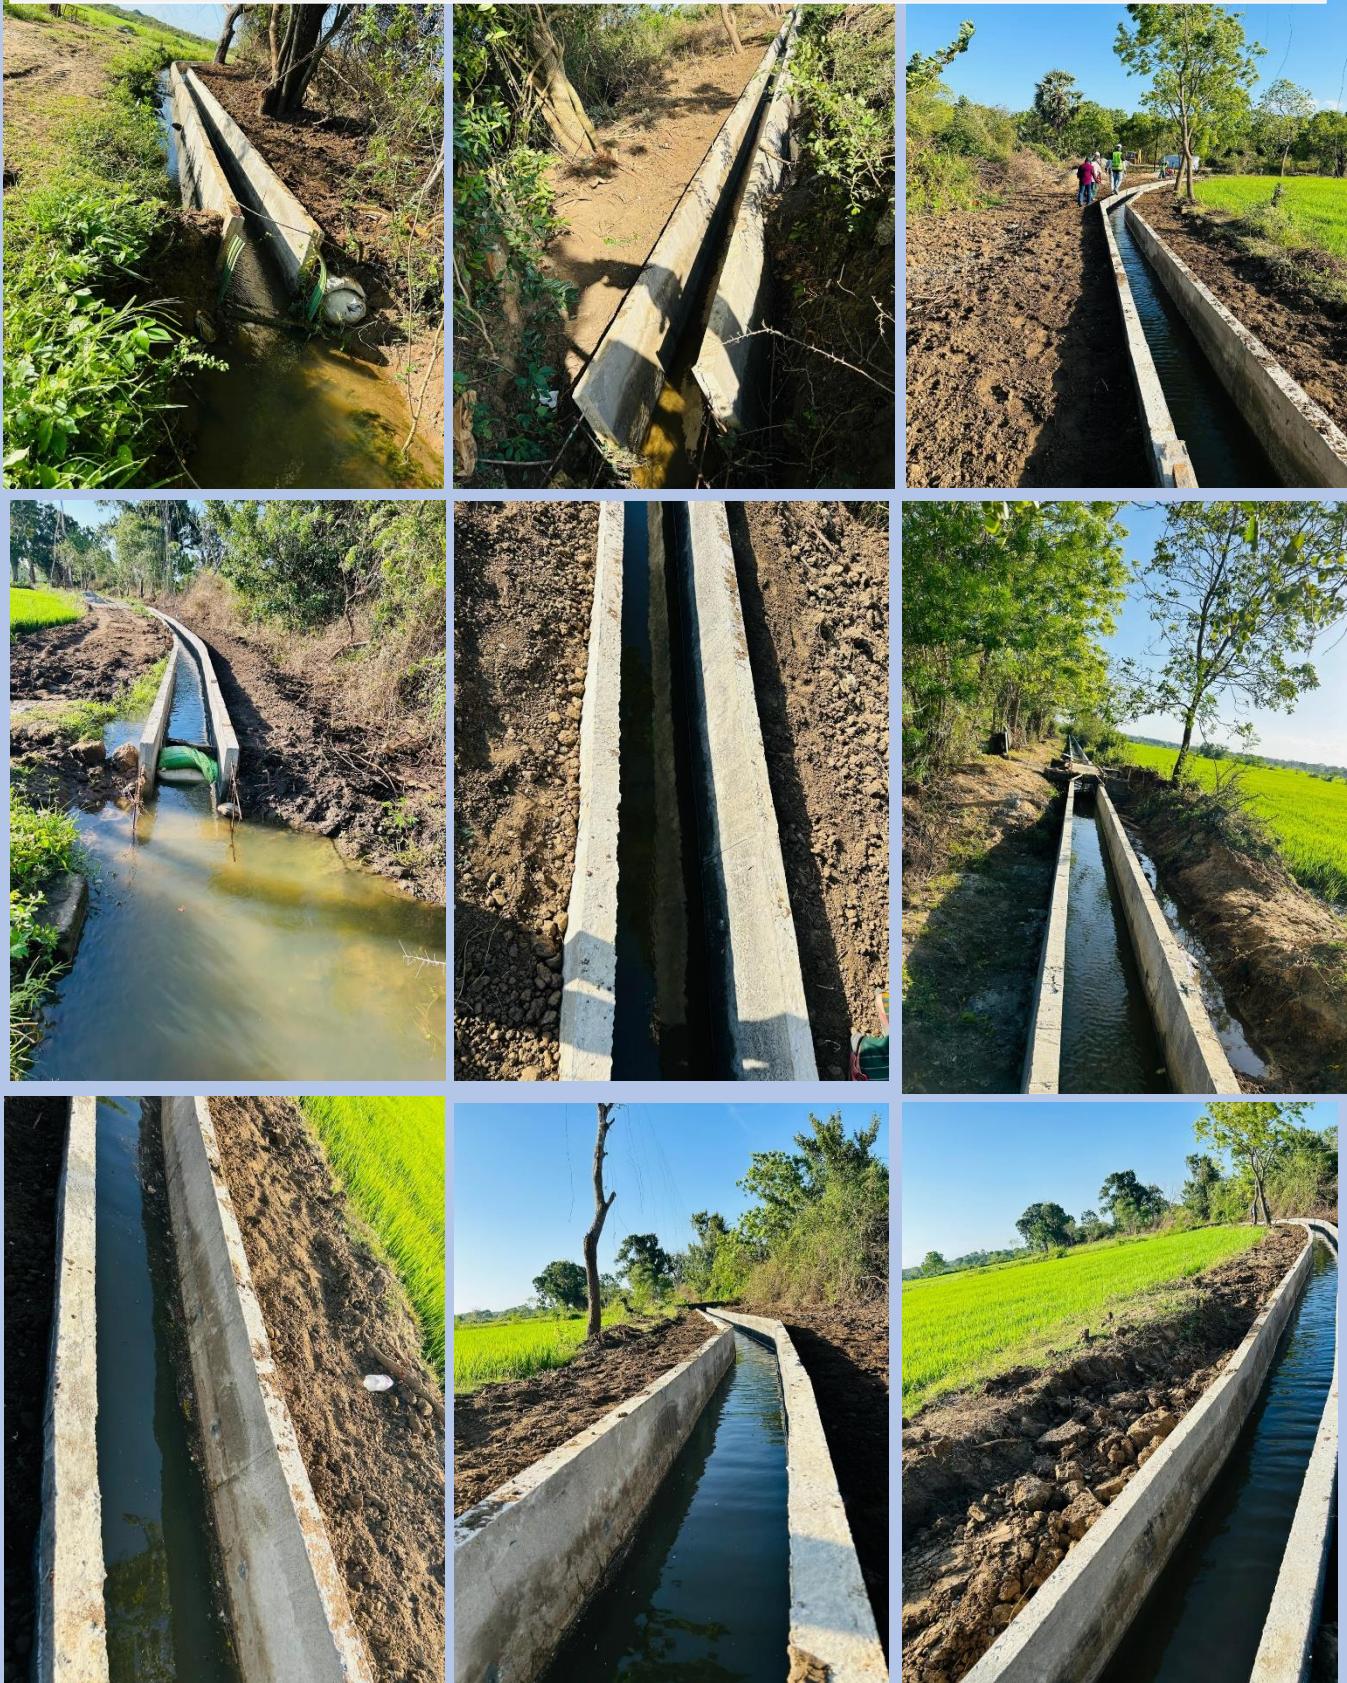
Representatives from the Farmers' Organization (FO), the Social Audit Committee (SAC), officers from the implementing agency, workers, contractor's site supervisors, the DPDO technical team, and the safeguard team were present at the site.

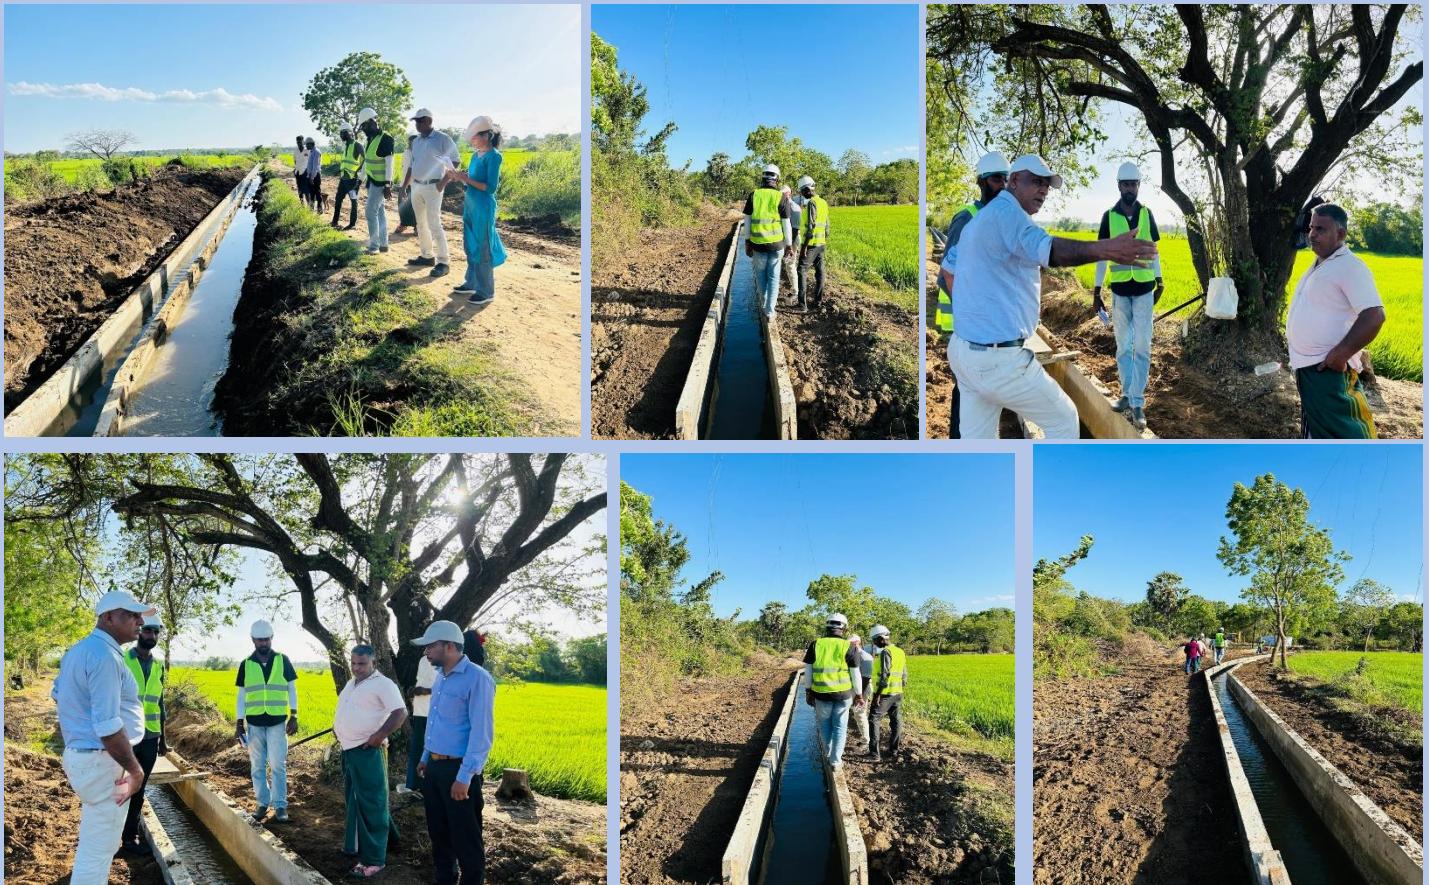
Construction materials, workers, and four (04) machinery were also observed.

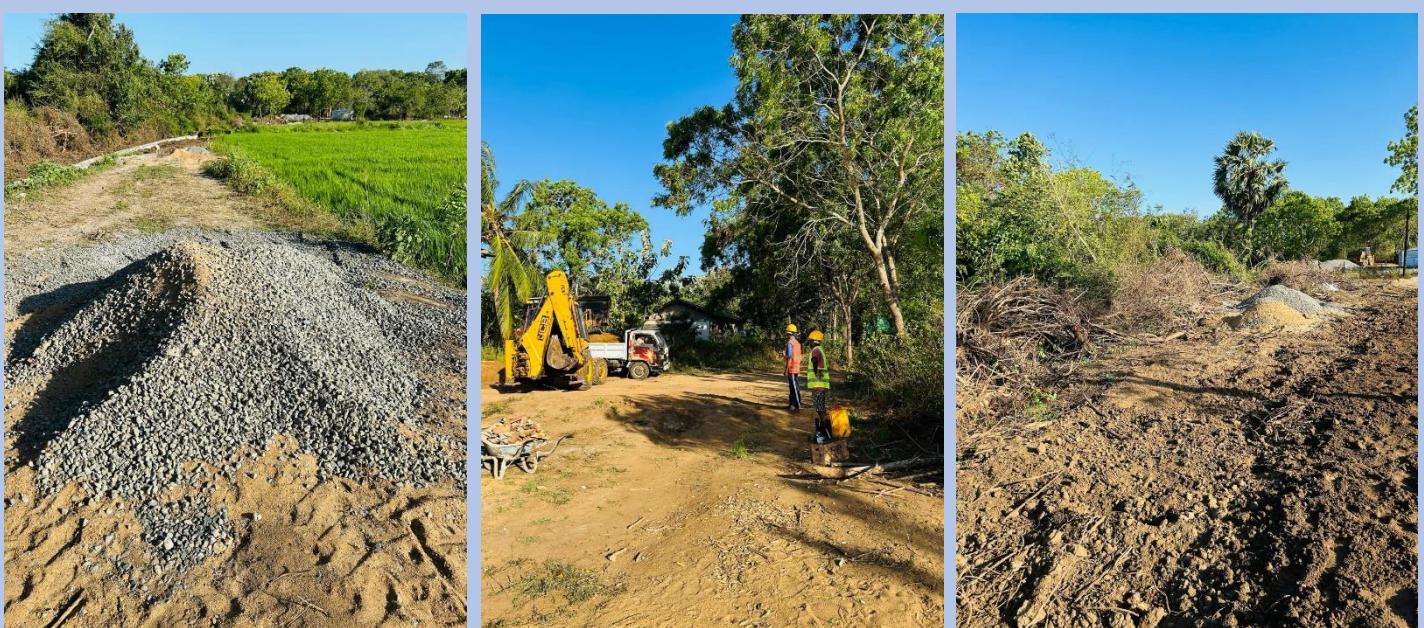
Site office and four (04) safety sign boards were also observed.

3. Continue ensuring that no tree removal or other environmentally sensitive activities take place within or near the rehabilitation area.
4. The contractor must display the subproject name board at the site to promote public awareness and ensure accountability.

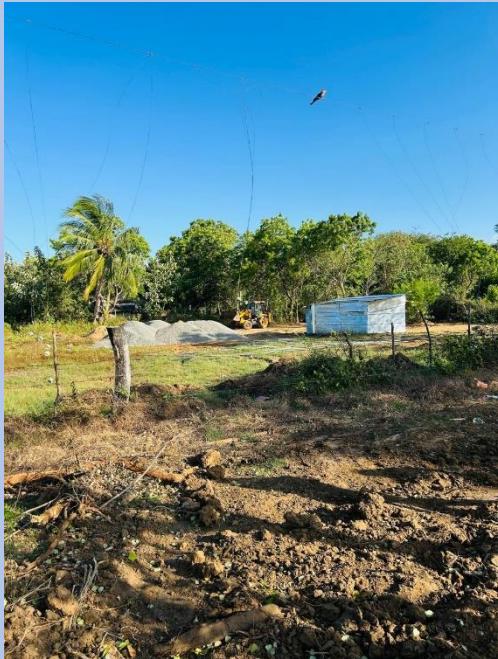
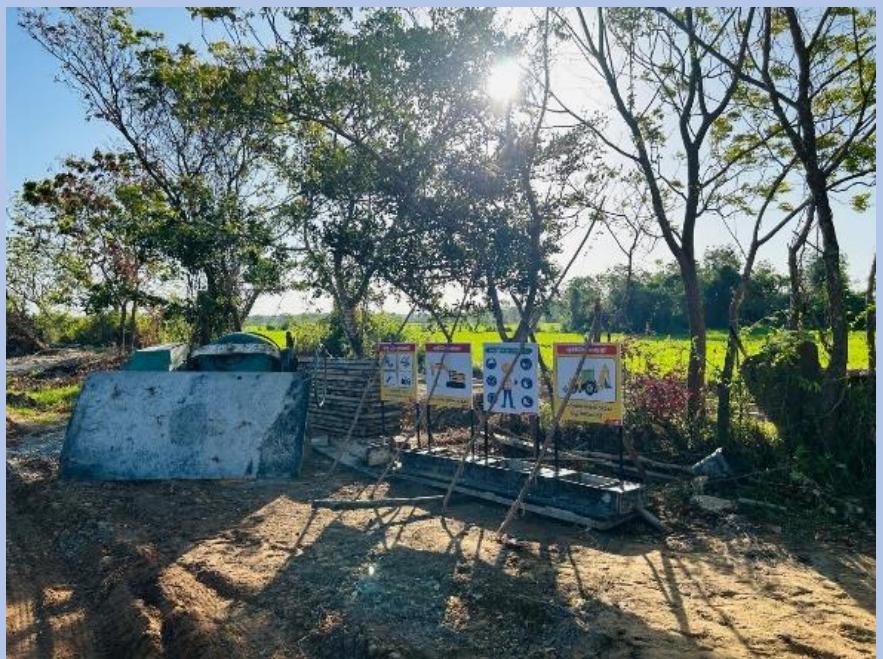
It was observed that workers were wearing PPE during the work.

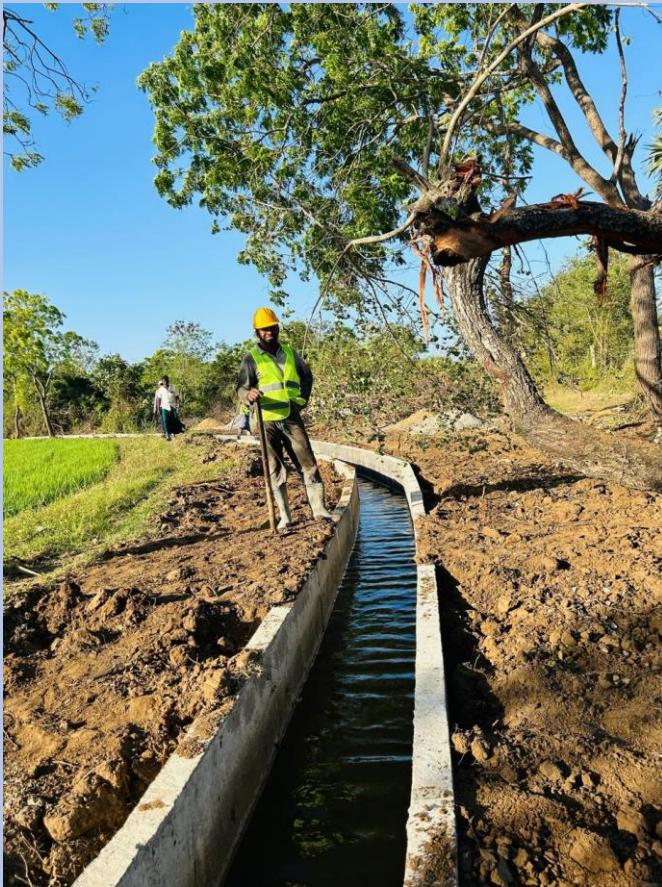
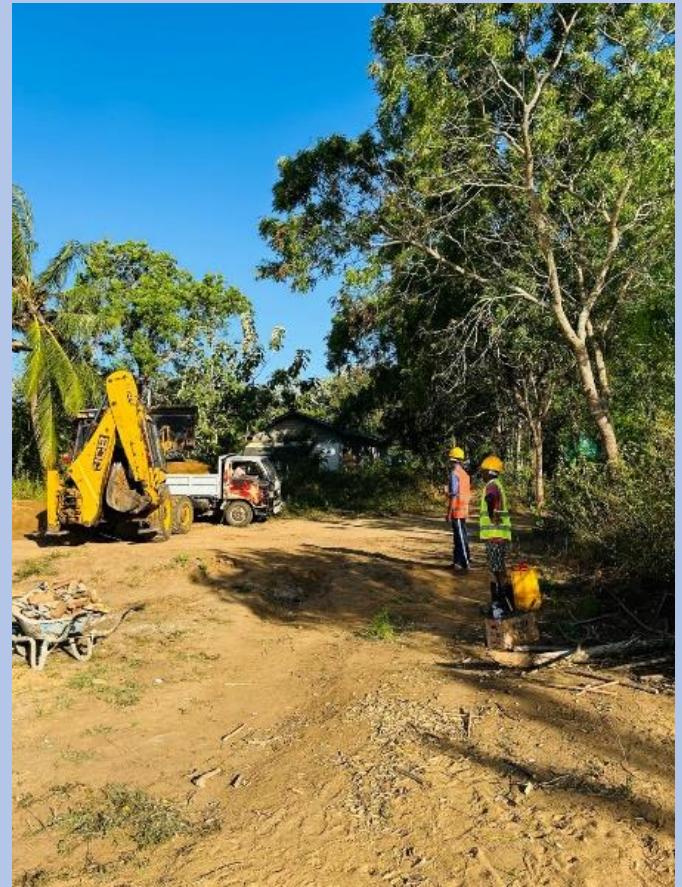
Minor vegetation clearing was observed along the sides of the canal where concrete lining was being carried out.
