**Field Visit Report
Murunga Wewa Rehabilitation (Phase II – CSIAP)
Southern Province**

**The World Bank financed Climate Smart Irrigated Agriculture Project (CSIAP)
Ministry of Agriculture, Livestock, Land and Irrigation**

FIELD VISIT REPORT OF THE MURUNGA WEWA TANK REHABILITATION (PHASE II – CSIAP)

Project: Climate Smart Irrigated Agriculture Project (CSIAP) – Phase II

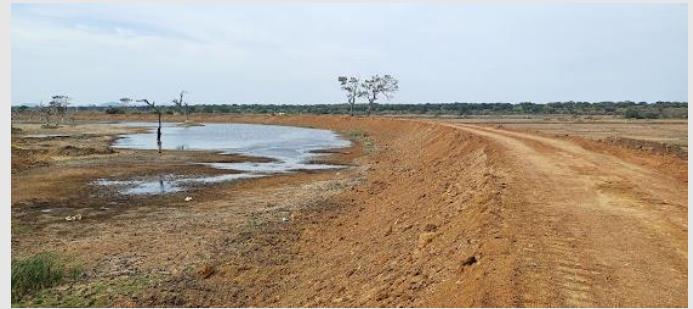
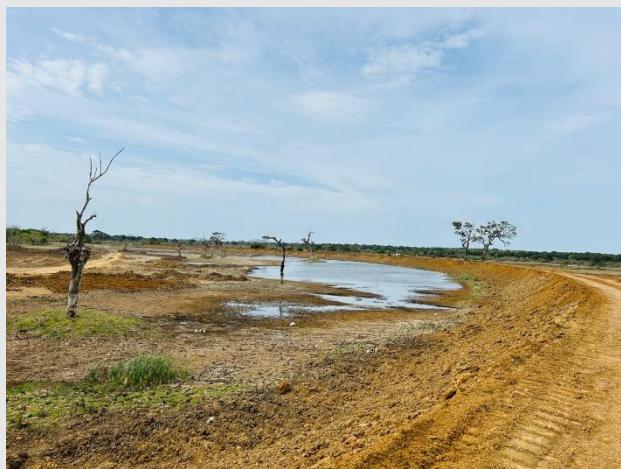
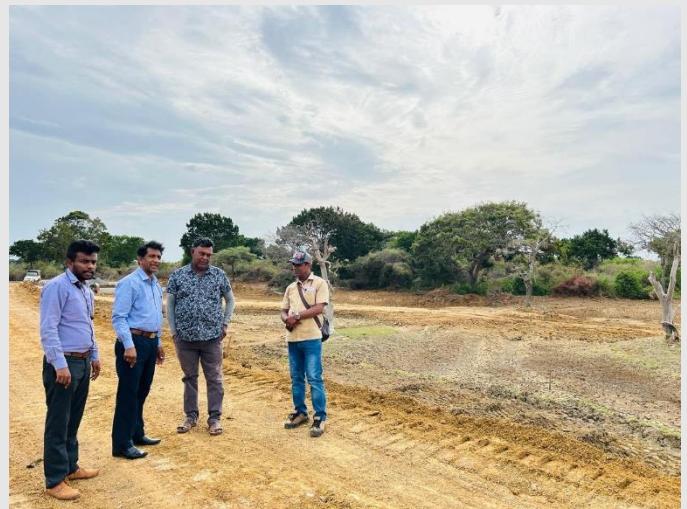
Improvement of a tank bund to enhance the tank's structural integrity and prevent seepage and erosion.

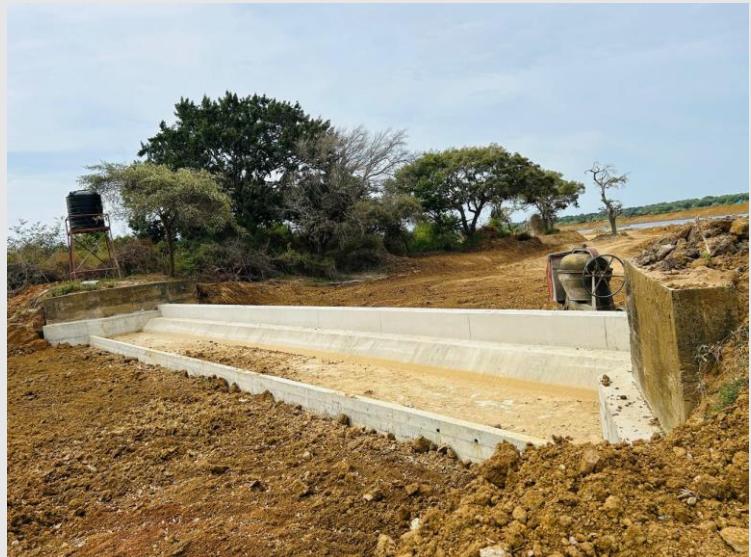
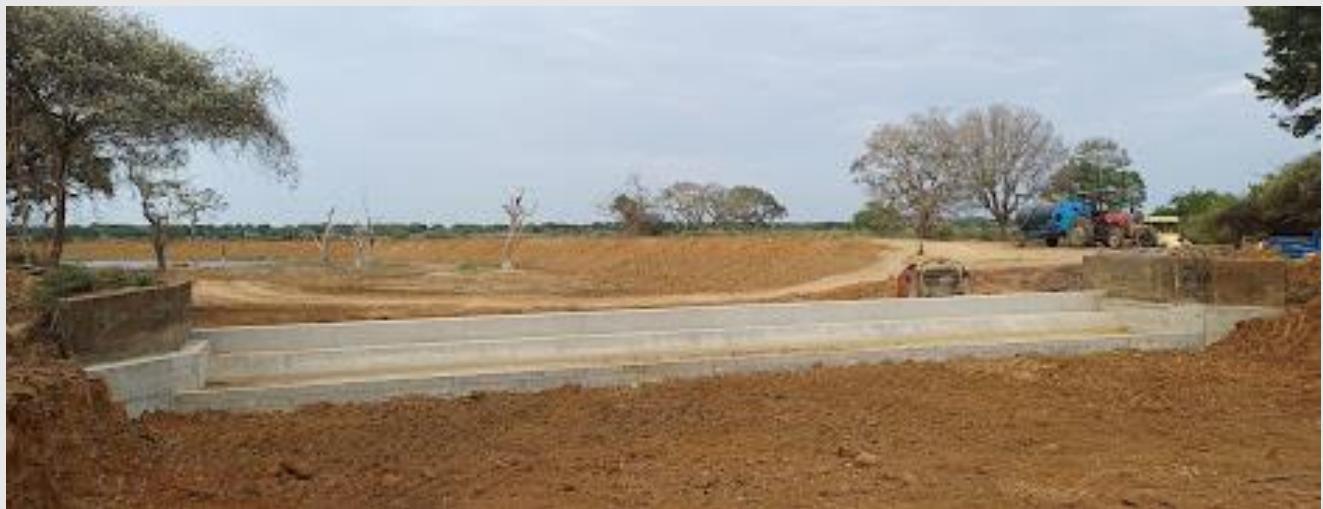
Constructed a new 21-meter-long spillway to safely manage excess water discharge during heavy rains, thereby protecting surrounding lands and infrastructure.

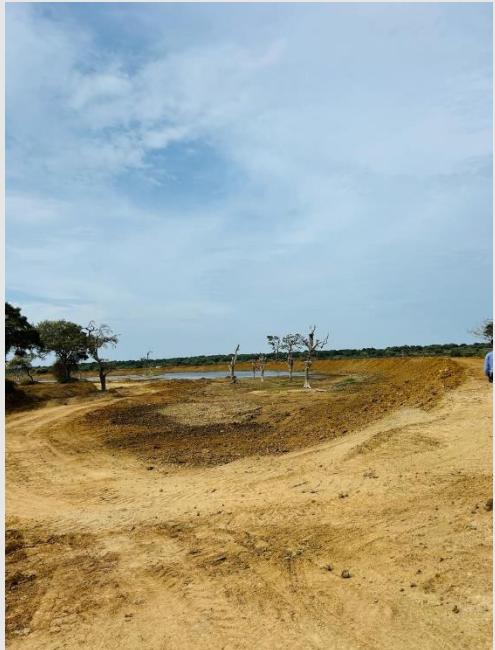
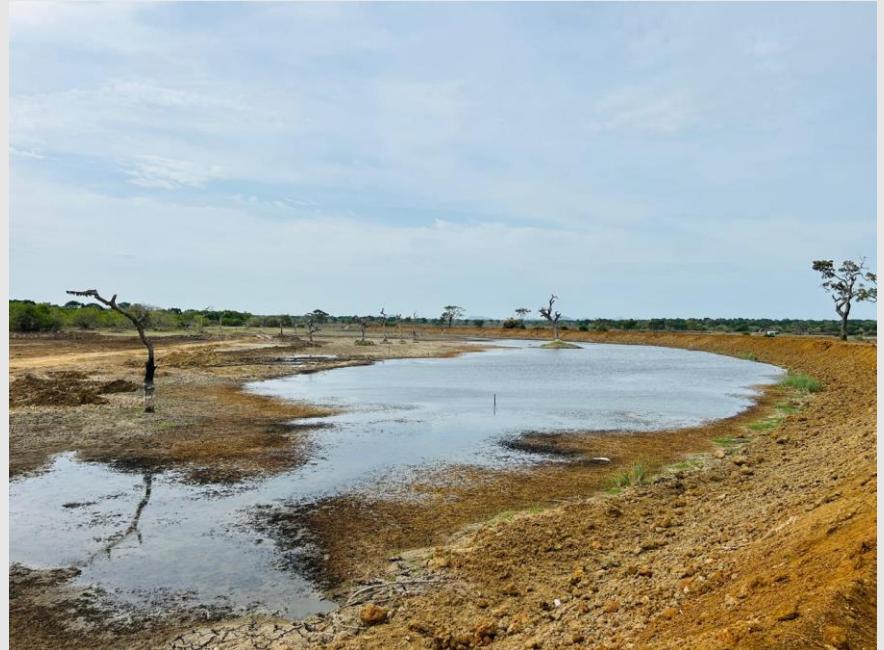
Installation of a new sluice gate to improve water control and facilitate timely irrigation scheduling.

Desilting of 6,500 cubic meters of accumulated sediment from the tank bed has significantly increased its water storage capacity.

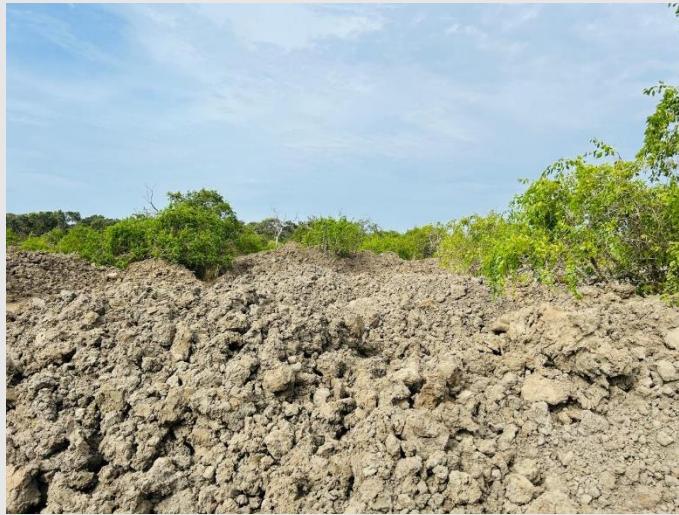
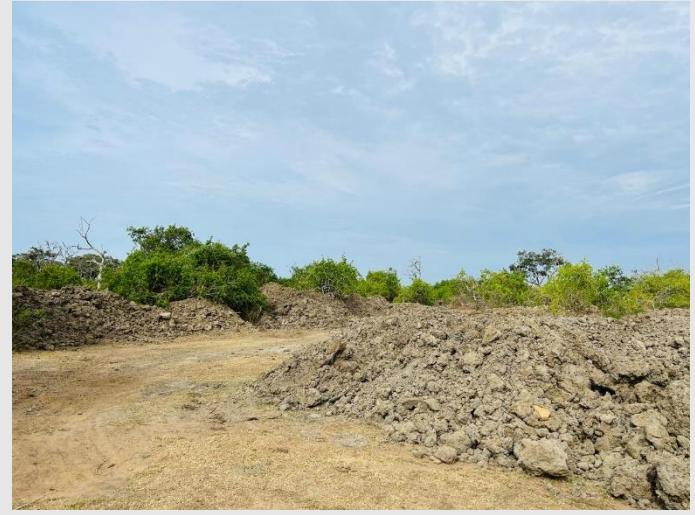
It was observed that the desilted material was dumped within the wildlife boundary, as per verbal instructions from the Department of Wildlife Conservation (DWLC).

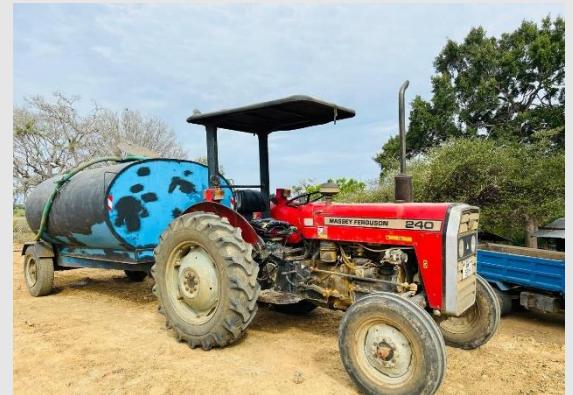
Watering was carried out during the transportation of construction and desilted materials to minimize dust generation.

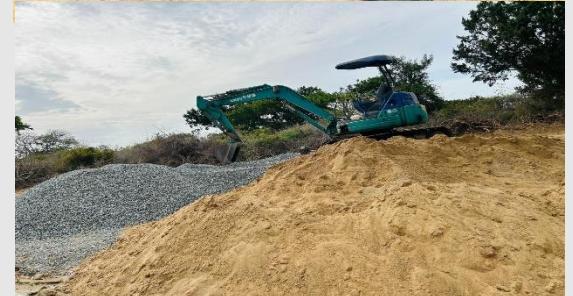
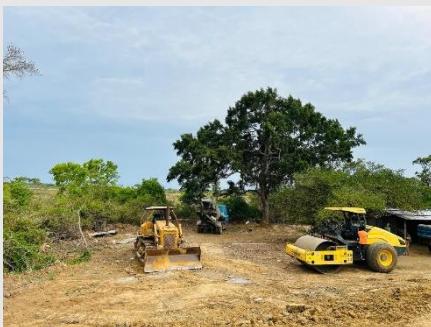
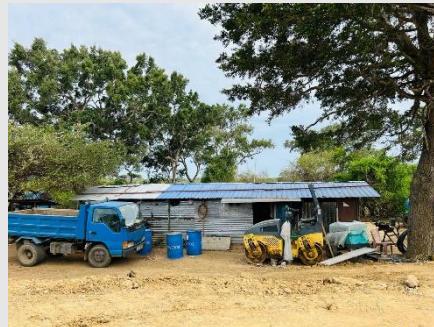
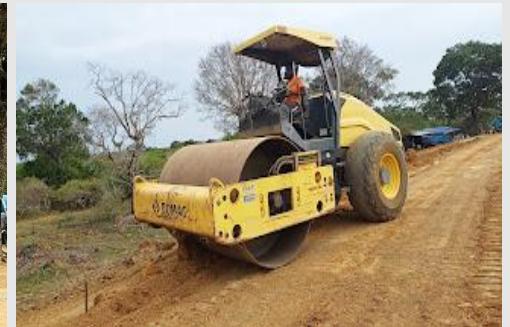
During the field visit, construction work was in progress. Construction materials and machinery were observed at the site, and a site office was also available.

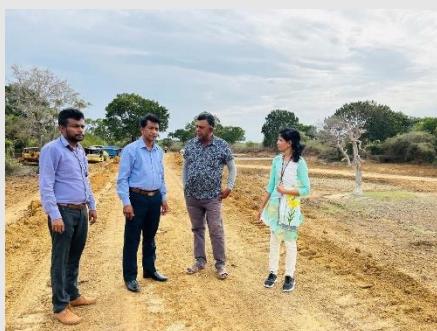
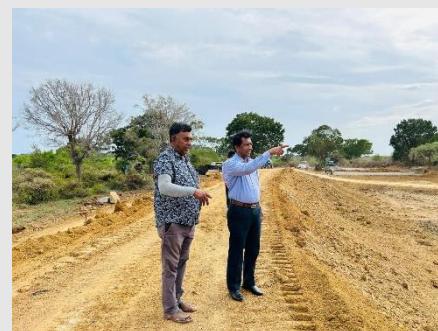
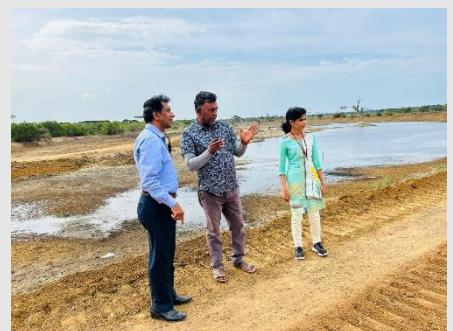
Field observation and discussions with the contractor conducted by the CSiAP team. And the safety sign board also displayed at the site.
