Field Visit Report
Wilmanna Tank Rehabilitation (Phase II – CSIAP)
Southern Province

FIELD VISIT REPORT

Wilmanna Tank Rehabilitation Site- SP

Date of Visit: 19/05/2025

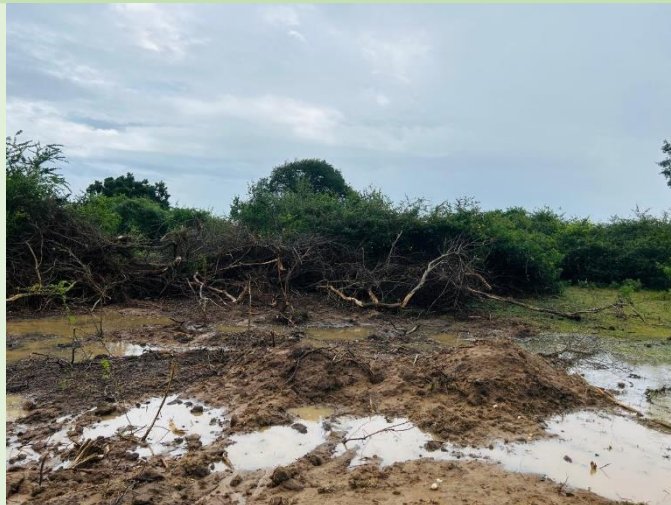
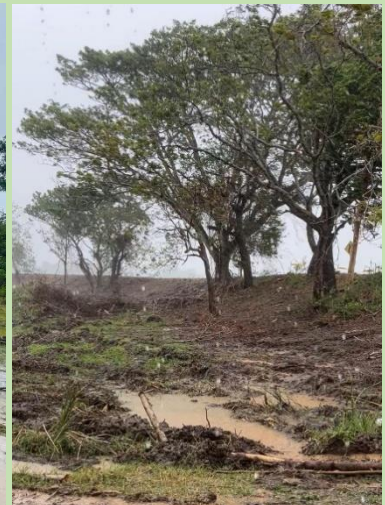
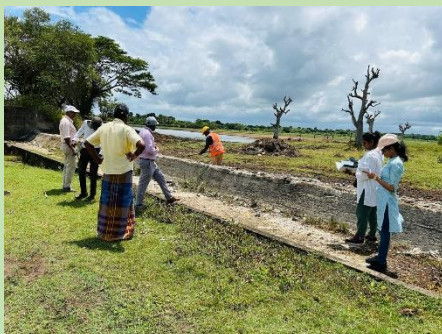
4. Farmers reported significant deviations in the weather pattern, with an unusual increase in rainfall. Due to unusually heavy rains over the past month, completion is now expected by **September 2025**.

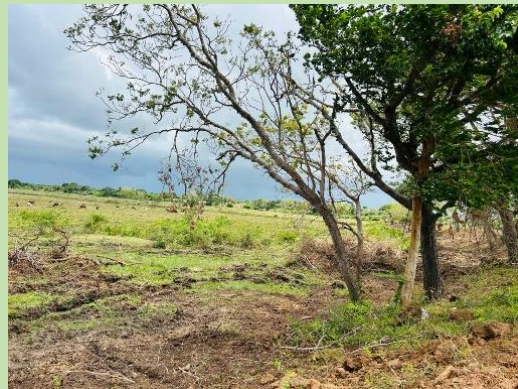
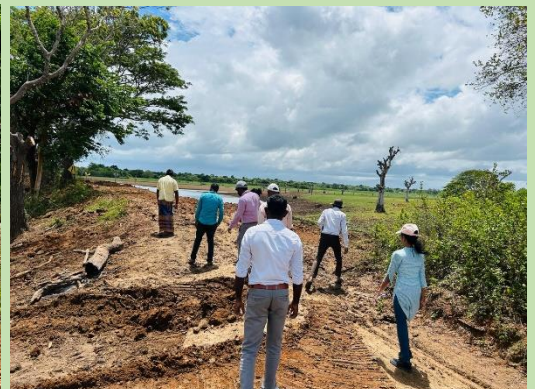
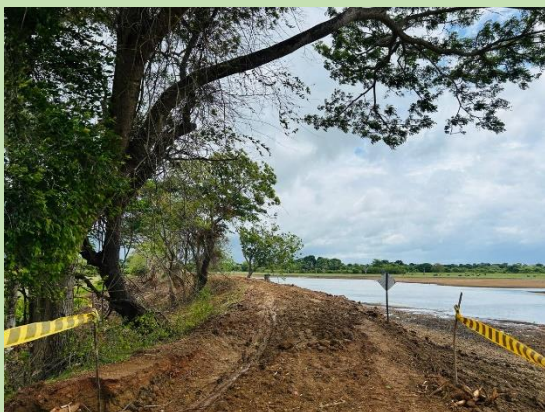
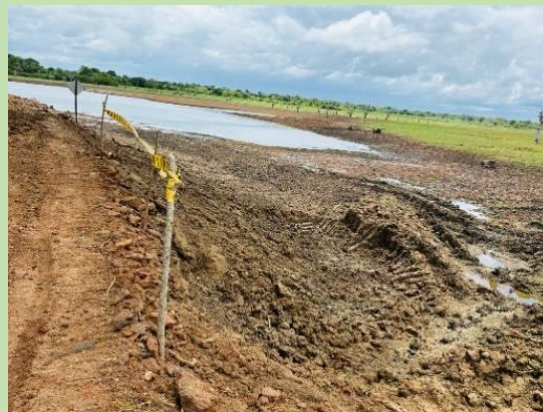
16. Farmers agreed to forego Yala paddy cultivation and requested the tank rehabilitation work be completed as soon as possible.
