Field Visit Report
Yoda Maha Wewa Rehabilitation (Phase II – CSIAP)
Southern Province

FIELD VISIT REPORT

YODAMAHA WEWA TANK REHABILITATION (PHASE II – CSIAP)

Date of Visit: 19/05/2025

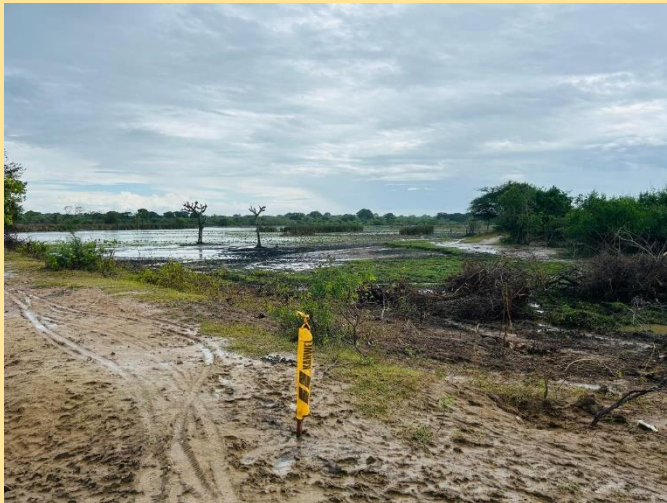
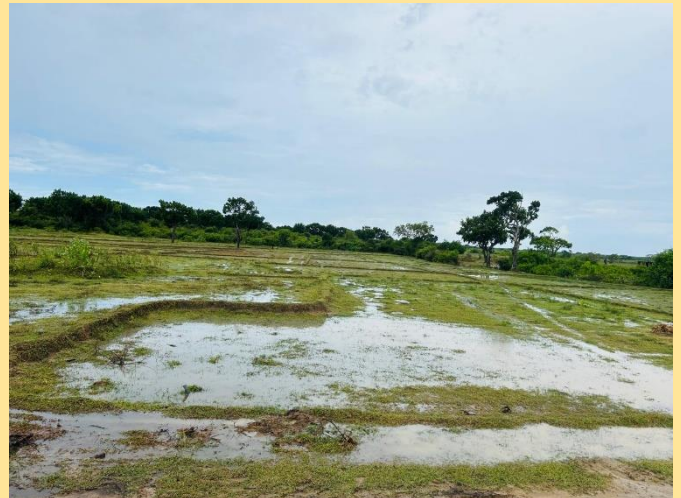
1. The **contractor** was in the process of **setting up a temporary hut** at the **work site** during our visit. Approximately **two laborers** were engaged in the **construction of the shelter**.
2. A **site rest house** is being set up; however, **work has temporarily stopped** due to **heavy rainfall**. During the **site visit**, **contractor representatives**, **Social Audit Committee (SAC)** members, and **Farmer Organization (FO)** members were **present and engaged in discussions**. The **contractor** has **rented a house** located **3 km away** from the **tank site** to **accommodate workers**.
3. Due to the risk of **wild animal encounters**, especially elephants, a request has been made by the contractor to install an **elephant fence** to secure the working area.
