Field Visit Report

Walas Wewa Tank Rehabilitation (Phase II – CSIAP)

Trincomalee, Eastern Province

The World Bank financed Climate Smart Irrigated Agriculture Project (CSIAP)

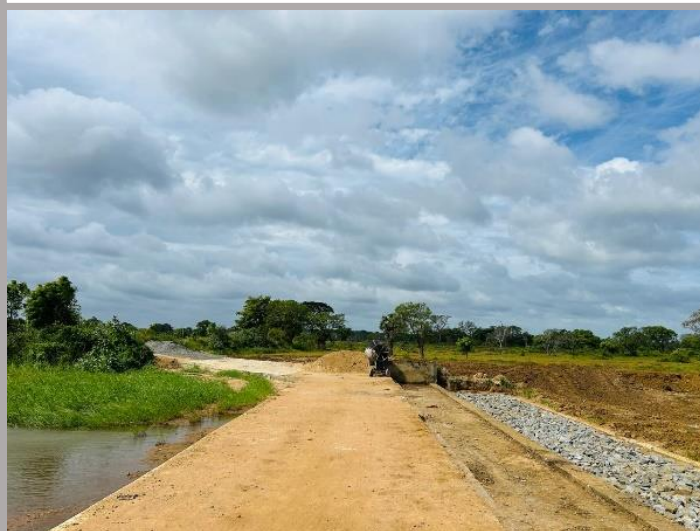
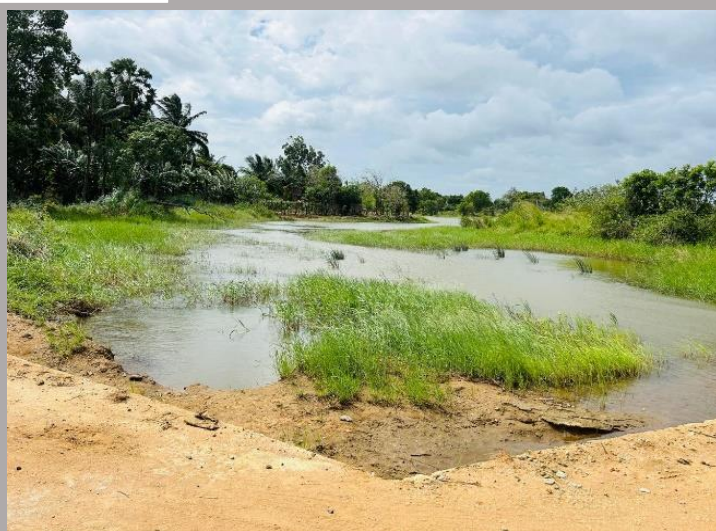
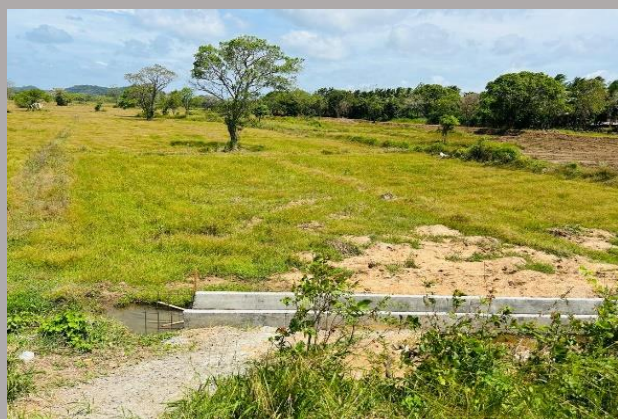
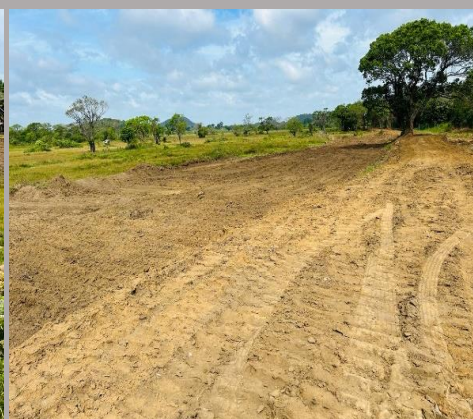
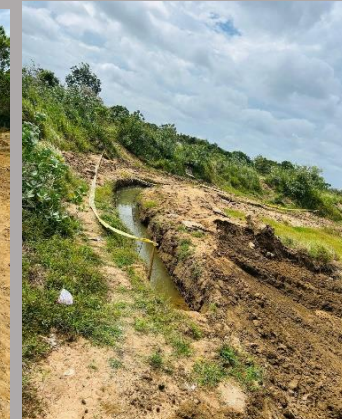
- A **technical officer** appointed by the DAD was **present** and actively maintaining the **site logbook**.
- **Work stopped** at the site on **20th April 2025**, and no contractor presence was recorded afterward.
- Completed works include **site clearing, excavation, causeway concreting and compaction, and initial framework** for concrete works.
- **Canal clearing and concreting** had started but was interrupted due to floods.
- A **temporary shed** at the site had **collapsed** and was unusable.
- The contractor stated that activities are **temporarily halted**, with no clear plan for canal work completion despite **dry weather**.
- **Artificial water drawdown** was done, and **farmers agreed to forego Yala 2025 cultivation**.
- **No heavy machinery** was observed at the site.

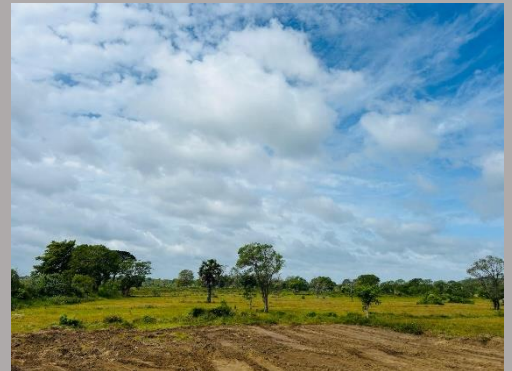
- Farmers agreed to forego Yala 2025 paddy cultivation due to tank rehabilitation.
- Usually, **12 farmers** cultivate around **6 acres**; this season, cultivation was **not done**.
- **Compensation** has been planned: affected farmer will receive **60 kg of green gram**.

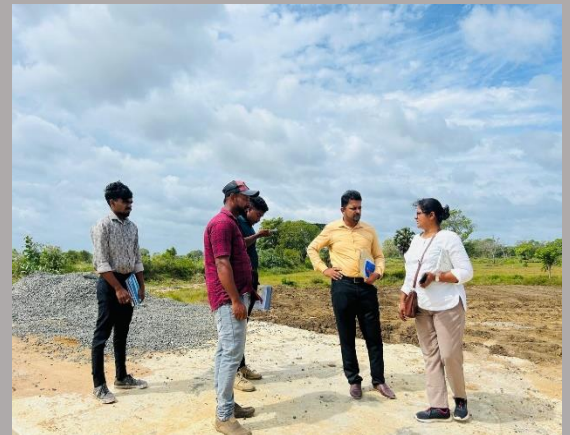
- No FO or SAC members were present or engaged during the visit.
- Coordination between contractor and farmers was **weak**.
- No SAC logbooks or documentation were available at the site.
- No grievances were reported, likely due to **lack of community participation**.
