Field Visit Report
Annuakkan Wewa Downstream Development/ Rehabilitation (Phase II – CSIAP)
Southern Province

FIELD VISIT REPORT

ANNUKKAN WEWA (DOWNSTREAM WORKS) REHABILITATION (PHASE II – CSIAP)

Date of Visit: 02/07/2025

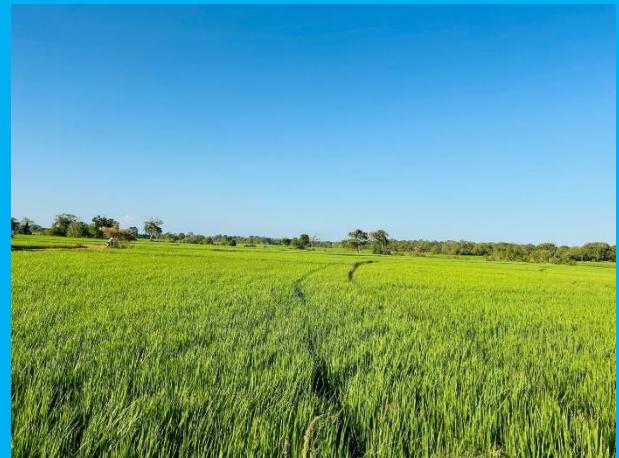
Annuakkan Wewa is undergoing minor irrigation rehabilitation, focusing solely on downstream canal works. The rehabilitation commenced in April 2025, with a scope limited to canal improvements and agricultural road rehabilitation. During the visit in April, it was observed that work had not yet started, and the contractor had only recently mobilized. However, due to continuous heavy rainfall, the contractor had been unable to begin the work. Meanwhile, paddy cultivation activities were ongoing.

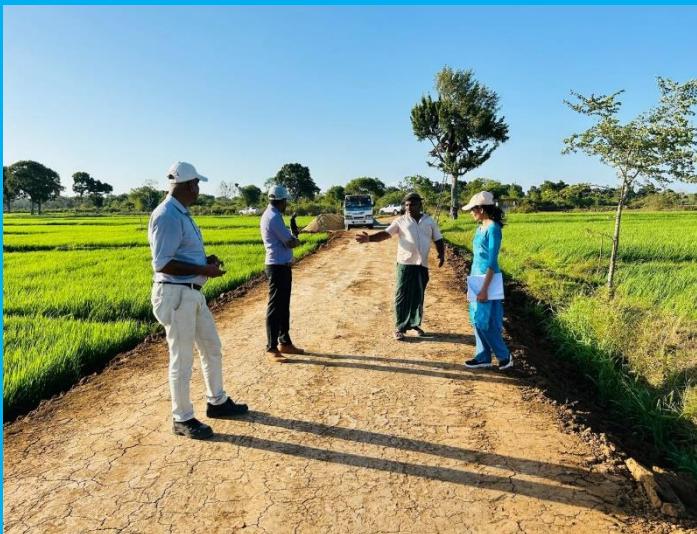
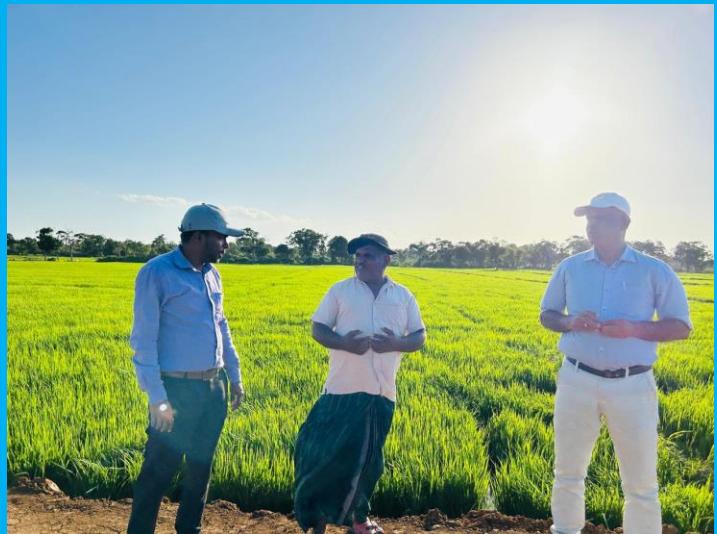
Representatives from the Farmers' Organization (FO), the Social Audit Committee (SAC), as well as officers from the DPDO technical team and the safeguard team, were present at the site.
