**Field Visit Report
Murunga Wewa Rehabilitation (Phase II – CSIAP)
Southern Province**

**The World Bank financed Climate Smart Irrigated Agriculture Project (CSIAP)
Ministry of Agriculture, Livestock, Land and Irrigation**

FIELD VISIT REPORT OF THE MURUNGA WEWA TANK REHABILITATION (PHASE II – CSIAP)

Project: Climate Smart Irrigated Agriculture Project (CSIAP) – Phase II

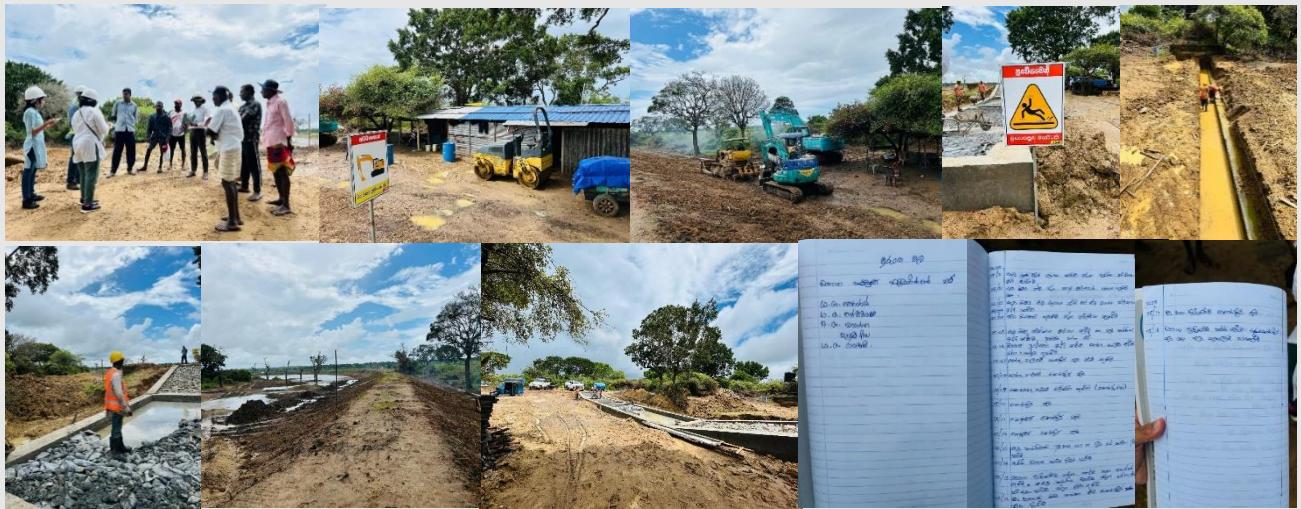
Photo taken on 19/05/2025

Usually, farmers do not cultivate during the Yala season, but due to high rainfall this year, water was available for cultivation. As a result, farmers had planned to cultivate paddy during the 2025 Yala season. However, following a request made by the CSIAF to the Wilmanna Suhuda Farmers' Organization (FO), the farmers agreed to forego Yala season cultivation this year to facilitate the tank rehabilitation. The rehabilitation activities were initiated with the full consent of the farmers.

The tank is located within a wildlife-protected area, and the necessary approval for rehabilitation has been obtained from the Department of Wildlife Conservation (DWLC). Elephant movements and crocodile sightings have been reported, with elephants frequently seen after 4:30 p.m. As a safety measure, contractors are not permitted to work after 6:00 p.m. A temporary elephant fence has been installed to protect workers and equipment. It was also reported that a wildlife officer regularly visits the site during major construction and rehabilitation activities. All relevant information, including vehicle numbers, worker names, and ID details, was submitted to the DWLC in advance.

Approximately 30% of the tank's water is retained to support wildlife, in accordance with guidance from the Department of Wildlife Conservation (DWLC). Farmers and SAC members confirmed their participation in the formation and ratification meetings. SAC members also received training on monitoring material quality, supervising construction work, and conducting rotational site visits.
